Title Diagnostic Trouble Codes ( DTC ) P20EE, P207F And P103C, Diagnostic Procedure - **R EPLACES GUIDED DIAGNOSTICS IN PREMIUM TECH TOOL ( PTT ) - US10+OBD2013 to US14+OBD2016 (Non-Common Rail) Emissions, Commonly Model Years 2014 To 2017**

Cause Procedures and checks to follow for P20EE, P207F or P103C on US13 to US16 chassis.

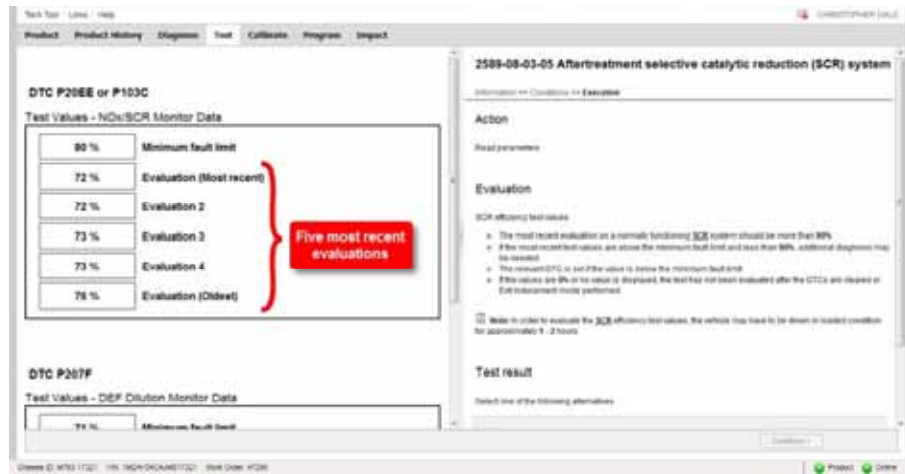
- The last five efficiency evaluations are displayed as shown in the screenshot above.

If all five tests are below the fault limit, SCR conversion has been poor for an extended amount of time.

If only one or two are below the fault limit, conversion is only intermittently poor.

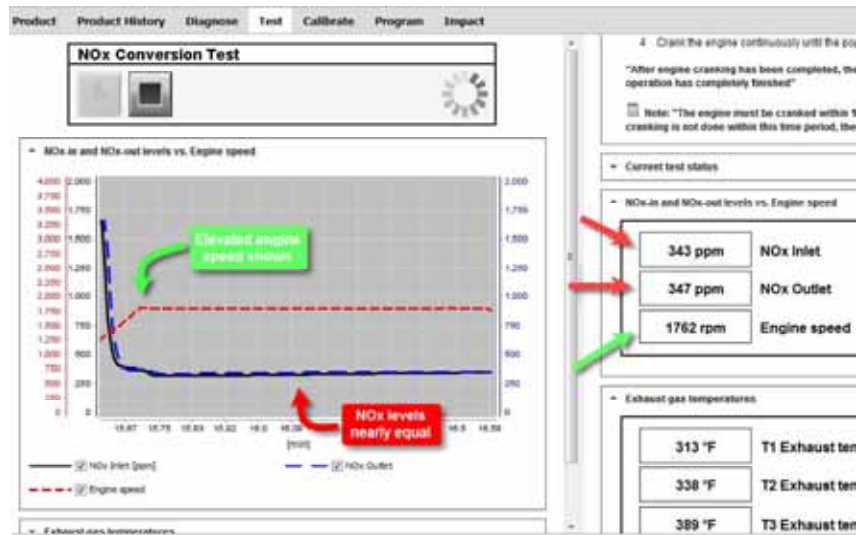
- **Note:** This test checks the function of both NOx sensors. It does not evaluate SCR efficiency.
  - While running the routine if you get new NOx sensor fault code (Egs: P220E-93 , P220F-93), then troubleshoot that fault code. Typically P220E-93 fault code suggests replacement of NOx1 sensor.
  - Inlet and Outlet NOx Sensor values should be close to each other at high engine speed (last portion of the test) as shown below.
- If during the test difference between NOx sensors are greater than 10%, we recommend replacing sensor reading higher value and re-do the test.

The likelihood that both sensors require replacement at once is low. Replacement of both sensors at once should not be considered immediately unless affected by an upstream failure.
