Check engine light on and fault codes P3005A9, P3005FF, P30074B in CDI Control Unit

Topic number	LI09.40-N-070781
Version	1
Function group	09.40 Turbocharger
Date	01-21-2020
Validity	907 with OM642, vehicle manufacturing date up to and including 15.11.2018
Reason for change	Cleanpoint, additional example image and further relevant countries added.
Reason for block

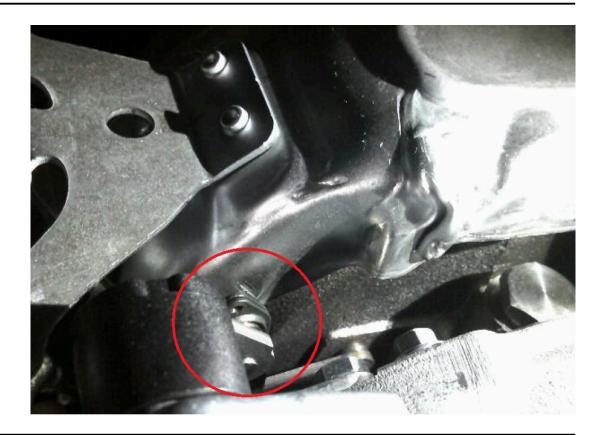
Turbolader.jpg:

Control rod of boost pressure regulator chafes on heat shield of exhaust gas turbocharger.

Installation of a new exhaust gas turbocharger heat shield A 642 096 1968.
