MBUX multimedia system (CONNECT907) : ESP menu not visible in central display

Topic number	LI82.60-N-070784
Version	1
Function group	82.60 Radio, audio, video systems
Date	01-21-2020
Validity	Model 907 with code E3M-E1E (MBUX 7-inch without navigation) up to FIN N001897; P005545 (up to and including manufacturing date 3rd May 2018)
Reason for change	Title and validity updated.
Reason for block

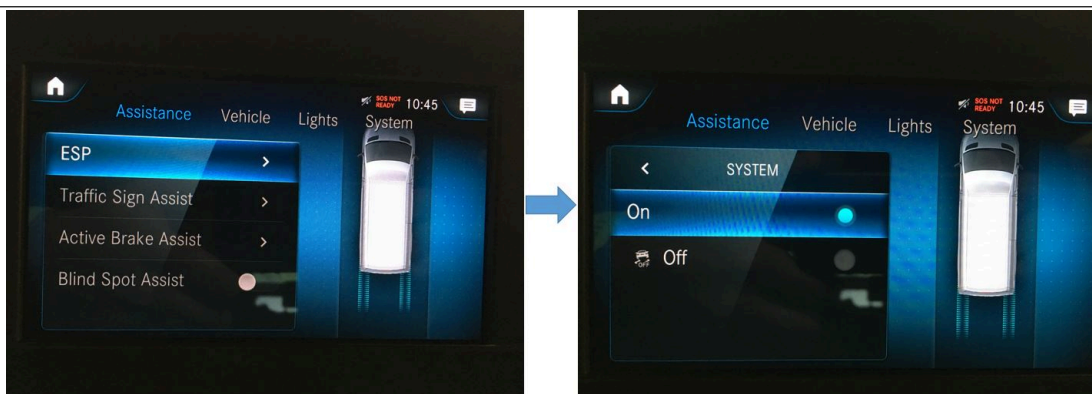
ESP-Menu_en.JPG:

Attachments	
File	Description
ESP-Menu_en.JPG	ESP menu available
