Title Diagnostic Trouble Codes (DTC) P20EE And P103C, Diagnostic Procedure; **REPLACE S GUIDED DIAGNOSTICS IN PREMIUM TECH TOOL ( PTT ) - US17+OBD16 Through US17+OBD2018 Emissions, Model Years 2018 And 2019**

Cause Procedures and checks to follow for P20EE and P103C on US17+OBD2016 and US17+OBD2018 chassis.

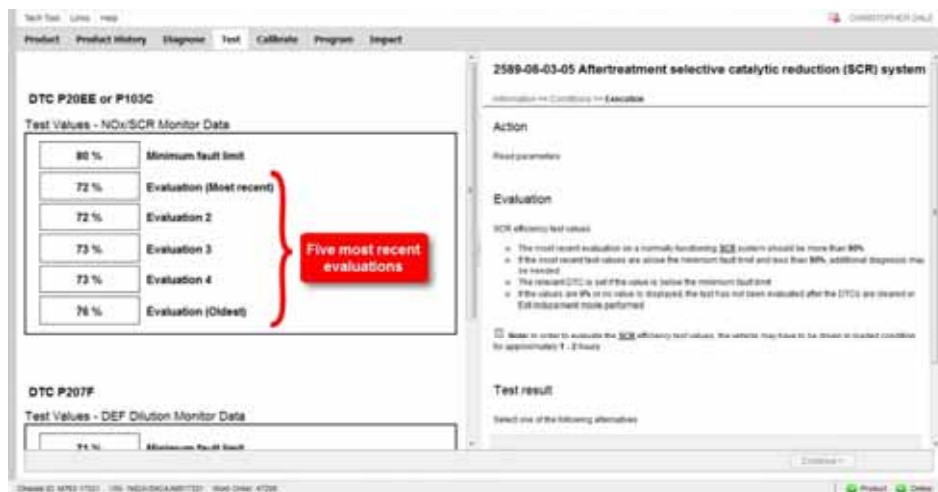
- The last five efficiency evaluations are displayed as shown in the screenshot above.

If all five tests are below the fault limit, SCR conversion has been poor for an extended amount of time.

If only one or two are below the fault limit, conversion is only intermittently poor.

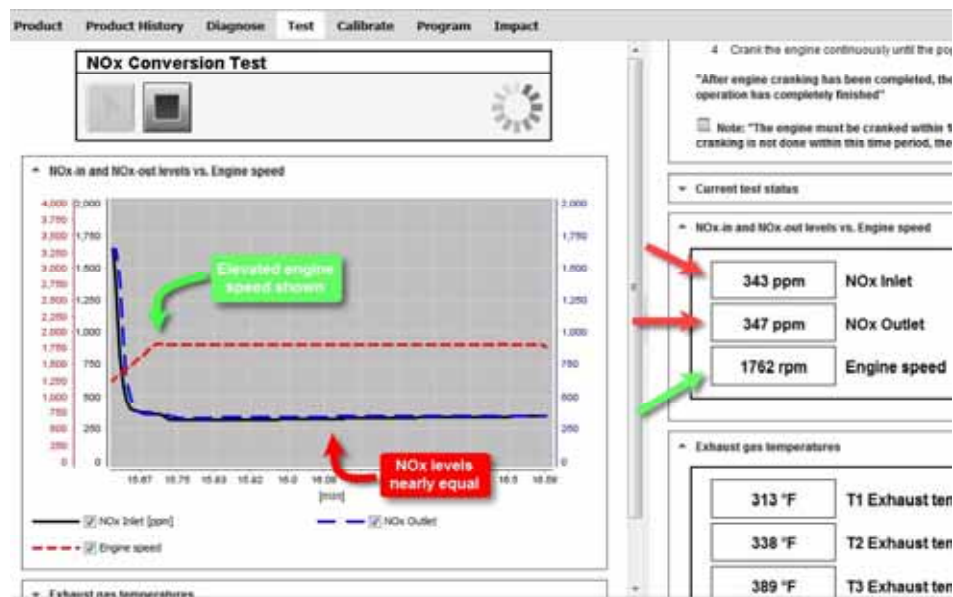
- While running NOx conversion test, if any new NOx sensor codes are logged (Egs: P220E-93, P220F-93), make sure to troubleshoot those codes.
- Inlet and Outlet NOx Sensor values should be close to each other at high engine speed (last portion of the test) as shown below.
- If during the test difference between NOx sensors are greater than 10%, it is recommended to replace the sensor reading the higher value and re-do the test.

The likelihood that both sensors require replacement at once is low. Replacement of both sensors at once should not be considered immediately unless affected by an upstream failure.

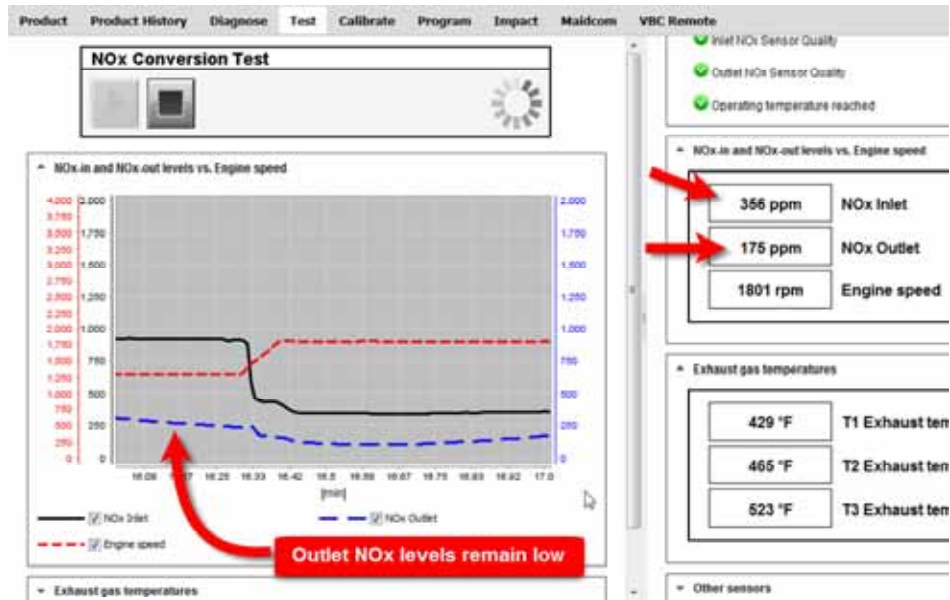
EMS Main Software Part Numbers 23470183 and 23470187, used for US17+OBD18 emissions, has a bug that allows DEF dosing to continue during the NOx conversion test. This causes continued low Outlet NOx sensor values as seen in the screen shot below and prevents the desired behavior shown above.

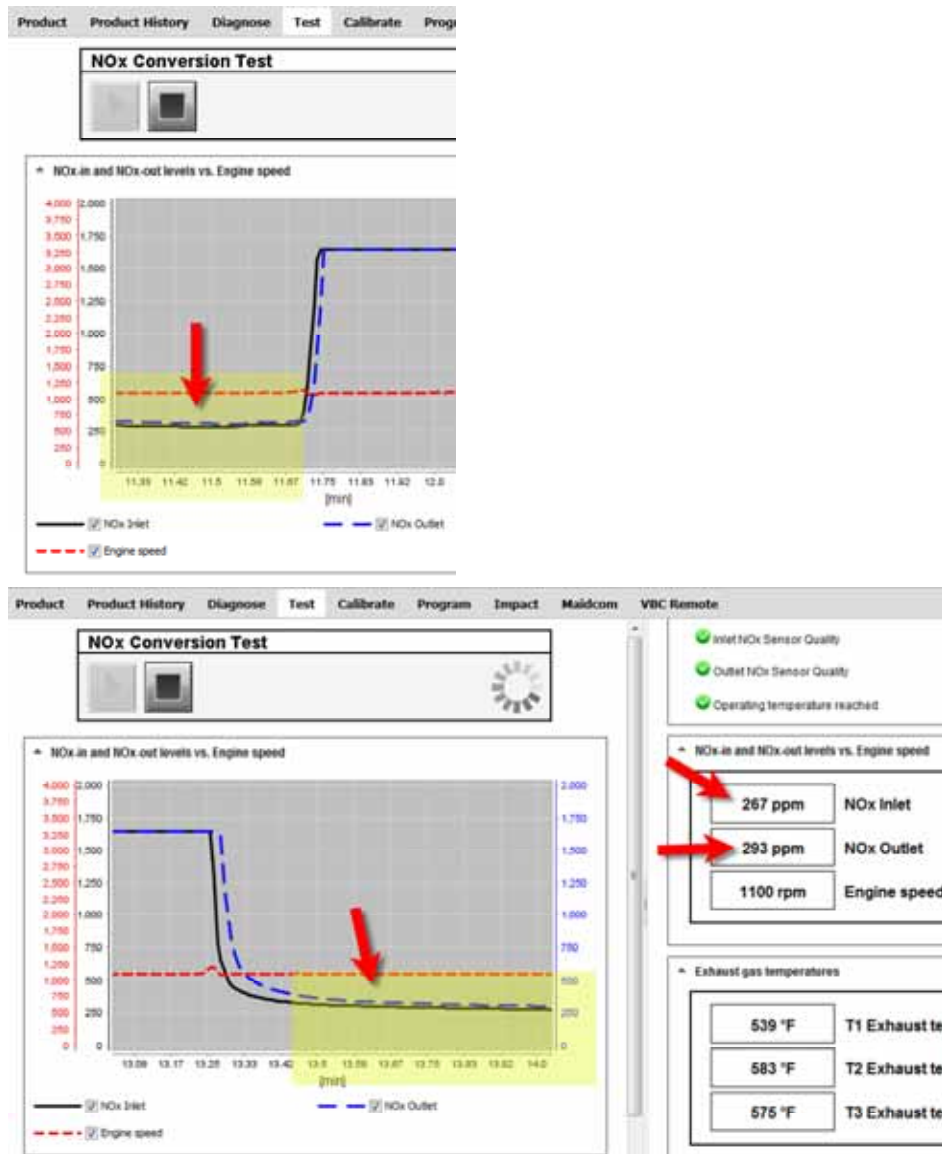
In this instance, review earlier sections of the test to ensure that both sensors are responding to changes in the same manner. Examples of different stages to review are shown below.

**COMPARISON SHOULD BE DONE WHEN BOTH NO<sub>x</sub> SENSORS ARE READING BELOW 600 PPM.**
