Technical Service Bulletin

20 MIL on or difficulty refueling, DTC P045100, P044100, P202500, and/or P045300 stored in the ECM

20 20 25 2050276/5 February 12, 2020. Supersedes Technical Service Bulletin Group 20 number 19-24 dated December 18, 2019 for reasons listed below.

Model(s)	Year	VIN Range	Vehicle-Specific Equipment
A6, A7	2016 - 2018	All	3.0T

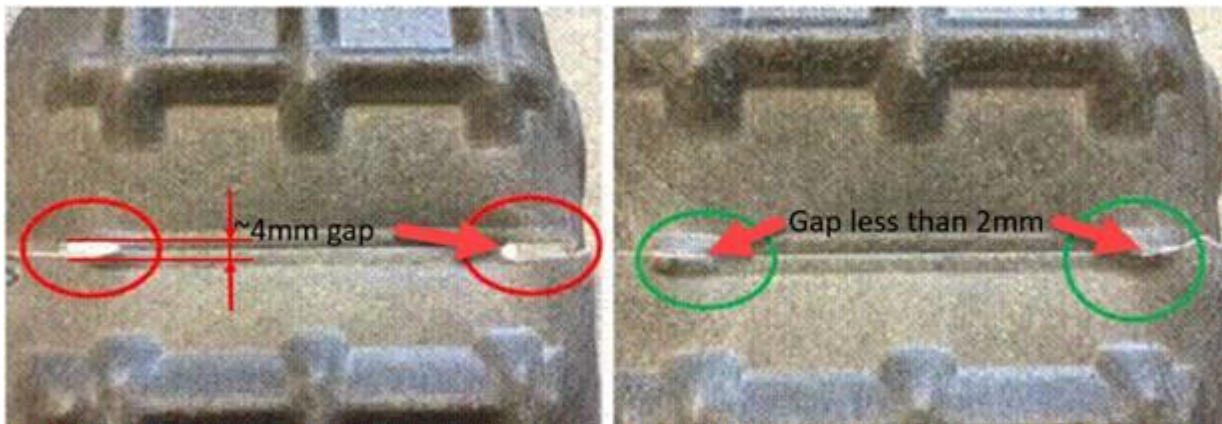
Figure 1. How to determine which steps to take Version 1 (~4mm gap) or Version 2 (gap less than 2mm).

Version 1 (A6 only):

1. If the updated wheel liner has not yet been installed. Then install the updated wheel liner, which has closed slots around the NVLD filter.
 - Remove the EVAP canister, ventilation tube, and NVLD pressure switch.
 - Remove all components mounted on the EVAP canister.

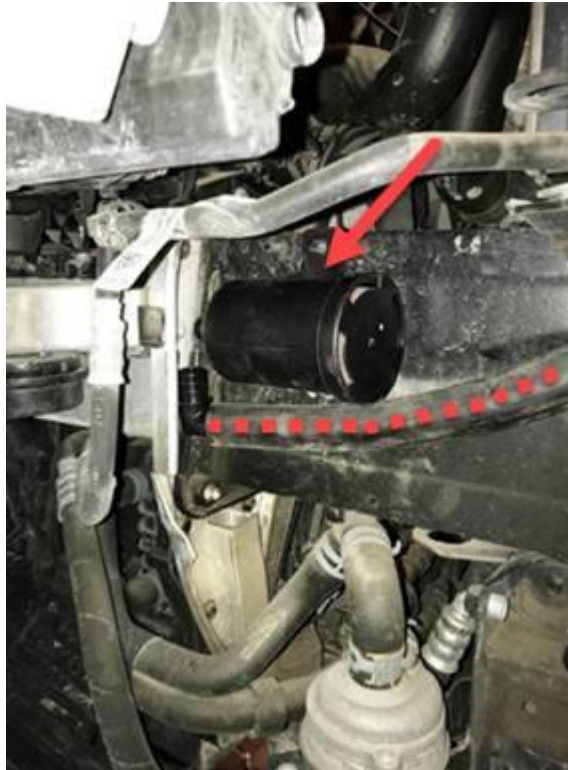
Figure 3. Installing the new NLVD filter.

1. Replace the EVAP canister only if weight is greater than 2650 grams.
 - Install a new J909.
 - Install the NLVD filter (new part number, Version 2) in the engine compartment on the left frame rail just in front of the ABS module, secure with M6 nut. (Figure 3).

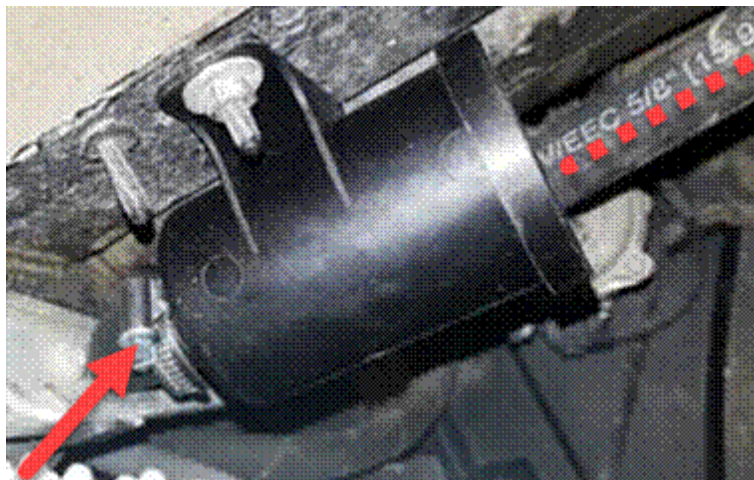
Figure 4. Connecting the NLVD filter.

2. Connect the filter to the 5/8" ID rubber hose via 1x plastic elbow and 1x rubber elbow (Figure 4).

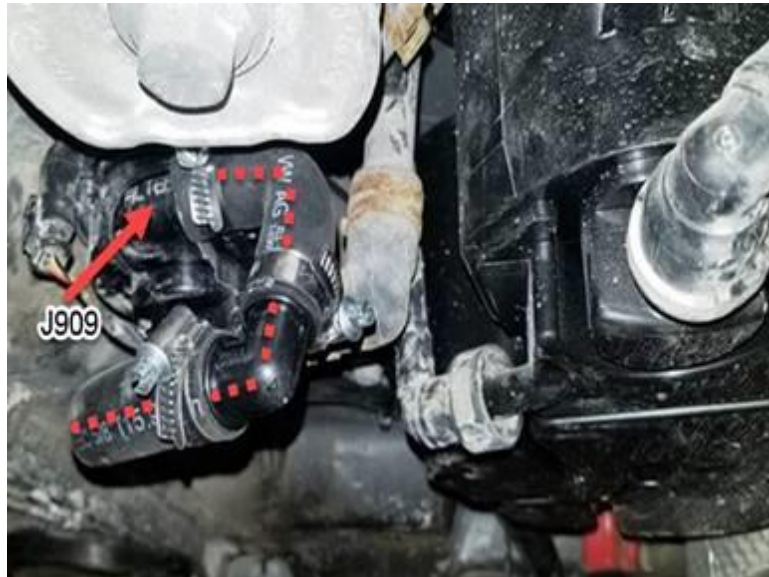
Figure 9. Closer look at the connections.

5. Before connecting 5/8" ID rubber hose to 90 degree connector, cut to length, as needed. Connection details to the J909 are shown in Figure 8 and 9.

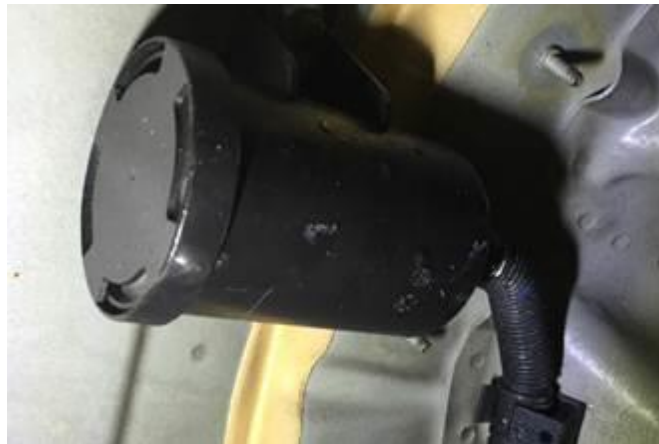
Figure 10. Remove original NVLD filter.

6. Remove original NVLD filter assembly. (Figure 10).
