Technical Service Bulletin

70 Noises from headliner/sunroof area

70 20 70 2044417/8 February 20, 2020. Supersedes Technical Service Bulletin Group 70 number 17-65 dated November 1, 2017 for reasons listed below.

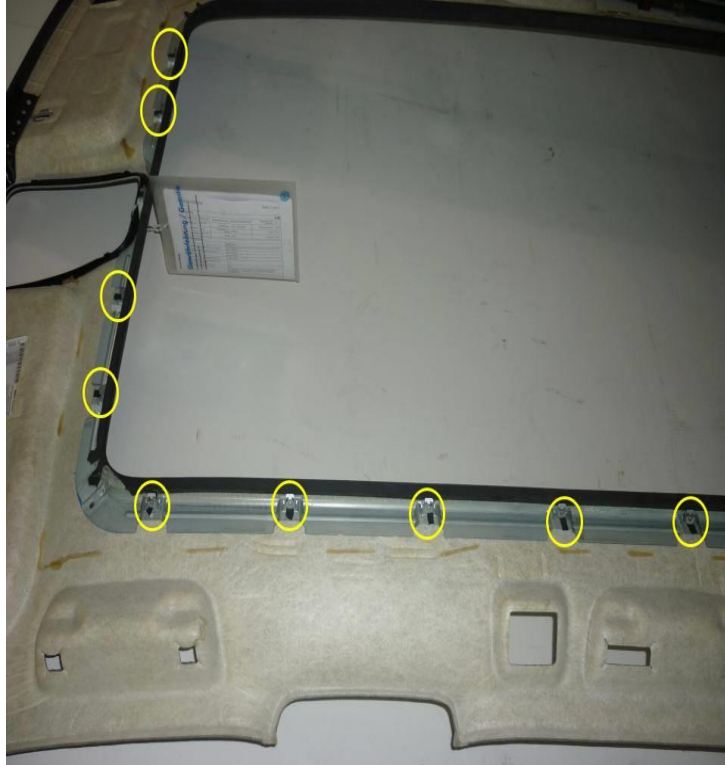
Figure 1. Location of the headliner to sunroof frame clips.

1. Test drive the vehicle (preferably with the customer) and duplicate the noise. Applying pressure to areas of the headliner around the perimeter of the sunroof will eliminate the noise, confirming the root cause.
2. Remove the headliner. The clips shown in the illustration will need webbing adhesive tape (D 004350A2) (Figure 1).

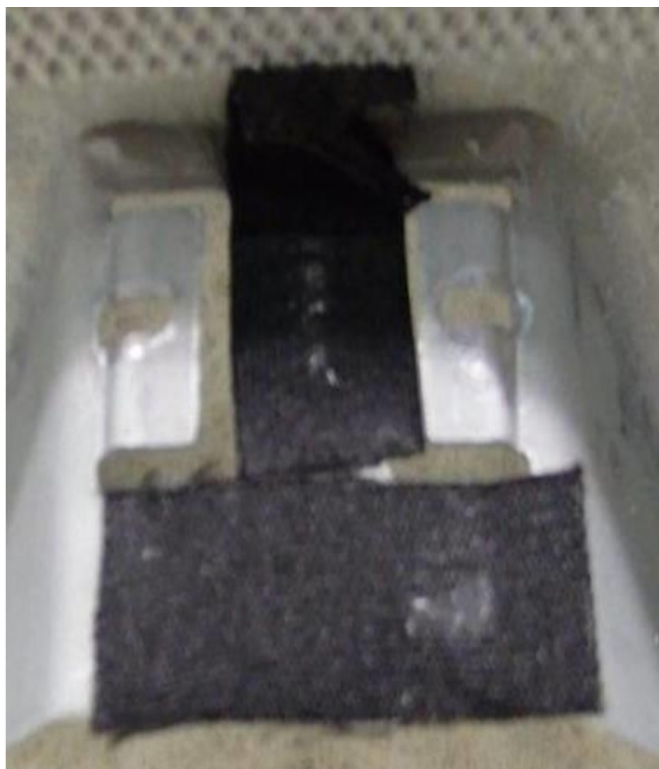
Figure 2. Location of the webbing adhesive tape application.

3. Remove the clips and apply the webbing adhesive tape underneath them, as shown (Figure 2).

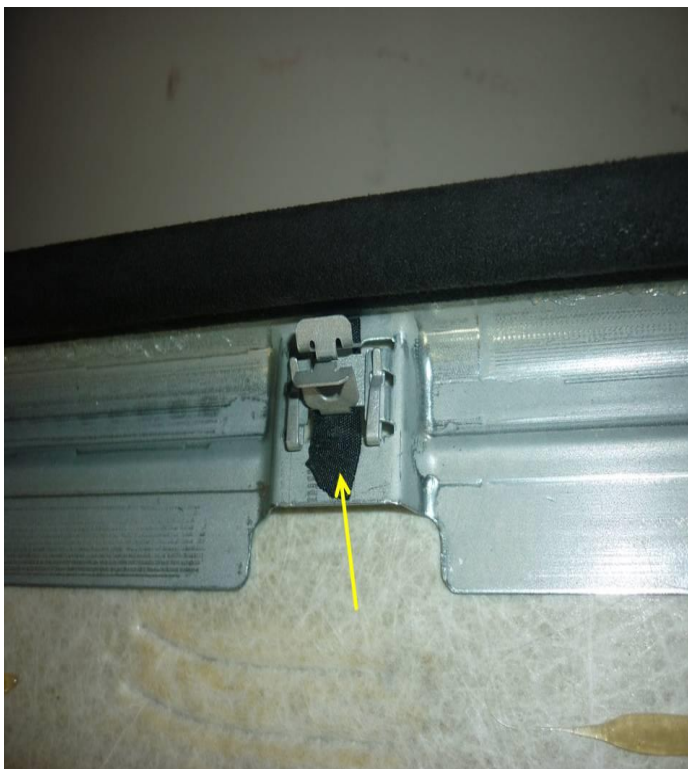
Figure 3. Clips reinstalled.

4. Reinstall the clips (Figure 3).

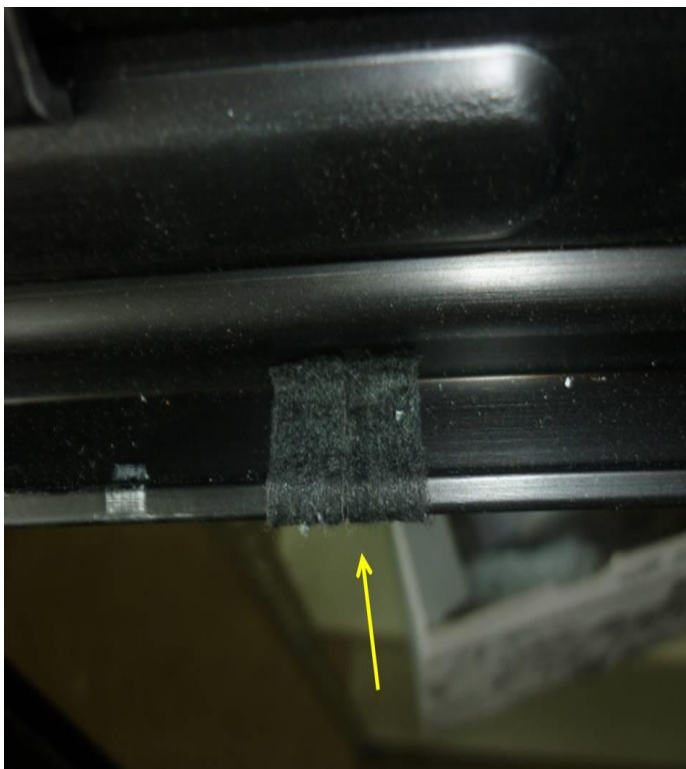
Figure 4. Application area on sunroof frame area of clip engagement.

5. Apply webbing adhesive tape to the sunroof frame lip at each clipping point (Figure 4).

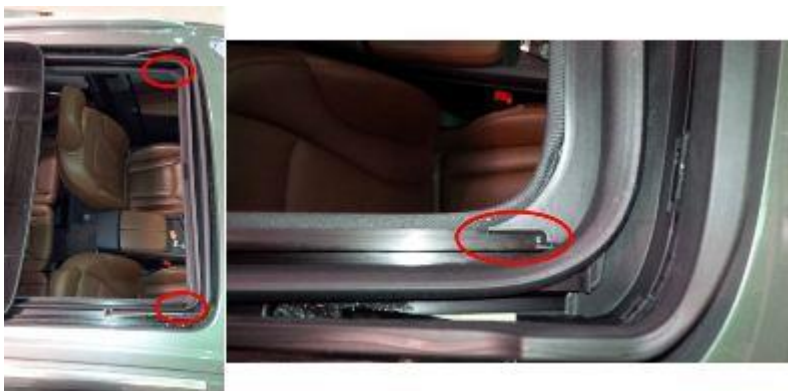
6. There are two additional points of contact at the front sunroof frame plates that could be a source for noise (Figure 5).

Figure 5. Areas of the sunroof frame to be isolated with webbing adhesive tape.

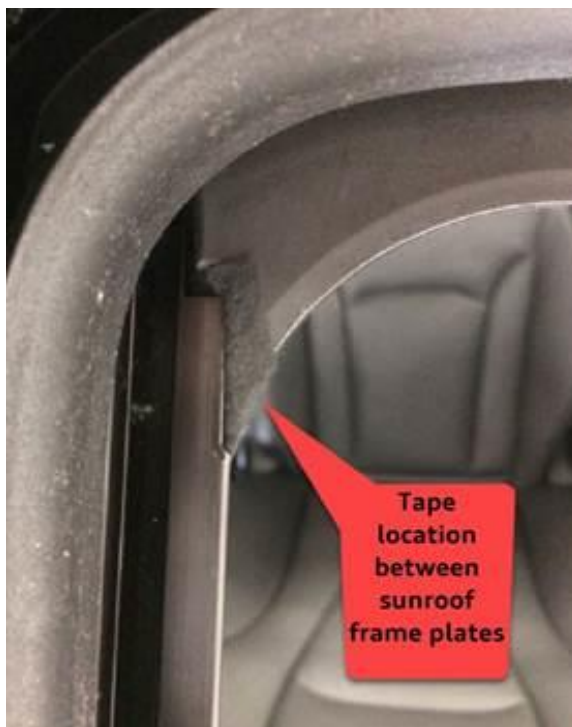
Figure 6. Webbing adhesive tape applied between the side and front sunroof frame plates.

7. Apply webbing adhesive tape between the sections of the sunroof frame plates on both the right and left sides as shown in the illustration (Figure 6).
