# Technical Service Bulletin

## 91 SOS Warning displayed in the instrument cluster, no communication to the telematics control module

91 20 40 2056076/7 February 21, 2020. Supersedes Technical Service Bulletin Group 91 number 20-28 dated January 14, 2020 for reasons listed below.

Model(s)	Year	VIN Range	Vehicle-Specific Equipment
A4, A5	2019	All	With ConBox
A6, A7, A8, Q5, Q7, Q8, and Audi e-tron quattro	2019 - 2020	All	With ConBox

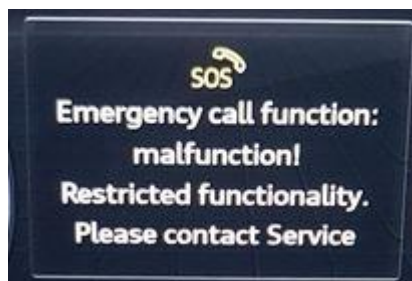
- An SOS Warning is displayed in the instrument cluster (Figure 1).

Figure 1. Emergency call malfunction warning.

- No diagnostics communication can be established with the control module for emergency call module and communication unit (telematics control module or ConBox), J949 (address word 0075).

A software bug can cause the control module to freeze during cold start.

1. Remove and unplug the telematics control module, J949 (address word 0075) according to the repair manual in Elsa.
2. Open the battery compartment of the telematics control module, J949 (address word 0075) and disconnect the backup battery.

3. Leave the battery disconnected for approximately 60 seconds.
4. Reinstall the backup battery back into the telematics control module, J949 (address word 0075).
5. Reinstall the telematics control module, J949 (address word 0075) back into the vehicle.
6. **If ODIS still cannot connect** to the telematics control module, J949 (address word 0075), follow the ODIS test plan.

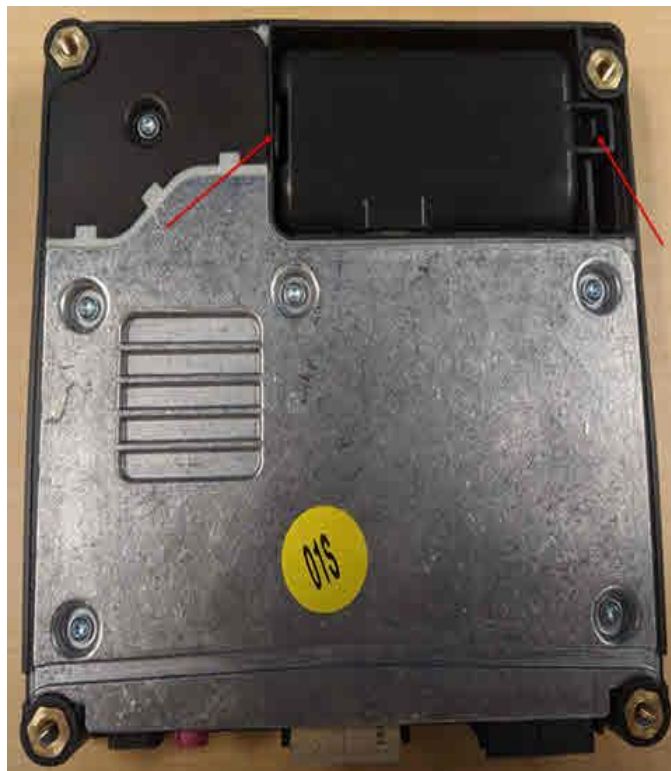
*Figure 1. Backup battery compartment location.*

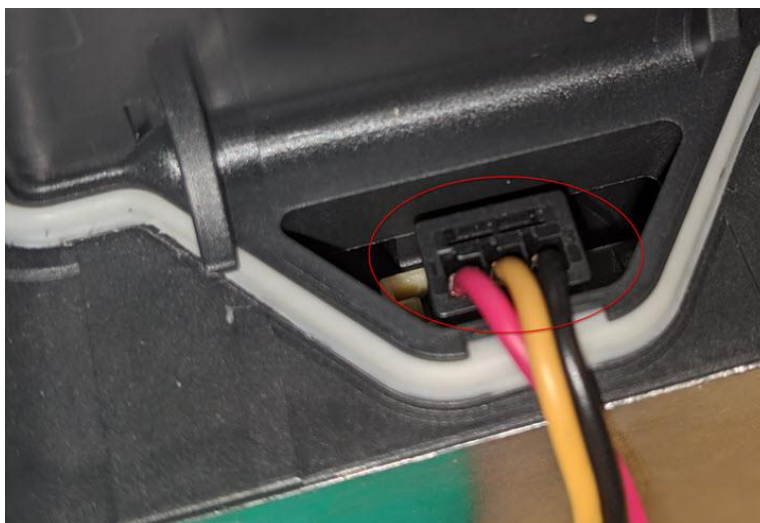
**Figure 2.** Backup Battery connector (no release mechanism).
