Service Bulletin

Bulletin No.: 19-NA-279

Subject: Radio Software Version V807 Over-the-Air Update

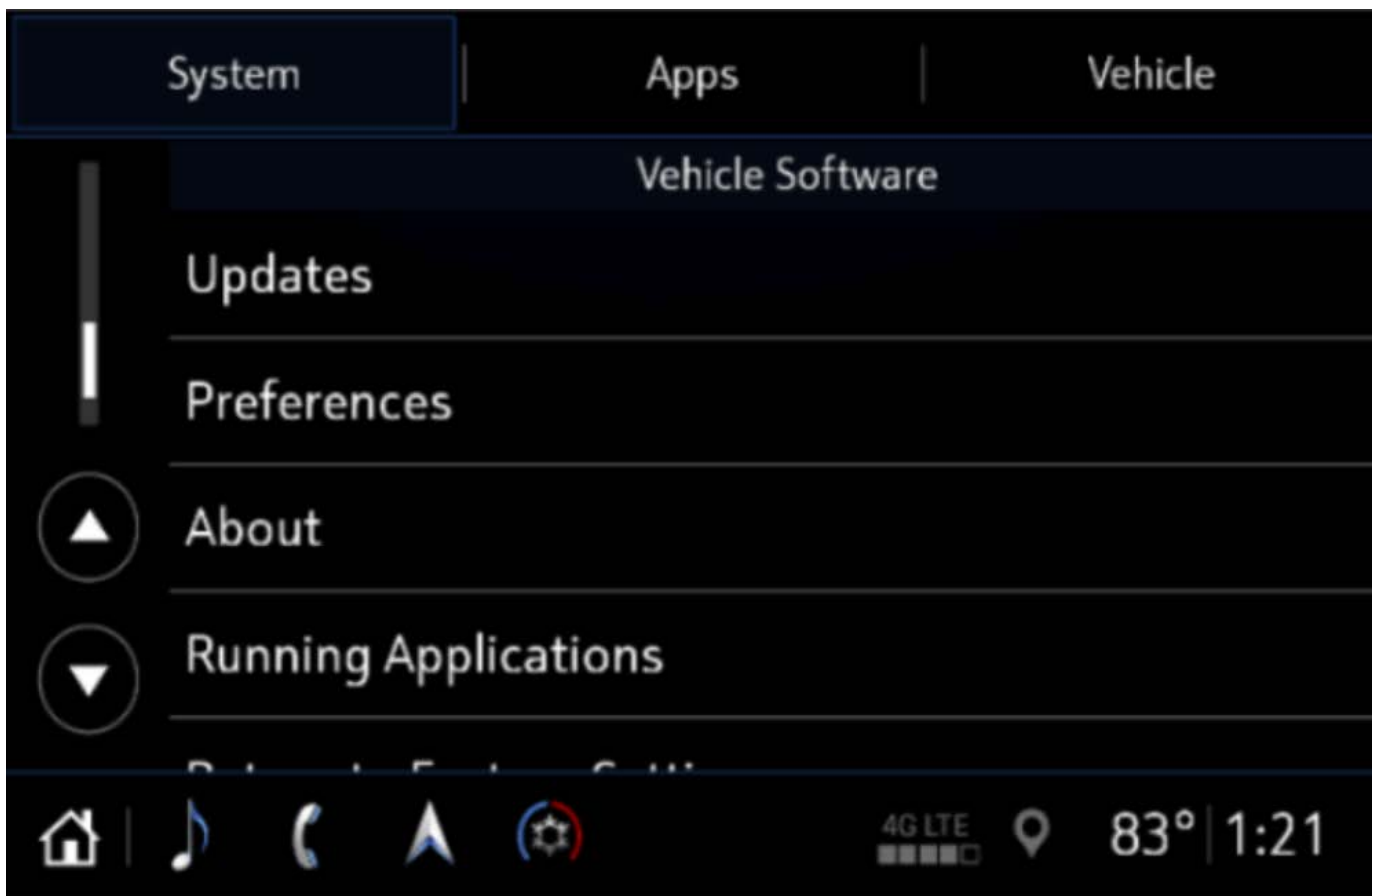
5313331

The process used for this update is dependent on the status of the software on the module and if the module already has a remote install package downloaded. To verify if an update package is already on the vehicle, open “Settings” and then scroll to “Updates” on the radio screen. If an update is shown under the “Updates” screen, proceed to the **Update Procedure Using Remote Vehicle Update** section of this document.

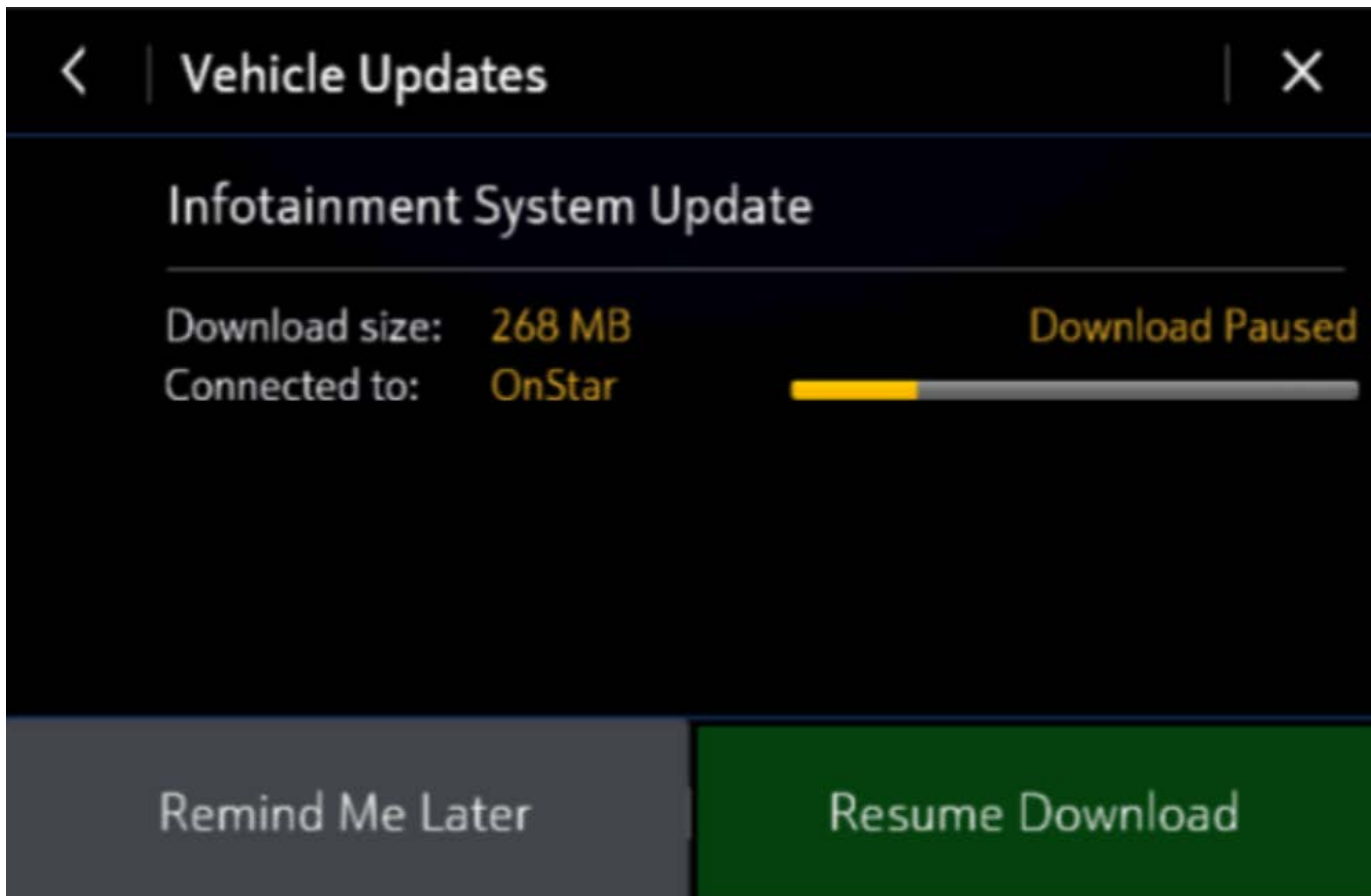
5313332

If no update is shown (see “No Updates Available” image in next section), go to the “About” screen and verify the build number (i.e., L206, V507, V509, V803 etc.). If the build number is less than V807, proceed with the software update following the **Update Procedure Using TIS2WEB (USB Download)** section of this document.

Caution: If Vehicle Update screen shows “Infotainment System Update” (such as the screen above) do not use TIS2WEB or insert a USB stick. Use of the USB stick when the Remote Update has already been downloaded, installed, or paused during installation could result in program failures or module lockup condition. The update should be completed using the Remote Vehicle Update procedure, following prompts on the infotainment screen. Refer to Update Procedure Using Remote Vehicle Update after reading the remaining information in this section if the Remote Update has already been downloaded to the radio.

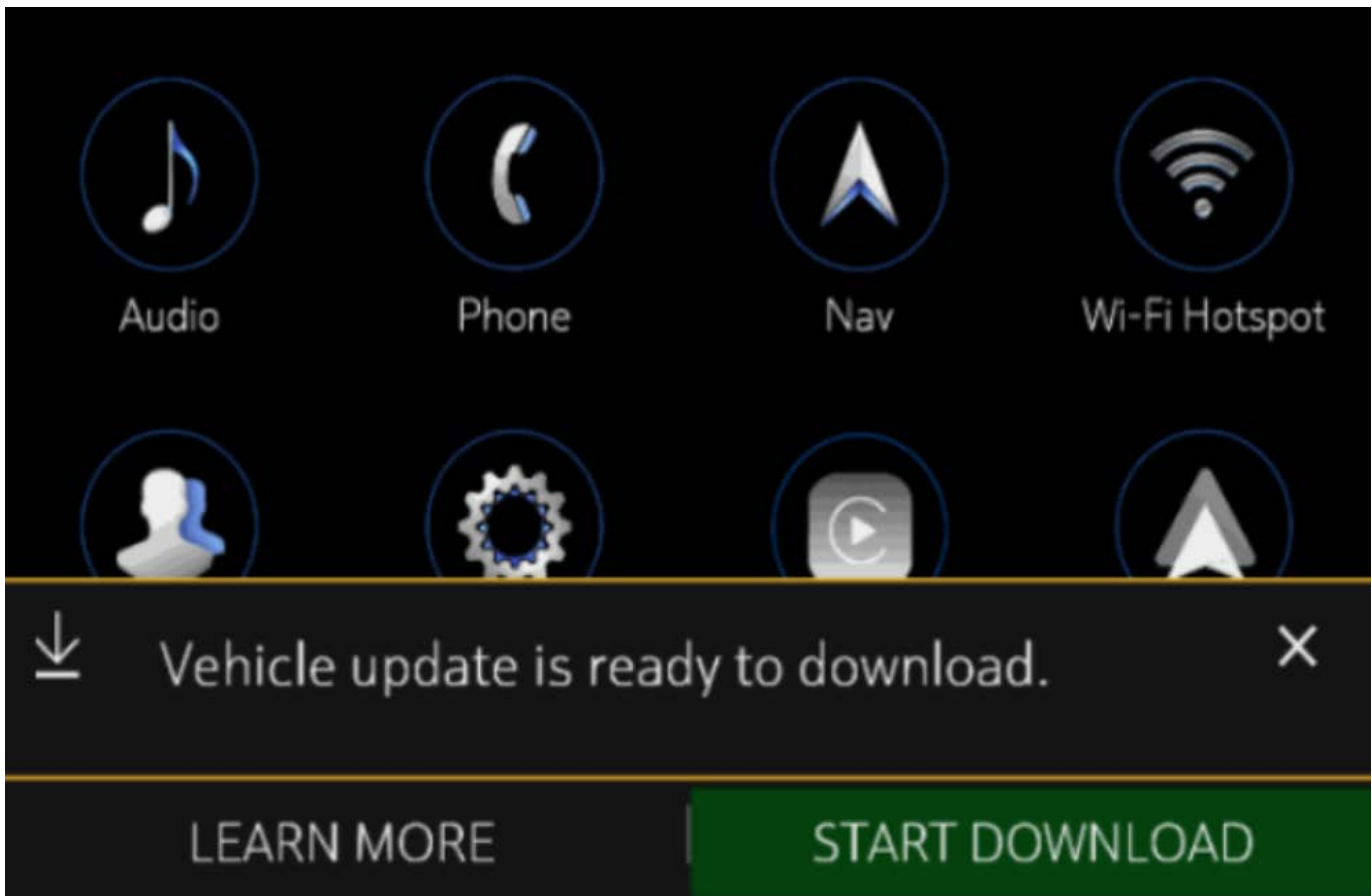
5313328

1. If a remote package is on the system, you may see the below pop up.
 - If the remote vehicle update has not been downloaded, select “Start Download,” wait for the download to complete and then follow the prompts to complete installation.

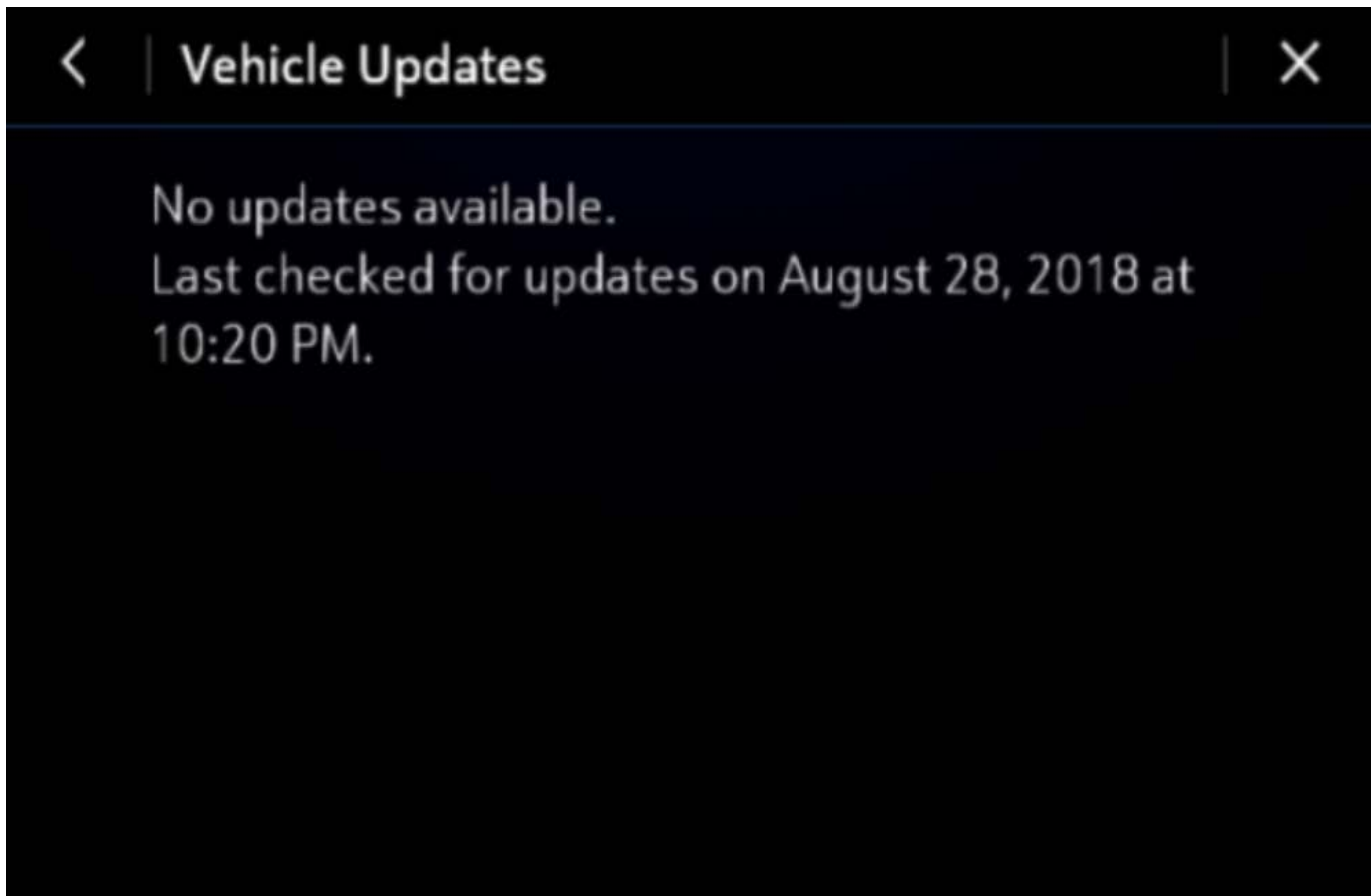
5313324

2. If no "Start Download" or "Install Now" pop up is displayed, navigate to "Settings" -> "Updates." If there is a remote package on the system, it will display "Install Now" Or "Start Download." If the screen below is shown, then there is no remote update package on the system. Navigate to Settings -> About to verify the software version. If the build number is not V807 or greater, update via USB.

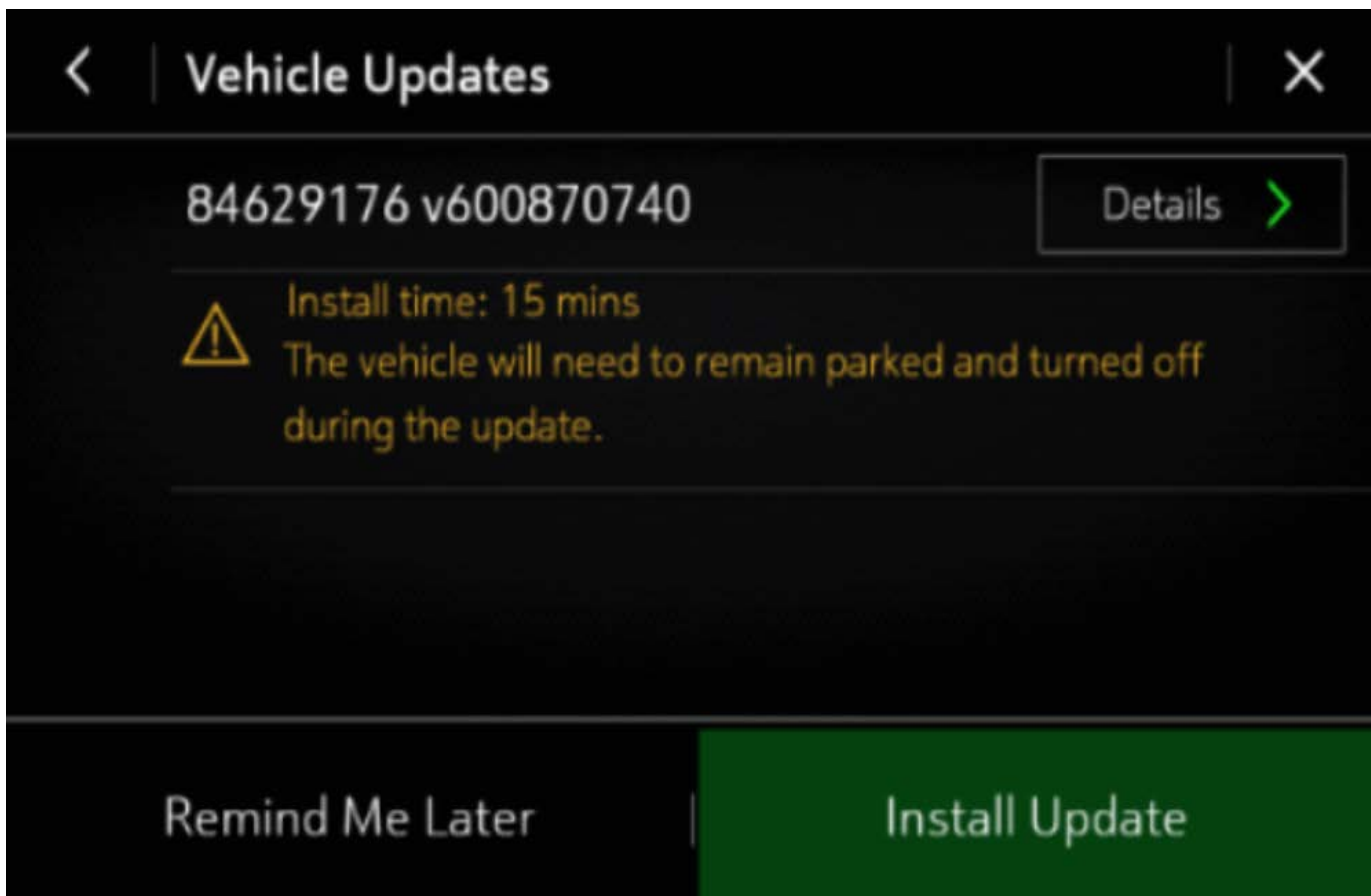
5313321

2. Record SPS Warranty Claim Code on job card for warranty transaction submission.
3. Insert the USB into the vehicle while in Park. On the radio screen, select "Settings" —> "Updates" or select "Learn More" on pop up after USB insertion.
4. Select Install Update.
5. Follow on screen prompts to complete the update.

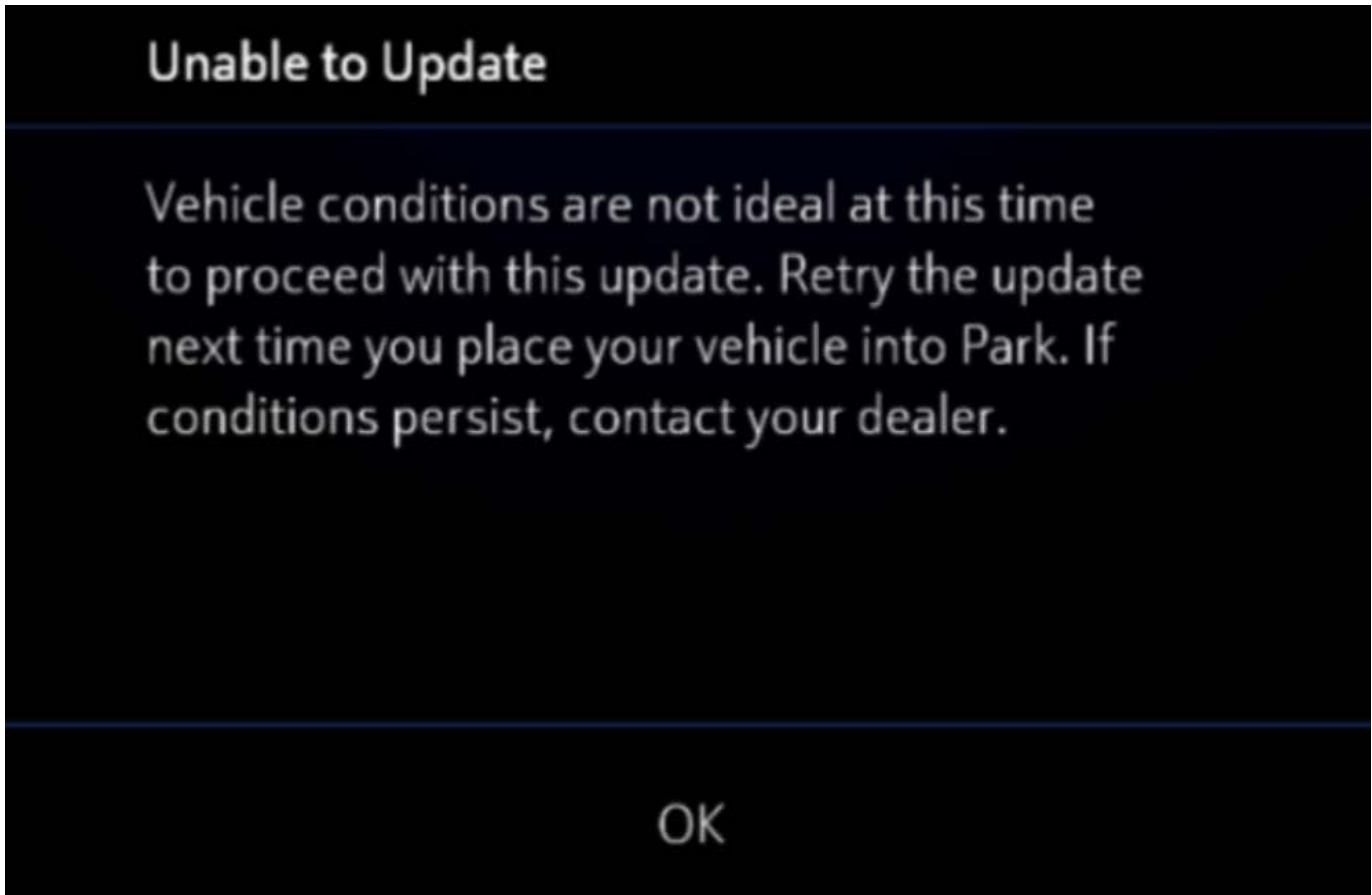
5313329

Scenario 1: Vehicle conditions are not ideal.

If the above screen is shown, download the update through TIS2Web and perform USB update. Upon USB insertion while vehicle is running, the "Install Now" pop up will be presented. Ensure the vehicle battery is being maintained (using EL-49642 or battery maintainer) while performing this update.

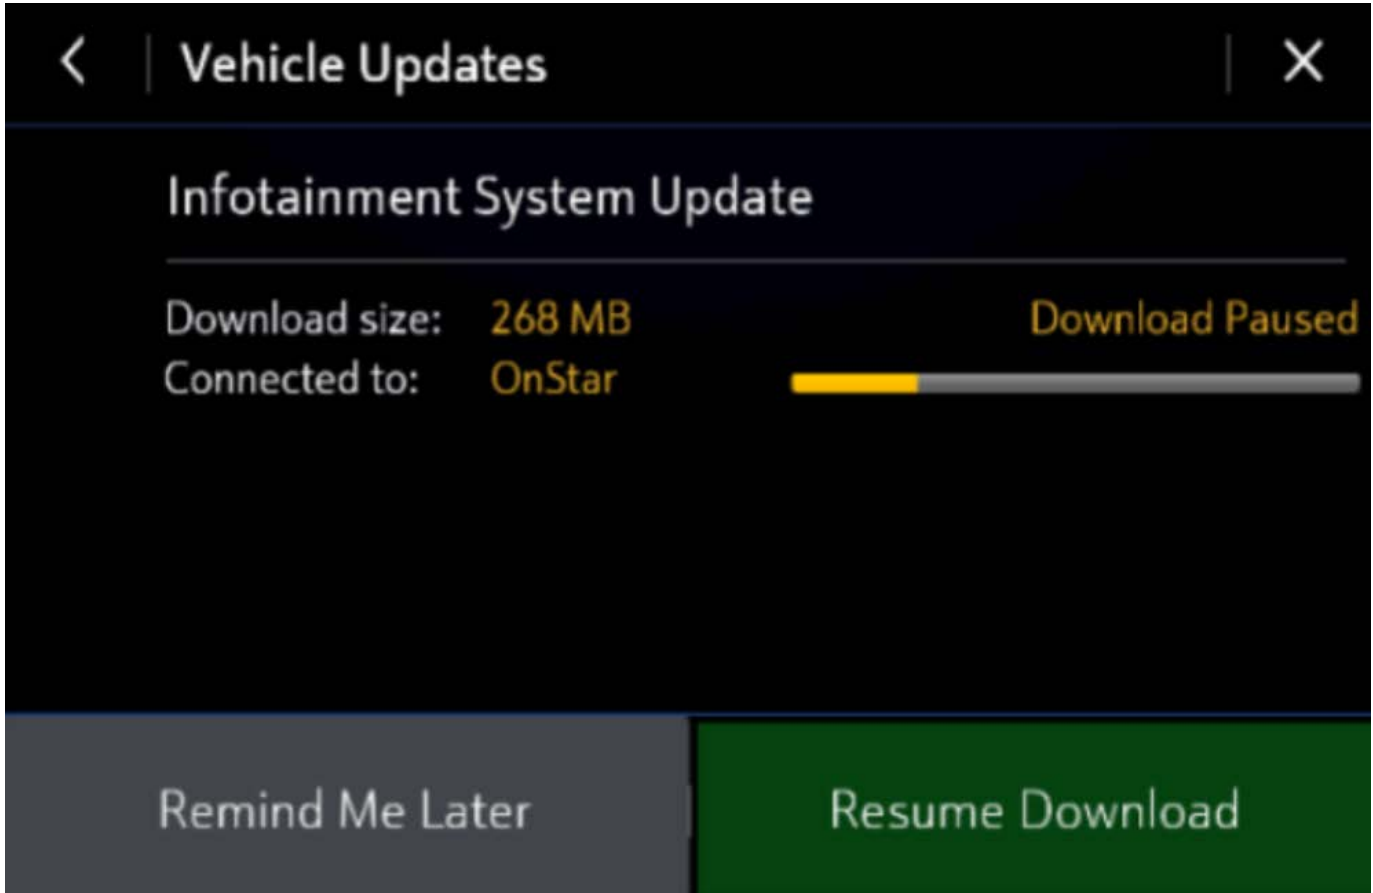
5313326

Scenario 2: Consistently Paused Download

If the above screen is shown and resuming the download repeatedly fails, a USB update will need to be performed. Turn the vehicle on, return to the home screen, and insert USB stick (see previous section). A pop up should be shown to "Install Now." Click "Install Now", verify the part number is correct and follow on screen prompts.

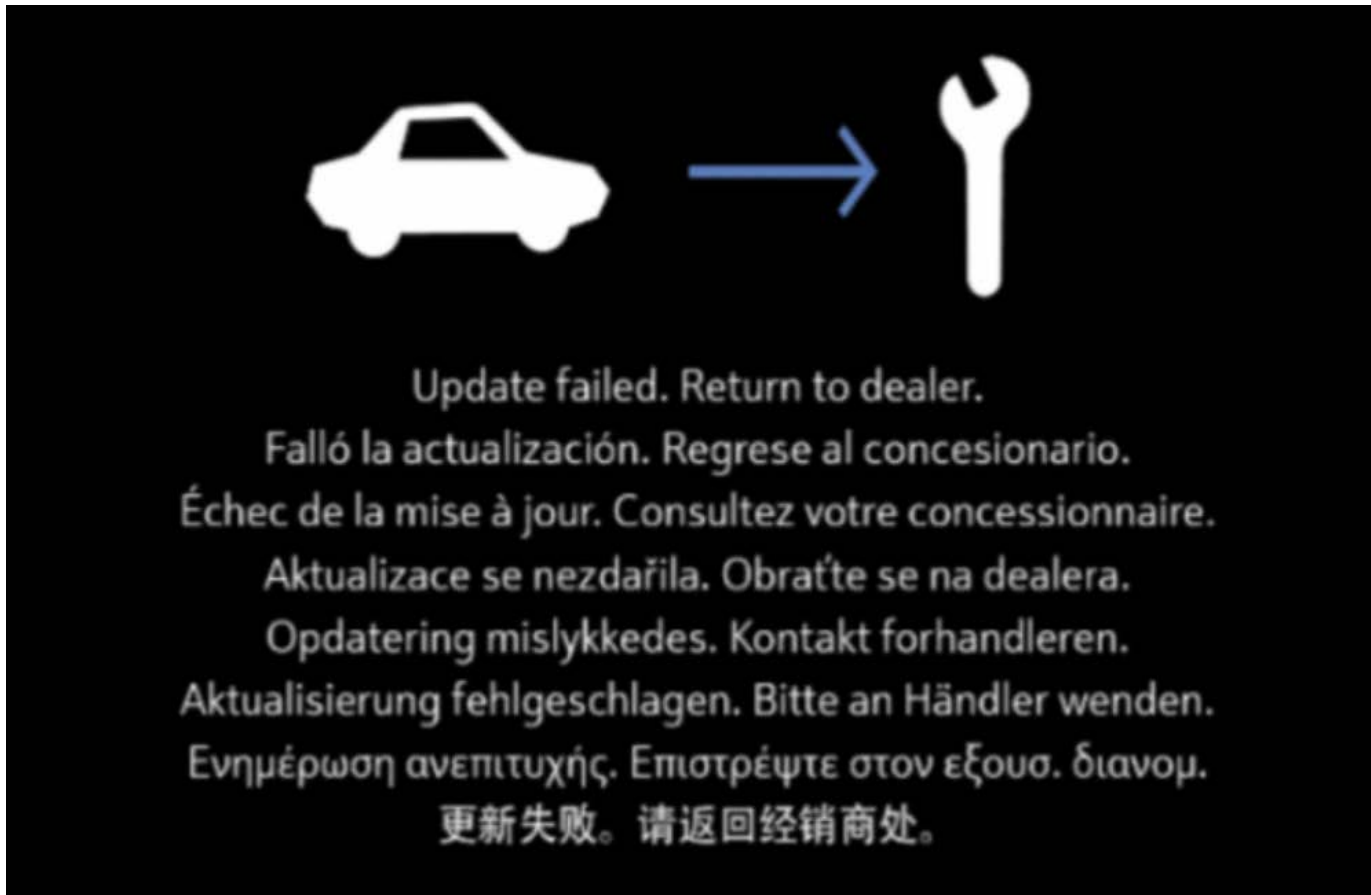
5313330

Scenario 3: Update Failed. Return to dealer screen.

1. If the above screen is shown, download the update through TIS2Web and insert USB stick into the radio **twice** (USB stick is not recognized on first insertion). A blue progress bar should come on the screen and update will proceed. If this screen above is shown when trying to update the radio through USB, reformat to FAT32 on your PC, and then try to download the update through TIS2WEB again.

2. After selecting USB File Transfer, if you are prompted by TIS2Web to select a software P/N then follow the on-screen instruction to attempt to gather the software P/N from the A11 Radio using GDS2 scan tool. If GDS2 indicates the radio is not communicating, go back to TIS2Web, select A11 Radio, and select when radio displays "**Update failed. Return to dealer.**" to complete the USB File Transfer programming event.

3. If the screen above is shown again, contact Technical Assistance (TAC) for further assistance.
