## SERVICE BULLETIN

**APPLICABILITY:** 2017-18MY Impreza  
 2018MY Crosstrek  
 2018MY Legacy and Outback  
 2018MY BRZ\*

**NUMBER:** 15-211-17R  
**DATE:** 06/13/17  
**REVISED:** 02/19/20

**SUBJECT:** Reprogramming File Availability for Additional Optimization of Harman Gen 3 Audio and Navigation Head Units

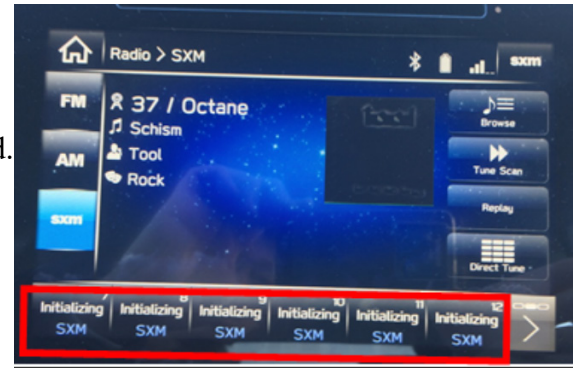
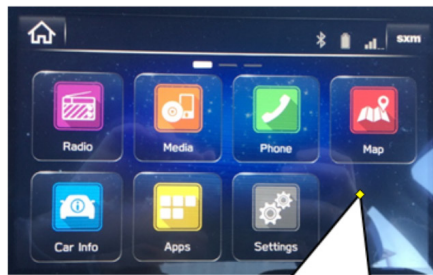
- On 2018MY Legacy / Outback models with Navigation (High) head units, the update corrects a condition where the head unit remains powered even after the ignition is OFF and the driver door is opened.
- Update for a condition where the SXM presets become lost and only “Initializing” appears as shown below.
- Update for condition where only the star field background is displayed (without icons) after the HOME button is pressed.

**Background shown, but no icons**

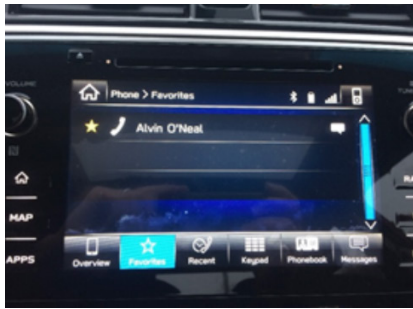
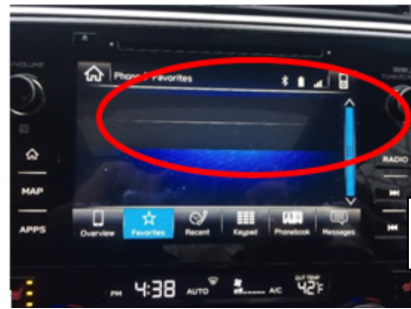
- Update for a concern of after selecting a contact to be a “Favorite” and the “Favorite” list display is blank.

List is blank

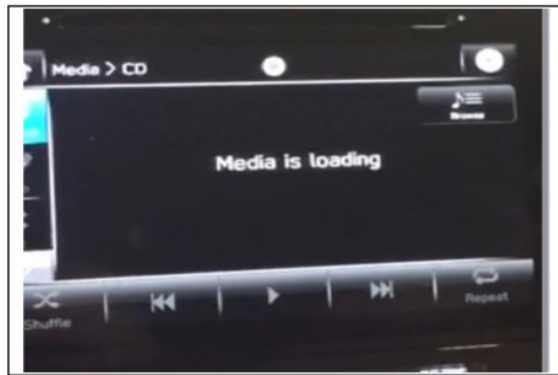
- 2- “Media is loading” is displayed on the screen but, the media never completes loading.

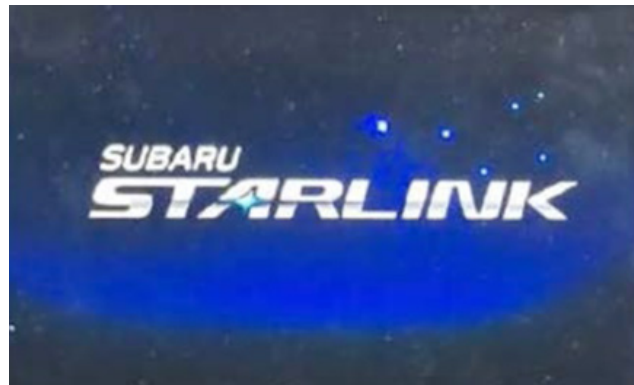
- 3- The screen freezes when the STARLINK screen is displayed.

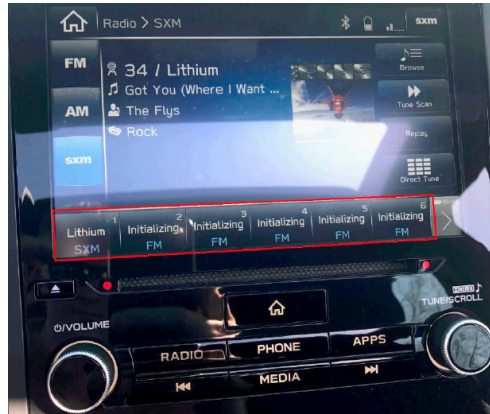
- 1- Radio station presets disappear (touch screen buttons return to “Initializing”).
