Technical product information

Topic	Clicking noises from front corner(s)
Market area	Bentley: worldwide (2WBE),Hongkong-Macau (5HK)
Brand	Bentley
Transaction No.	2052853/4
Level	EH
Status	Released for publishing
Release date	11-Feb-2020

Bentayga

Clicking noise from front corner(s)

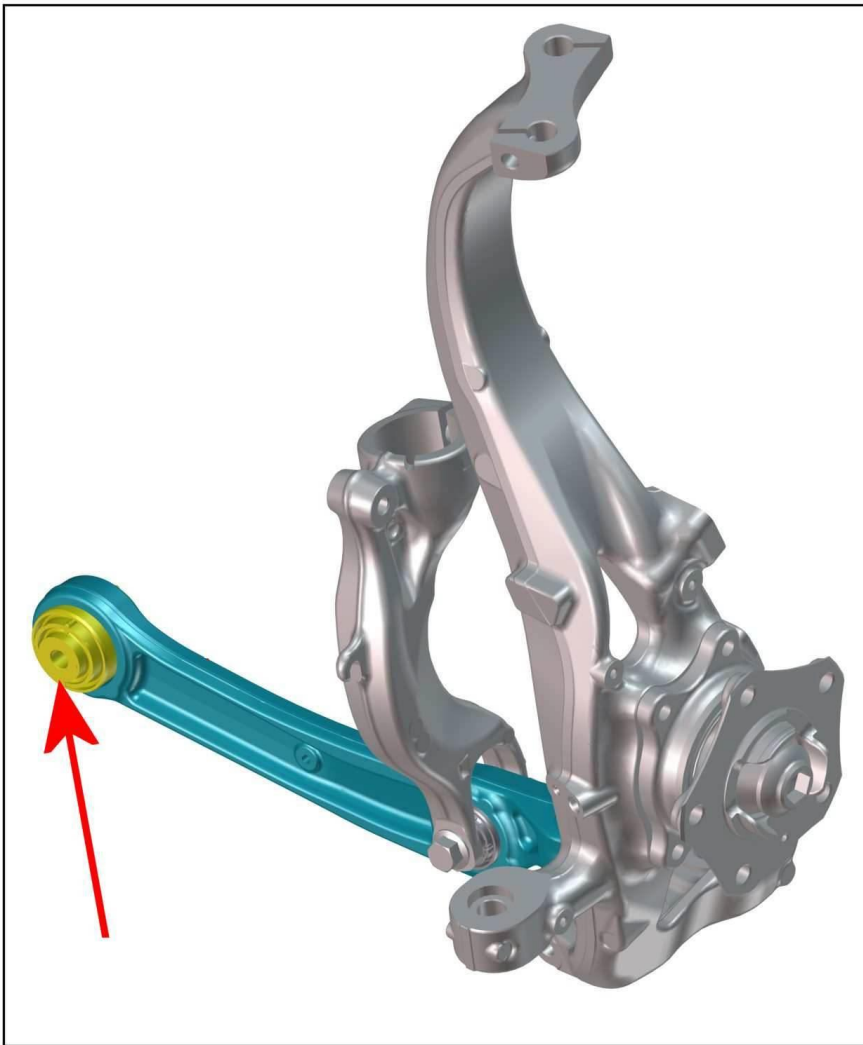
Figure 1

Symptom 1 - Single click from the front wheel corner(s) when the steering is moved from lock to lock whilst stationary

Ensure fault is as described and reference video <https://vimeo.com/298953282> If so then replace both front lower inner control arm bushes (Figure 1)

IMPORTANT: Please check the vehicle Repair History to confirm the inner bushes have not been previously replaced, if they have been replaced once before, You must then replace the complete arm, Do Not carry out the bush replacement procedure more than once (per lever)

IMPORTANT: Prior to starting this procedure ensure you have assembly lubricant part number G 052 566 A2 this must be used when fitting the new replacement bushes, the lubricant should only be used when the bushes are replaced as per the instructions within TPI 2052853/-

Each bush should have 5ml of lubricant applied prior to fitment within the bush, the grease should remain present throughout the fitting/pressing in procedure as the grease aids the fitting process and is also crucial once fitted to eliminate any further noise issues *Please Note that x1 – 100 ml tube will be sufficient for use on 20 bushes (10 vehicles) – Do not order x1 tube of lubricant per each individual vehicle complaint*
