Technical product information

Topic	Continental GTC - Hood insulation cover checks prior to replacement
Market area	Bentley: worldwide (2WBE)
Brand	Bentley
Transaction No.	2058465/1
Level	EH
Status	Approval
Release date

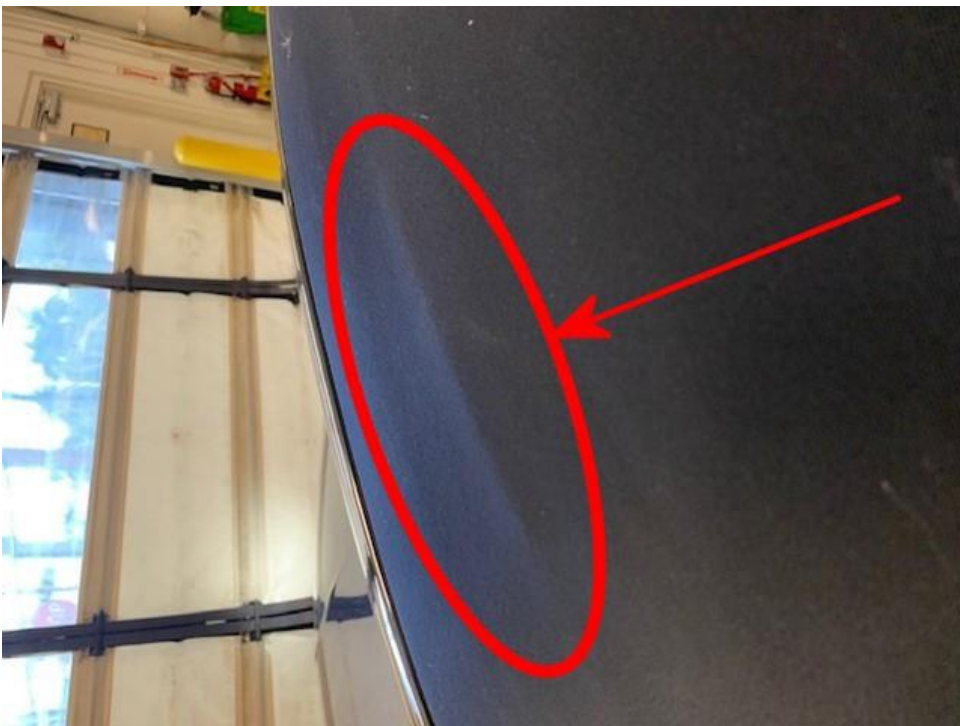
2) In the event the insulation pad is as shown in Figure 1, the insulation pad **MUST** be replaced - Refer to Rep.Gr61 - NOTE: The issue shown in Figure 1 relates to an issue with the insulation pad rubber retainer

IMPORTANT: The instructions within TPI 2058277/1 **MUST** be adhered to when replacing the insulation pad

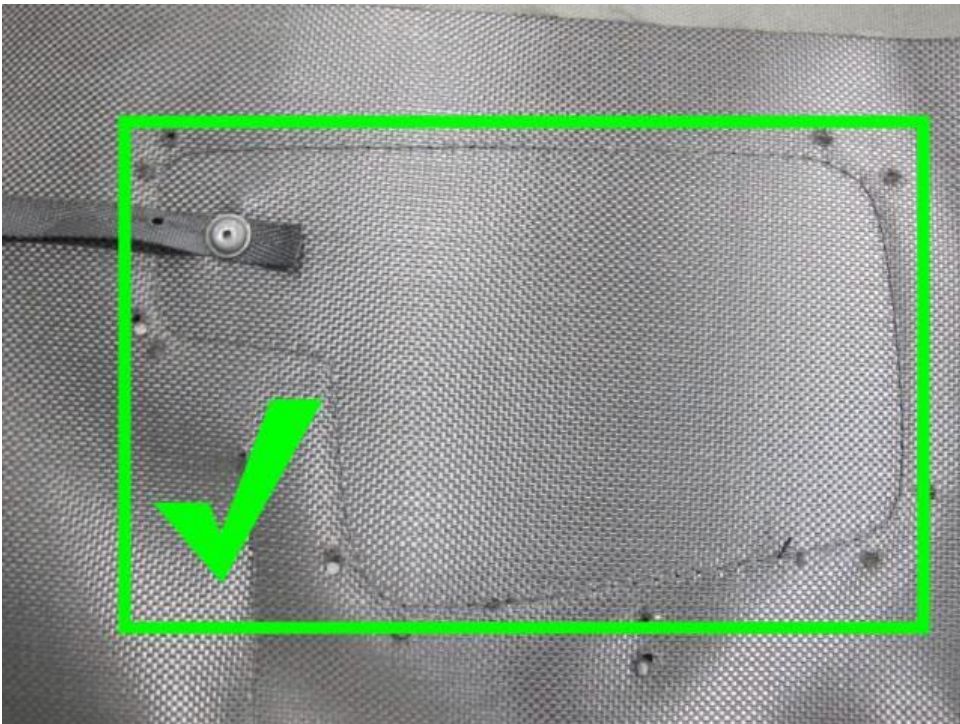
3) Referring to Figure 2 (Point A) - Check and confirm the insulation pad plastic paddles are not broken – missing or damaged **IMPORTANT:** the operative should confirm the paddles are flat, not bent or broken at any location

IMPORTANT: There is no requirement to replace the insulation pad should the plastic paddles not be broken - missing or damaged the example shown in Figure 2 is to specification and exhibits no issues

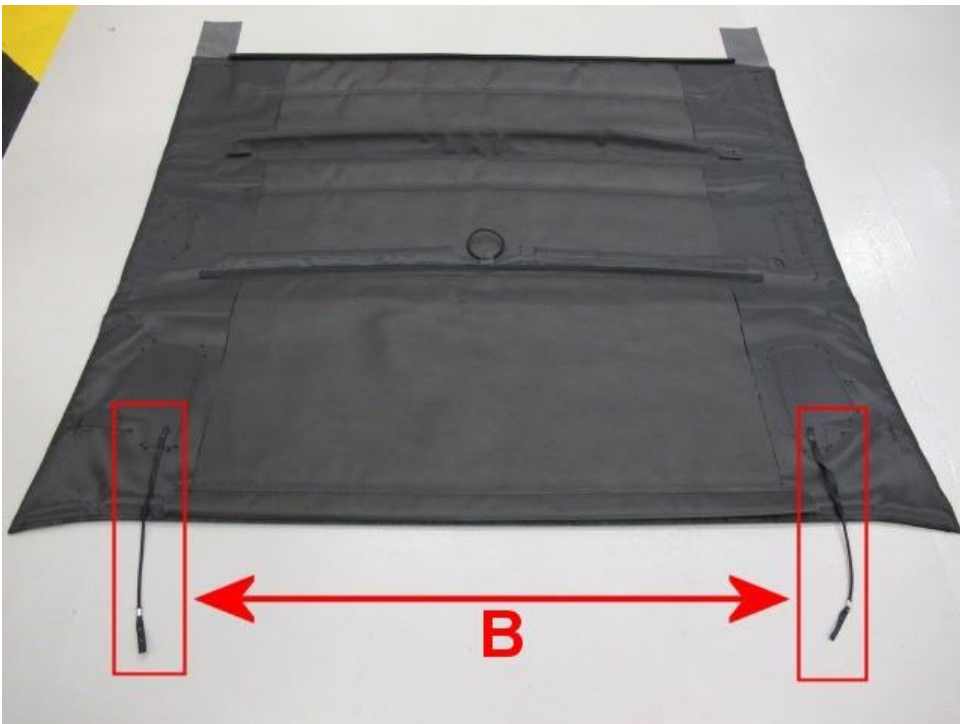
- Referring to Figure 3 - Check and confirm the tension straps are fitted to the insulation pad as shown

- In the event the tension straps are not fitted – Refer to the instructions within TPI 2058277/1
