WT20-001

ITB20-003

2014-2020 Q50 AND 2017-2020 Q60; TPMS SENSOR LEAKING AIR

APPLIED VEHICLES: 2014-2020 Q50 (C37)
2017-2020 Q60 (CV37)

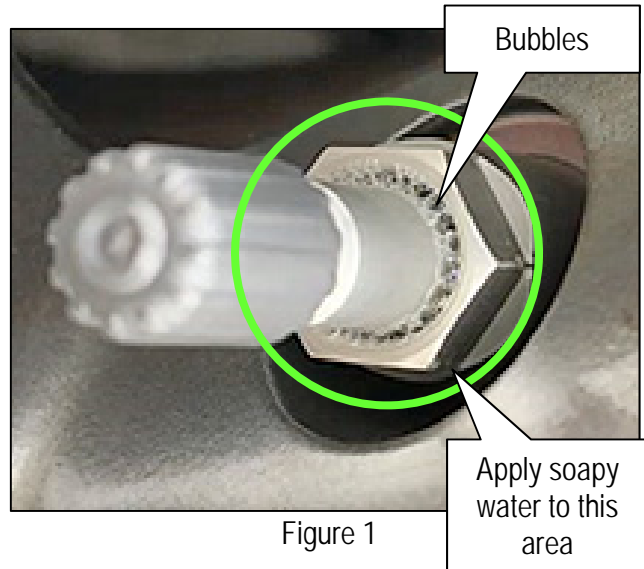
2. Apply a mixture of soap and water to the area shown in Figure 1.

3. Visually inspect for bubbles in the area between the valve stem and the valve nut.

- If bubbles were found in the area shown in Figure 1, proceed to step 4.
- If no bubbles were found, this bulletin does not apply. Further inspection may be necessary to locate a wheel/tire leak that is not covered by this bulletin.

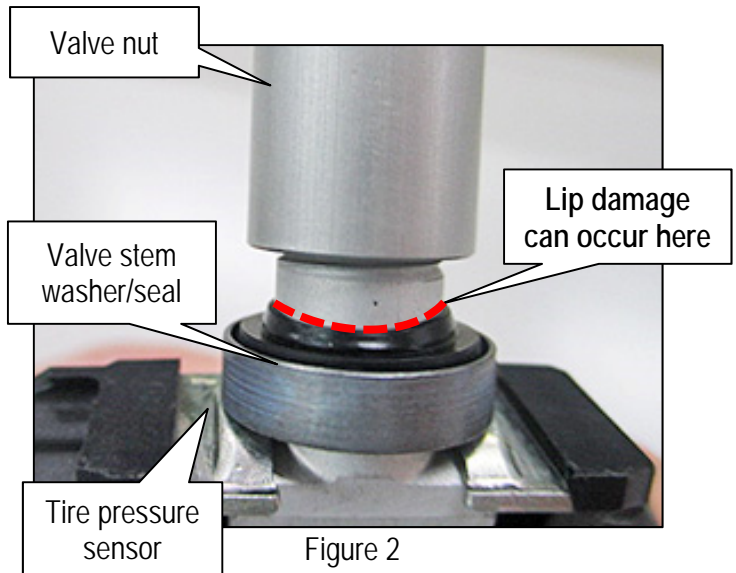
NOTICE Valve stem washer/seal lip damage may occur if the valve stem seal is not centered in the wheel. Take care to center the valve stem when installing into the wheel (see Figure 2).

5. Replace the valve stem washer/seal.

6. Reinstall the tire pressure sensor into the wheel with a new valve nut from the **PARTS INFORMATION** on page 3, and then torque to the new specification below.

- Valve nut torque: 10 N•m \pm 0.5 (1.02 kg-m, **88.5 in-lb**)
