Title Correct Aftermarket Installation Of Permanent Electronic Log Devices (ELD) (Qualcomm, PeopleNet, Omnitrac, GPS, Location Tracker, Etc.) RP1226 connection On The Data Link; Installation Instructions And Information For Third Party (Aftermarket) Devices Connected To The Data Link - **US17+OBD16 And Newer Emissions, Models Built up to Week 37 (9/13) 2019.**

Mack Model AN - Anthem , GR - Granite , PI - Pinnacle

Volvo Model VN , VNL , VNR , VNX , VAH , VHD

Emission Standard US17 , US17+OBD16 , US17+OBD18 , US17+OBD19

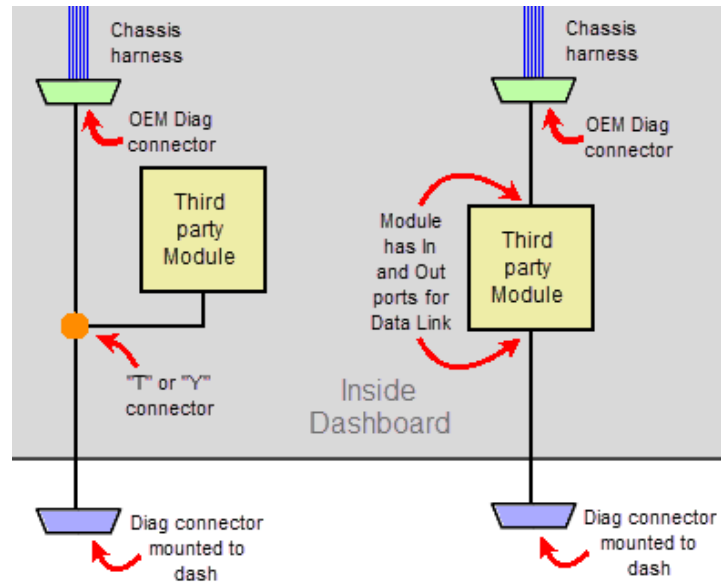
Cause An aftermarket device improperly installed on the data link can cause a variety of symptoms. Various Data Link codes can be generated from any modules connected to the affected circuit. In addition, interference can create a variety of physical symptoms that may or may not seem to be related. Some examples are intermittent loss of throttle, incorrect or no readings from instrument cluster gauges, regeneration failure, and derate.

Recent models of third party devices in many cases utilize either a "T" or "Y" connector that connects to the OEM Diagnostic connector, or will place the module in-line so the diagnostic connector mounted to the dash is in fact a diagnostic connector from the third party device. A diagram showing these two situations can be seen below:

- Do not daisy chain more than 2 overlay harnesses.
 - 3rd party connecting harness length should not be more than 1 meter in length.
 - 3rd party devices must not be connected to the main diagnostic connector under the steering wheel.
 - 3rd party devices must be listen-only or passive mode.
 - 3rd party devices must not use power with key off to avoid battery drain.
 - The truck must maintain all factory install terminating resistors in the harness.
- All newer trucks will have the RP1226 connector installed on the Cab Harness DL5 located in the FRC.**

An OEM overlay harness is available that should always be utilized to connect modules meeting the above specifications to the vehicle data link. Refer to the pictures and part numbers below.

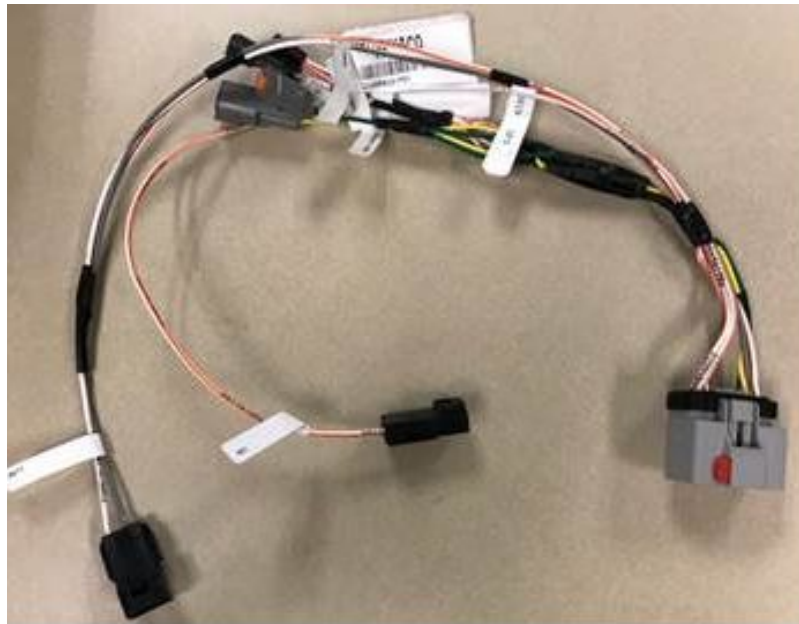
23295912 = Connects to the vehicle and terminates to a RP1226 connector.

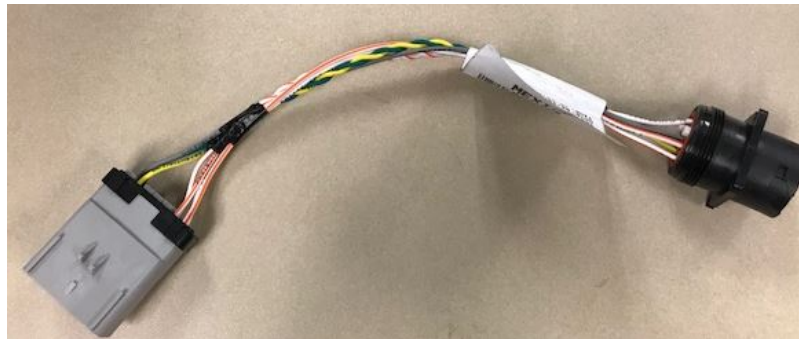
23295906 = From the RP1226 to a 9 pin connector.

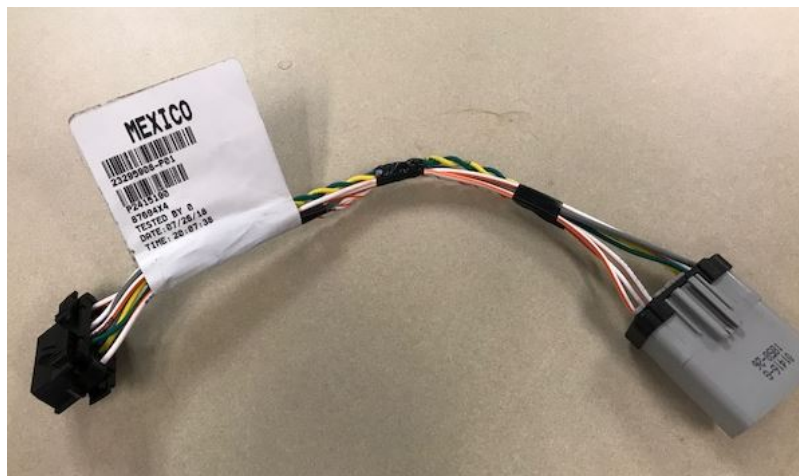
23295908 = From the RP1226 to a 16 pin connector.
