Mercedes-Benz

Campaign No. 2020020012, February 2020

SUBJECT: **Model 907 (Sprinter), Model Year 2019
Seat Adjuster Weld Seam**

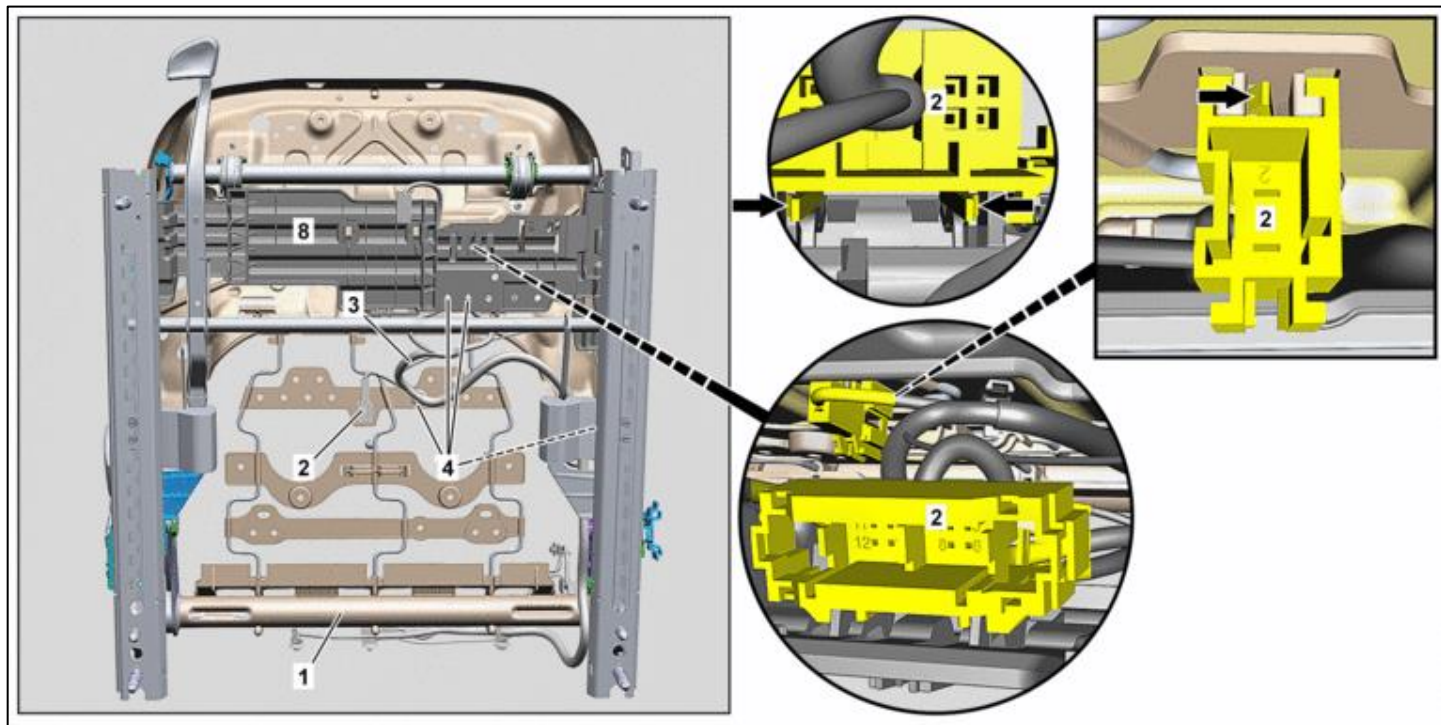
D91. 10-A005-79

Shown on driver's seat

1 Seat frame
2 Connector

3 Electrical wiring harness
4 Retaining clips

8 Bracket

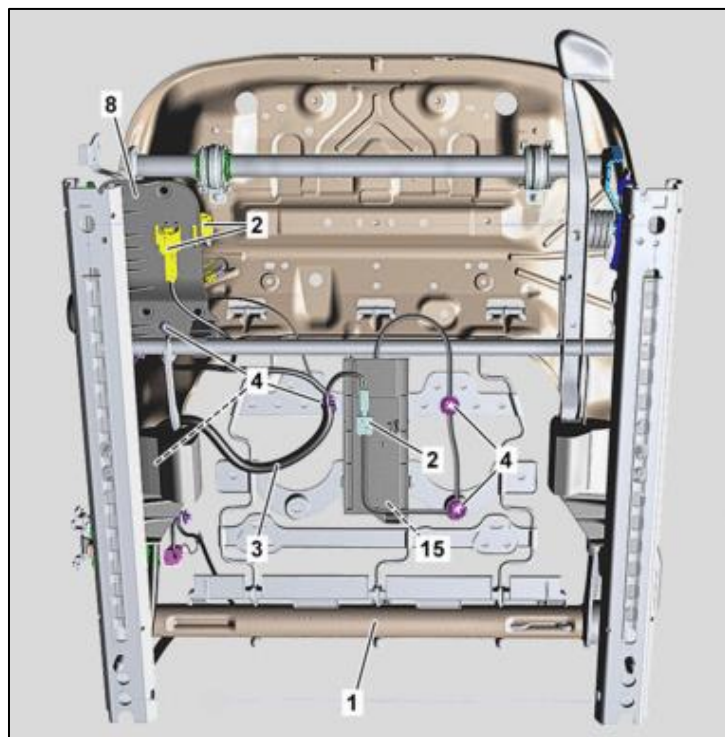
D91. 10-A009-82

Shown on front passenger seat

- 1 Seat frame
- 2 Connector
- 3 Electrical wiring harness
- 4 Retaining clips
- 8 Bracket
- 15 Seat occupancy recognition

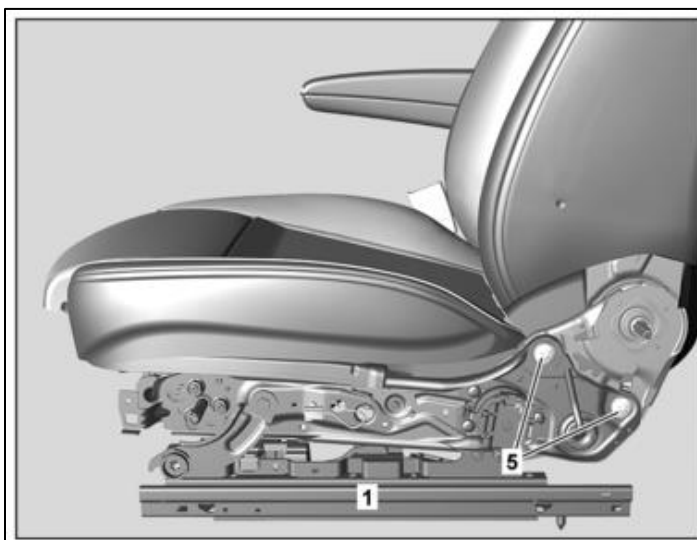
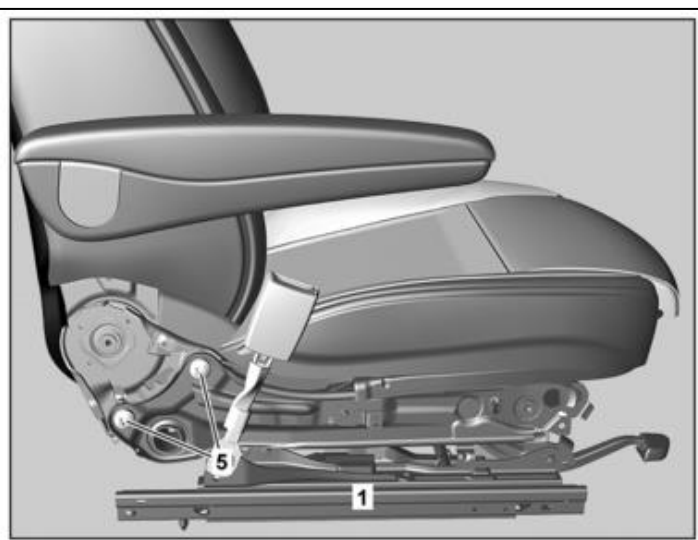
D91. 10-A004-08

1 Seat frame

5 Bolts

- 2 Connector
- 6 Mounting rail
- 7 Mounting rail
- 10 Adjustment unit
- 11 Thigh cushion padding
- 12 Seat cushion padding
- 13 Seat cushion cover
- 14 Bolts
