Service Bulletin

Subject: Ticking, Tap, or Rattle Noise from Engine

This bulletin replaces PIP5331H. Please discard PIP5331H.

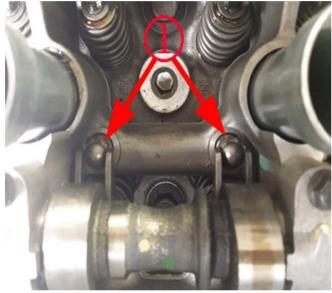
4475559

- Remove the cam cover of the affected bank (both if needed) for inspection of the SHLA (1) (Stationary Hydraulic Lash Adjusters) (Lifters).
- 4. Push down on the rocker end at the SHLA to test for a soft or spongy feel.

Note: Right side exhaust are most common.

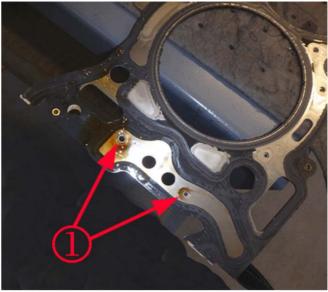
4480610

- 4.1. If soft or spongy SHLAS are found, carefully remove the affected head and inspect the oil passage (1) below the head gasket for debris.
- 4.2. If debris is found, inspect the camshaft caps for wear or discoloration due to lack of oil.

- 4.3. If wear or discoloration is found, then replace the cylinder head assembly with camshafts.
- 4.4. If there is no wear or discoloration, clean the oil passages and replace the head gasket.
