Service Bulletin

Bulletin No.: 20-NA-047

Subject: Front or Rear Crankshaft Oil Leak, Malfunction Indicator Lamp (MIL) Illuminated - DTC P1101 Set

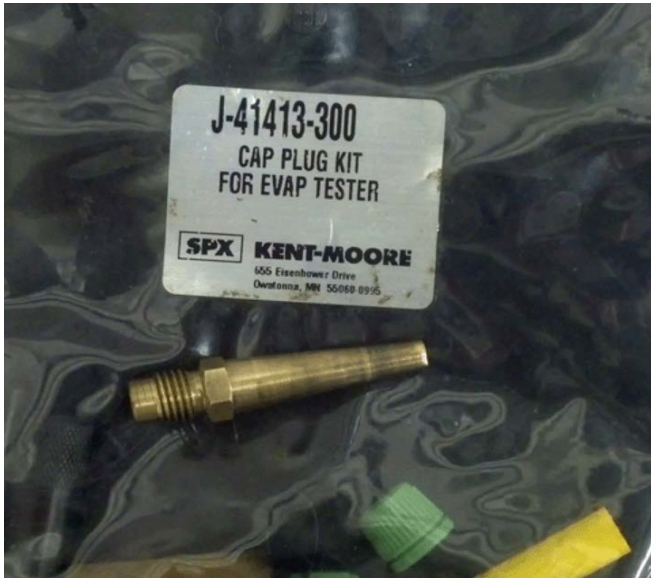
3416804

EEST hose adaptor

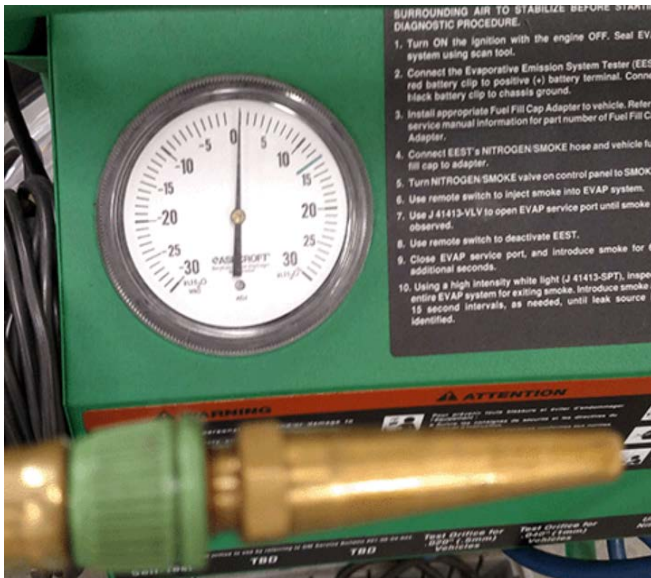
4573240

EEST Gauge at 0 reading

Note: The connection must be made with the engine off. The engine is then started and the pressure reading is recorded.

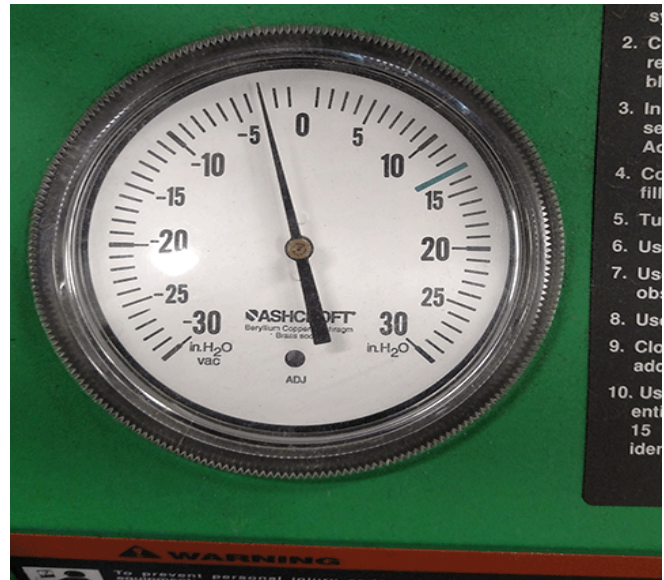
4573243

Normal crankcase pressure readings for the L3A, LE2, LFV and LYX are between -1 & -5 inches of water in park at hot idle.

- If the crankcase pressure is in the proper range, follow Strategy Based Diagnostics for engine oil leaks and/or P1101 per SI.
- If the crankcase pressure is excessively positive, above 0 inches of water (0 inches of HG / vacuum), then a positive crankcase pressure concern exists requiring further diagnostics.

Inspect for any air induction restrictions in the front air intake duct to air cleaner housing or in the air cleaner housing (nesting materials, water intrusion or ice blockage, kinked PCV tube or modifications to the air induction system).

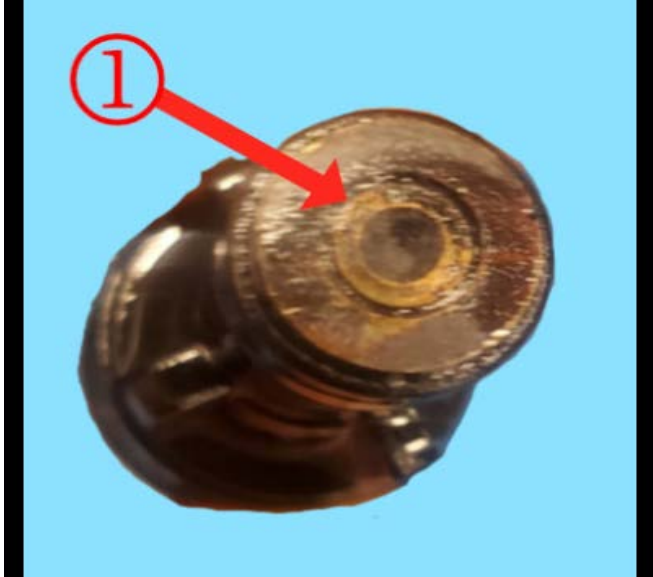
5513764

If diagnosing for oil leaks and/or DTC P1101 with no engine oil leaks and excessive positive crankcase pressure exists, an obstructed PCV orifice (1) would be suspect requiring a PCV orifice replacement.

Remove the camshaft cover and remove the PCV orifice and inspect for blockage. Replace the orifice as necessary along with the camshaft cover gaskets. Make sure the camshaft cover does not have any blockages in the PCV passages.
