New Software Not Compatible Pop-up Message During Radio Head Unit Software Update

USA

All Applicable Models

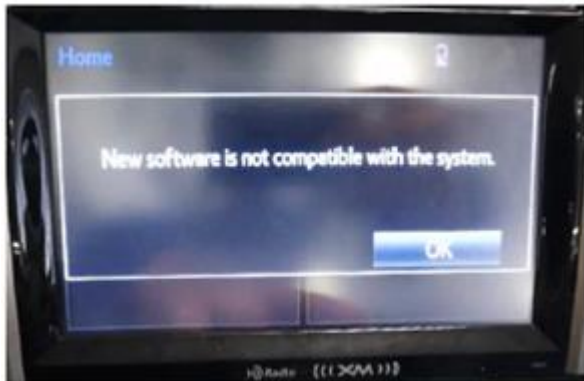
Some vehicles may experience a “New software is not compatible with the system.” Pop-up while performing T-SB-0003-20 during the head unit software installation process.

If this pop-up occurs during the installation process, please contact TAS or your FTS for further assistance.
