# Technical Service Bulletin

**97 Car jerks/bucks or hesitates while driving DTCs P023400, P023500, P023600, P023700, and P023800 are stored in the ECM**

97 20 71 2058976/1 March 19, 2020.

Model(s)	Year	VIN Range	Vehicle-Specific Equipment
Q5	2018 - 2020	All	2.0 liter

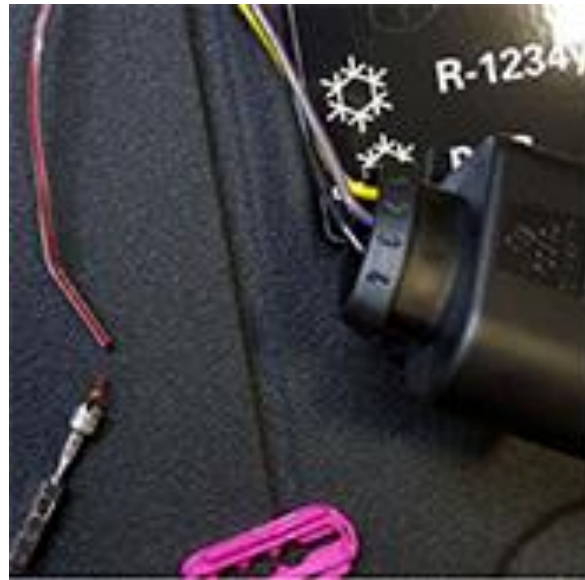
One of the pins or wires at the boost pressure sensor (G31) connector T4e may be backed out or broken due to the routing concept of the engine harness. When inspected, the harness is found to be too tight in the area of the sensor.

Figure 1. T4e with damaged wire.

If there is damage to the pins or wire, repair the harness as needed (Figure 1). Ensure there is sufficient slack in the harness to prevent future issues.
