Technical Service Bulletin

94 Light malfunction message in instrument cluster, DTC 03280, 01800, B126AF0 or B126AF1 stored in the vehicle module

94 20 20 2017806/13 March 17, 2020. Supersedes Technical Service Bulletin Group 94 number 19-13 dated September 17, 2019 for reasons listed below.

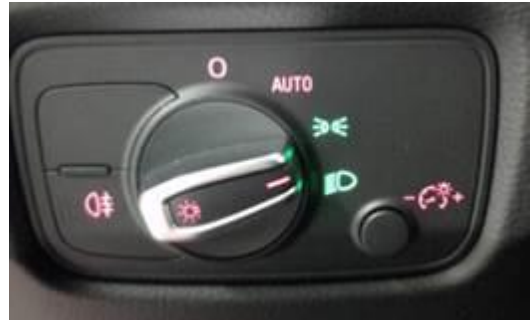
If the headlight switch is moved to an intermediate position and remains there (Figure 1), the light bulb warning light and the error message appear after approximately ten seconds (Figure 2).

Figure 1. A headlight switch in an intermediate position.

Determine if the above situation applies to the vehicle, and explain the *Technical Background* to the customer. Replacing parts does not change the behavior.

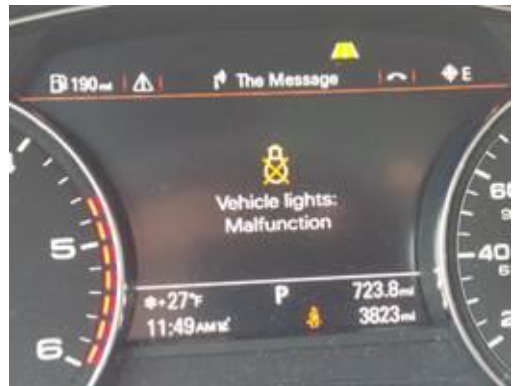
Figure 2. The warning light and error message in the instrument cluster display.

Once displayed, the message turns off after approximately five seconds. The light bulb warning light turns off only after the headlight switch is turned to a defined position, and the status of **DTC 03280** and **DTC 01800** or **DTC B126AF0** and **DTC B126AF1** are changed to sporadic.

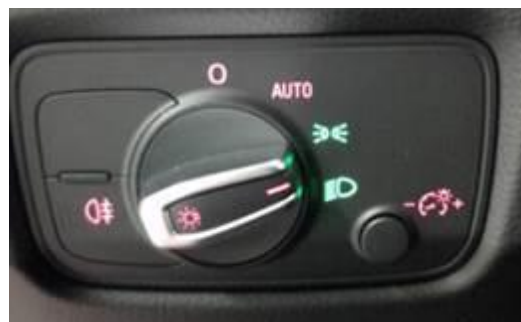
In this example, the intermediate position of the rotary knob (Figure 3) is correctly detected in the MVBs of the 09 module (Figure 4). This is normal and does not indicate a faulty component. In this case, explain the operation to the customer.

Figure 3. Switch in an intermediate position (2018 A4).
