Complaint - Check Engine Light Active Together with Fault Memory Entries Relating to Oxygen Sensor (20/20)

Vehicle type: **Macan S (95B)/Macan Turbo (95B)/Cayenne (9YA)/Cayenne Coupé (9YB)**

Subject: **Oil separator**

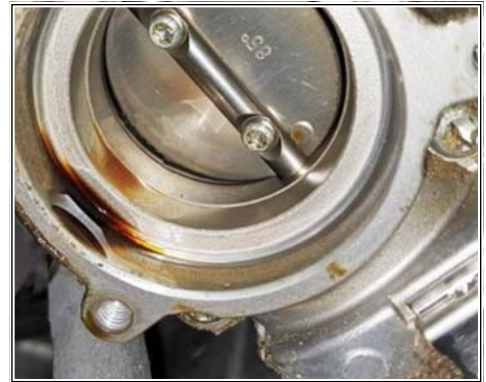
Throttle valve

An oil film in the intake system and in the throttle valve, particularly in the intake tract of cylinder bank 2 and sometimes even with drops forming, is perfectly normal and is not the cause of the fault memory entries for the oxygen sensors.

- The one-sided introduction of crankcase full load ventilation on cylinder bank 2 results in a significantly larger oil film compared to cylinder bank 1.
- The traces of oil occur particularly during frequent short journeys or in cold weather.

Replacing the oil separator will not correct the problem; PAG will not cover the costs of unwarranted replacement.

Continue fault finding to determine the cause of the fault memory entries for the oxygen sensors.

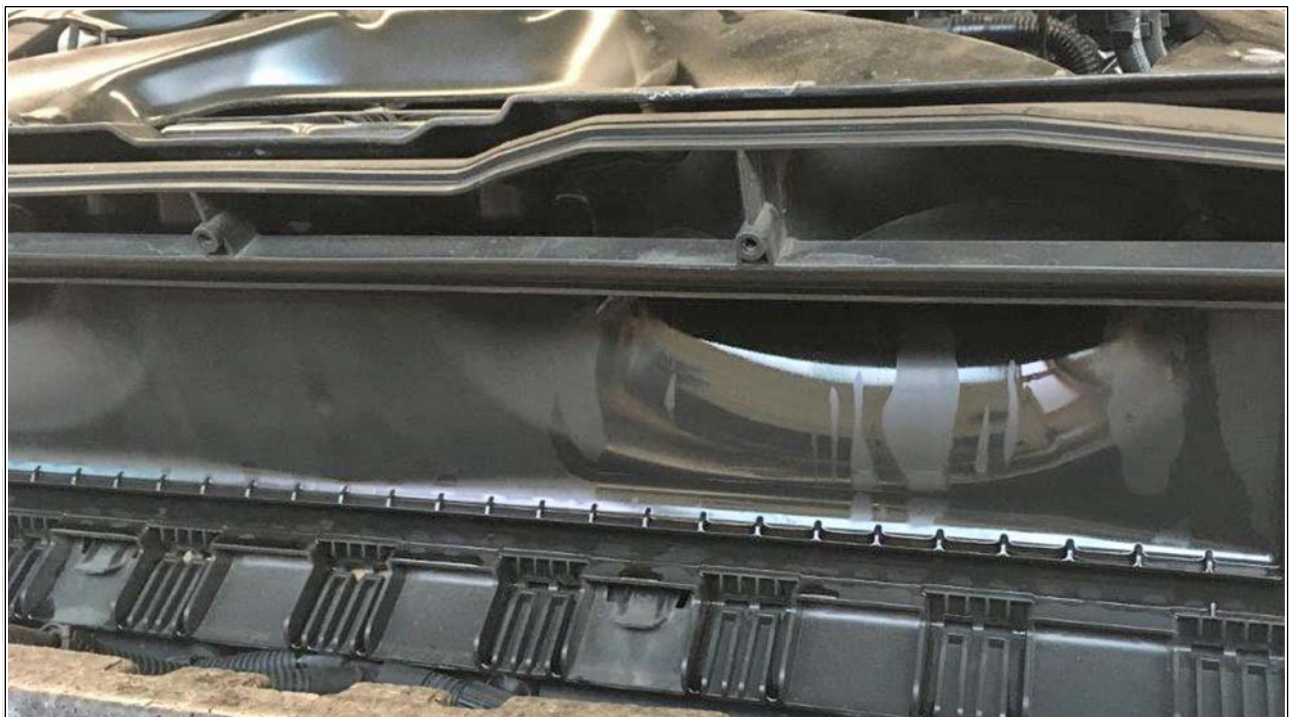
Air cleaner housing

An oil film in the intake system and in the throttle valve, particularly in the intake tract of cylinder bank 2 and sometimes even with drops forming, is perfectly normal and is not the cause of the fault memory entries for the oxygen sensors.

- The one-sided introduction of crankcase full load ventilation on cylinder bank 2 results in a significantly larger oil film compared to cylinder bank 1.
- The traces of oil occur particularly during frequent short journeys or in cold weather.

Replacing the oil separator will not correct the problem; PAG will not cover the costs of unwarranted replacement.

Continue fault finding to determine the cause of the fault memory entries for the oxygen sensors.
