Noise Symptom - Noises From Around the Steering Shaft: Replacing Intermediate Steering Shaft (SY 17/14)

Model line: **Macan (95B)**

Subject: **Intermediate steering shaft**

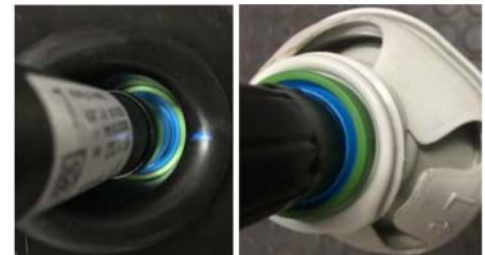
Figure 1. Left - passenger compartment side, right - engine compartment side

- The intermediate steering shaft has two blue sealing rings, which must be lubricated separately because the lubricant cannot flow effectively from one sealing ring to the other ⇒ *Figure 1. Left - passenger compartment side, right - engine compartment side.*
- Lubricate each sealing ring separately and hold the shaft vertically while doing this.
- First lubricate the upper sealing ring, then turn the shaft over and lubricate the lower sealing ring.
- The two rings are visible in the assembly overview shown in Figure 2.
- Both rings are identical. The ring on the passenger compartment side is cut away for clarity. Note the felt insulator in between ⇒ *Figure 2.*
