## Field campaign

<b>Topic</b>	V8 Kovomo - Control module updates (SC20/09)
<b>Market area</b>	United States E05 Bentley USA and rest America (6E05)
<b>Brand</b>	Bentley
<b>Transaction No.</b>	2059124/1
<b>Campaign number</b>	EB51
<b>Note</b>	
<b>Type</b>	
<b>US code</b>

### New Continental GT and Bentayga

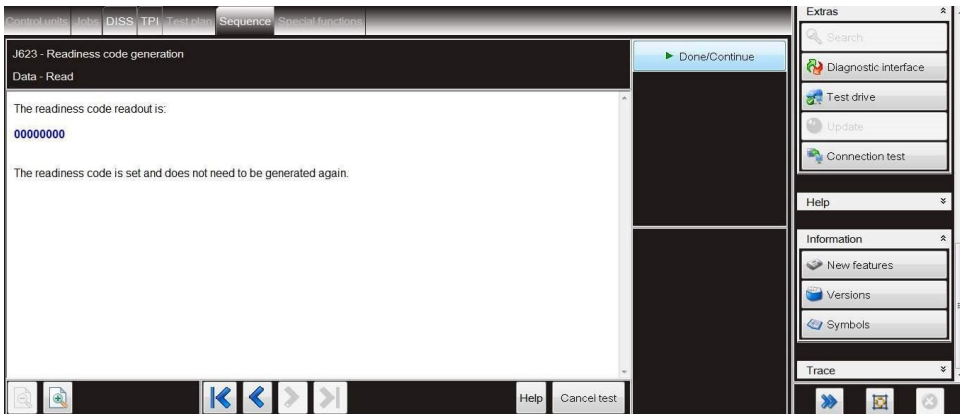
9. At this point check and confirm the actual readiness code, the readiness code MUST be as shown in Figure 7

Should the readiness code bytes be 00000000 NO FURTHER ACTION IS REQUIRED

*Should ANY of the bytes be 1, YOU MUST repeat the Basic settings test again from step 8. Once complete you must then recheck and confirm the readiness code is 00000000*
