SERVICE PROGRAM BULLETIN

APPLICABILITY: 2014-2016 MY Forester

NUMBER: WUT-05R

SUBJECT: Forester Rear Coil Springs

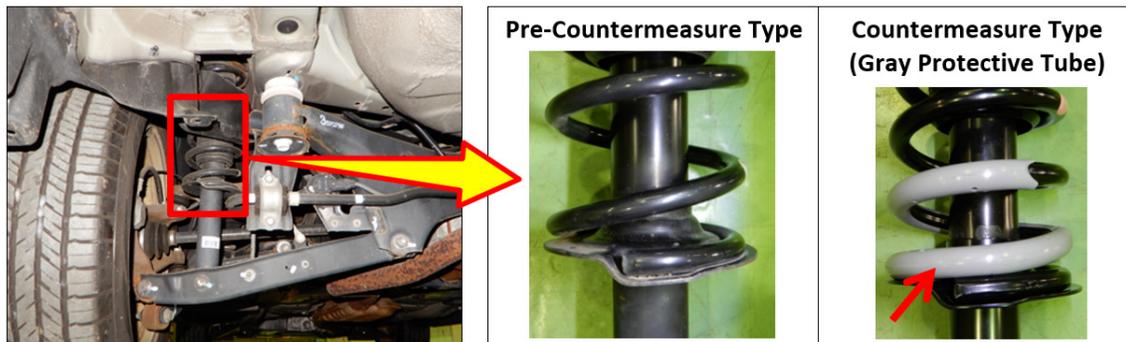
Step 1) INSPECTION: Inspect the coil springs on both rear shock absorber assemblies to determine if either has a gray colored protective tube installed on the bottom coils as shown below.

- If either (or both) of the coil springs are the Pre-Countermeasure Type (NO gray protective tube on the bottom coils), proceed to **Step 2** and replace ONLY the affected spring(s).
- If **BOTH** coil springs are the Countermeasure Type (gray protective tube installed on the bottom coils), the procedure is complete. Proceed to the Claim Reimbursement and Entry Procedures section and process a claim for Inspection Only.

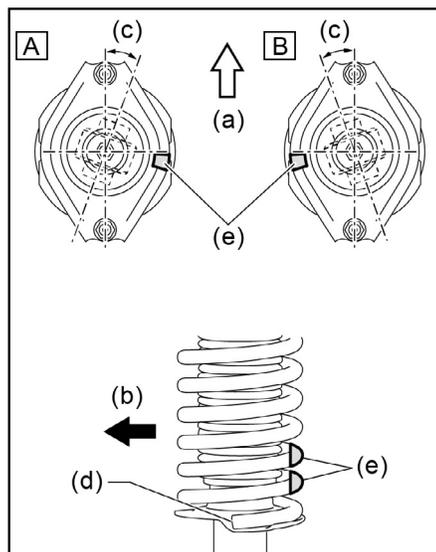
A - Left (Driver's) Side

B - Right Side

- (a) Front of Vehicle
- (b) Toward OUTSIDE of Vehicle
- (c) 10 degrees +/- 5 degrees
- (d) End of Coil Spring
- (e) Identification Marking

TIP: When reassembling the rear shock mount, confirm the direction and angle relations very carefully as described in the applicable Service Manual and illustrations shown here.

NOTE: The end of the coil spring with the gray protective tube (d) must be installed toward the base of the shock absorber assembly.
