**SERVICE PROGRAM BULLETIN**

**APPLICABILITY:** 2015-2018MY Forester 2.0L Turbo  
2016-2018MY WRX 2.0L Turbo

**NUMBER:** WUK-96R

**SUBJECT:** DIT Exhaust Pipe Front (EPF) Nut Torque

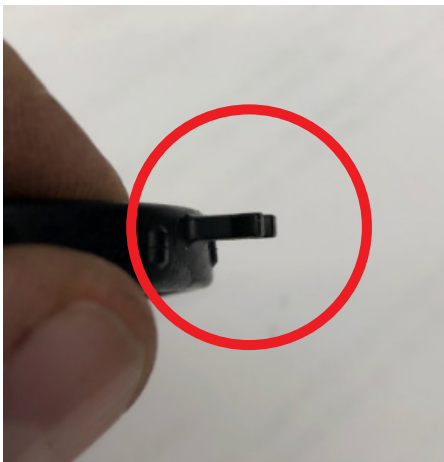
Locating Tab Is Offset  
(not centered).

- After draining the cooling system, ALWAYS replace the o-ring on the radiator petcock (a new one is included in the EPF parts kit).
- Be sure to remove (and re-install) the braided ground strap from the heat shield above the front exhaust pipe connection.
- The turbocharger stay bracket, main and sub cooling fans and the water pump pulley DO NOT need to be removed.
- When installing the new o-rings on the air flow meter, they both look the same but, they have different part numbers and two different locating tabs. The tab on the turbo outlet (charge) pipe o-ring is not centered. The tab's offset must be toward the turbocharger otherwise, it will distort as shown below. The other o-ring's tab is centered and can be installed in either way.

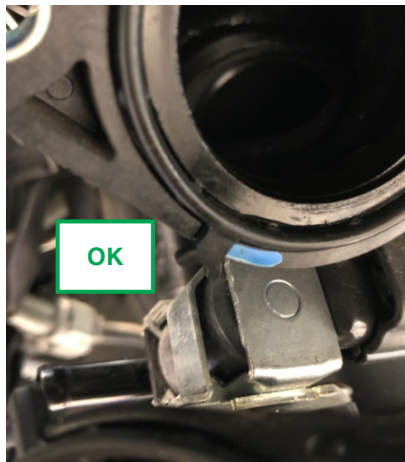
Locating Tab Is Installed  
Toward Turbo, O-Ring Is **OK**.

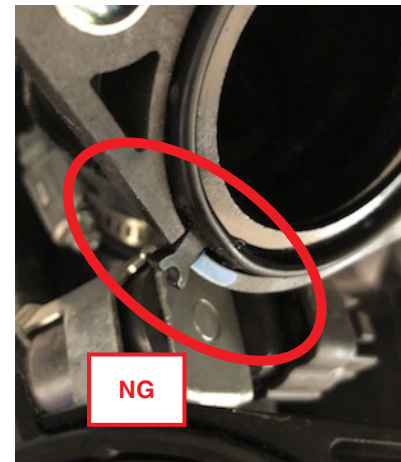
Tab Is Installed Toward Meter,  
O-Ring is Distorted.

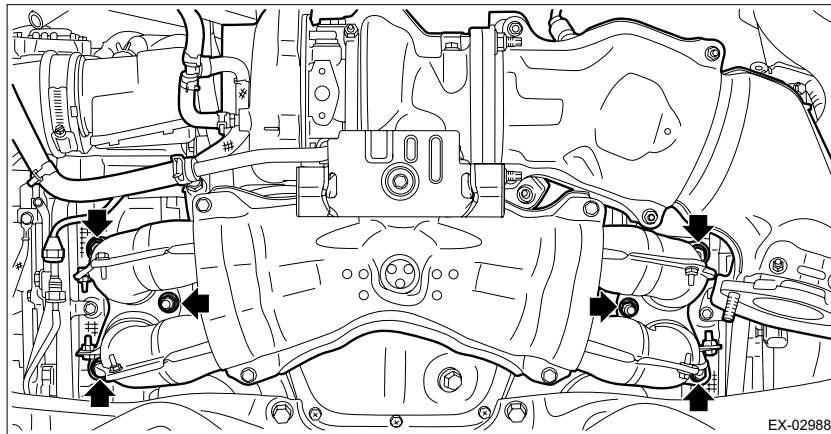
**Step 1:** Remove the front under cover and guard. Inspect the following two areas carefully:

- Are any of the 6 EPF nuts shown in the figure below missing?
- Is there any trace of exhaust gas leakage (soot deposits) around the EPF mounting flanges at the cylinder heads? **IMPORTANT:** Always check for exhaust gas leakage even if all the EPF nuts are in place.

**NO** → When all 6 of the EPF nuts are in place or, if there is no trace of exhaust gas leakage, proceed to **Step 2:** and inspect the 6 EPF nuts for proper torque.

**YES** → When any of the 6 EPF nuts are missing or, if there is exhaust gas leakage: proceed to **Step 3:** and replace the EPF assembly.

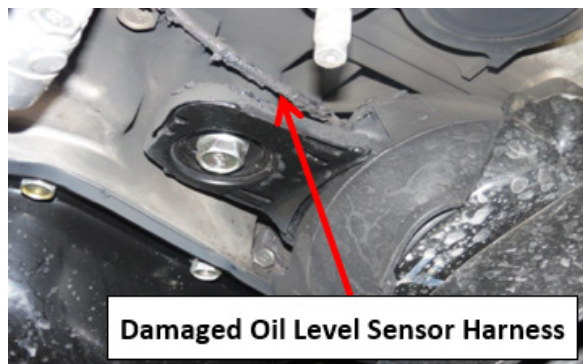
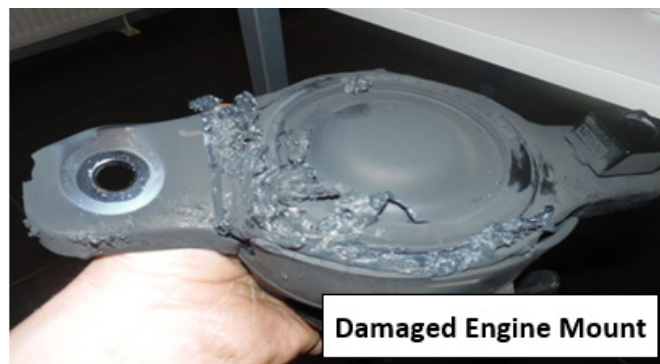
**Step 3:** When inspections during **Step 1)** or **Step 2)** dictate the EPF needs to be replaced, replace it following the procedure in the applicable Service Manual. During EPF replacement, inspect the peripheral parts (engine mount, oil level switch / harness, etc.) for any heat damage from leaking exhaust.

If none of the peripheral parts near the EPF are damaged, replace the EPF assembly to complete the procedure.

If any peripheral parts near the EPF are damaged, replace them as needed along with the EPF assembly following the procedures outlined in the applicable Service Manual.

**REMINDER:** When reinstalling the Turbo / EPF assembly, only snug (do not tighten / torque) the 6 EPF flange nuts at the cylinder heads. Install the 2- 14mm hex bolts for the turbocharger stay bracket, tighten / torque them to specification **FIRST** then, proceed to torque the 6 EPF flange nuts **TWICE** and **IN THE PROPER ORDER** as specified in the applicable Service Manual.
