Title Front Accessory Drive Noise, Alternator Belt Wear, Alternator Belt Tensioner Failure -  
Model Year 2017 And Newer

**Mack Models**

**Volvo Models**

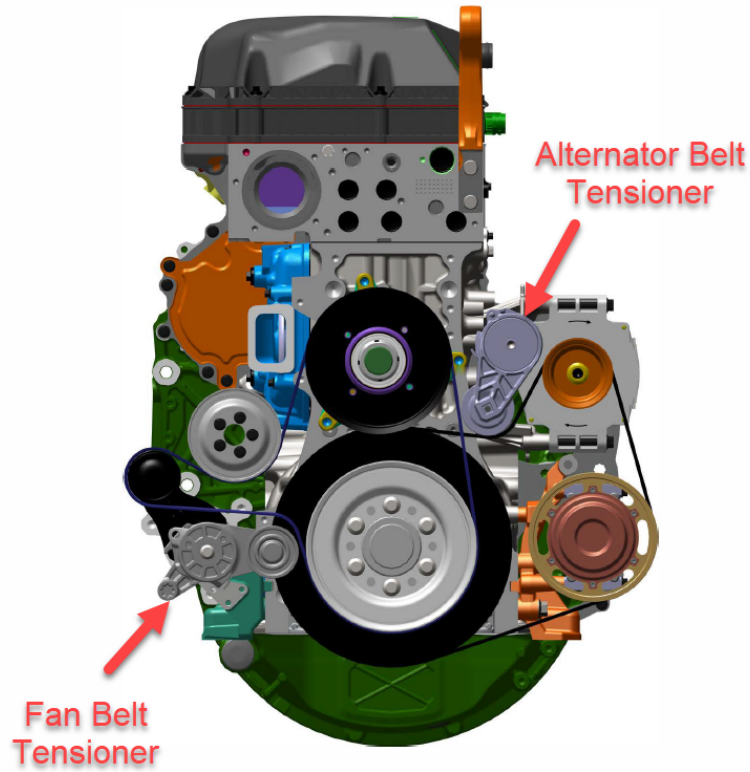
**Cause** Vehicles manufactured for Model Year 2017 and newer may experience excessive noise originating from the accessory drive belt and pulleys. Noise may be accompanied by excessive belt wear or alternator belt tensioner failure.

It has been determined that these issues were caused by a flaw in the alternator belt tensioner itself.

**Solution** An improved version of the alternator belt tensioner, Part Number [23669029](#), has been released to address this issue.

**NOTE:** Part Number [23669029](#) is ONLY for the Alternator Belt Tensioner, it is **NOT** compatible for the Fan Belt Tensioner. If a fan belt tensioner is needed, order the current part listed in [Impact](#).
