Field campaign

Topic	Bentayga - Control Unit for Fuel Pump (SC 20/05)
Market area	China 796 VW Import Comp. Ltd (Vico), Beijing (6796),United Kingdom E01 Bentley UK (6E01),United States E05 Bentley USA and rest America (6E05)
Brand	Bentley
Transaction No.	2058764/1
Campaign number	EB47
Note	
Type	Field Campaign
US code

Bentayga

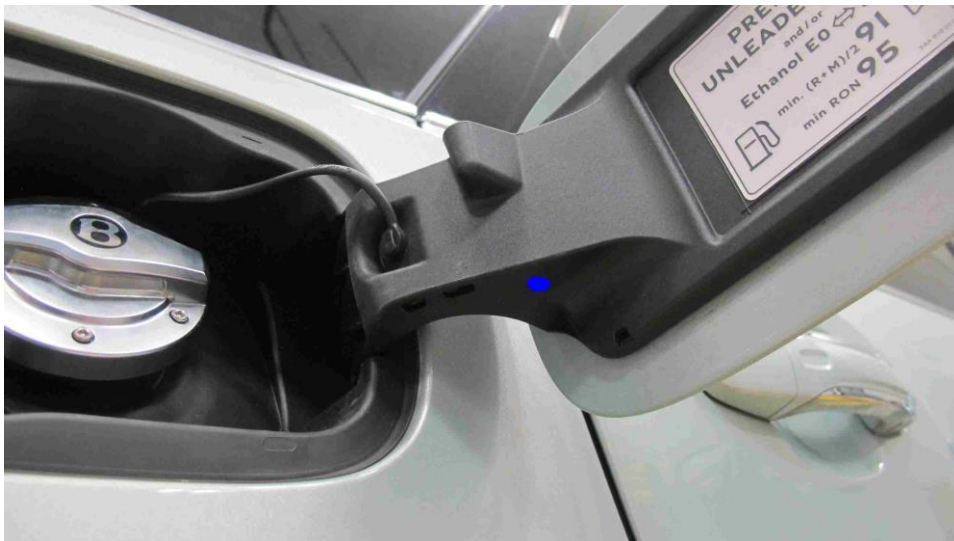
Figure 1

If the vehicle is not already listed in the "Repair History" (Elsa Pro) check for the Blue campaign identification mark on the underside of the fuel filler door hinge—figure 1.

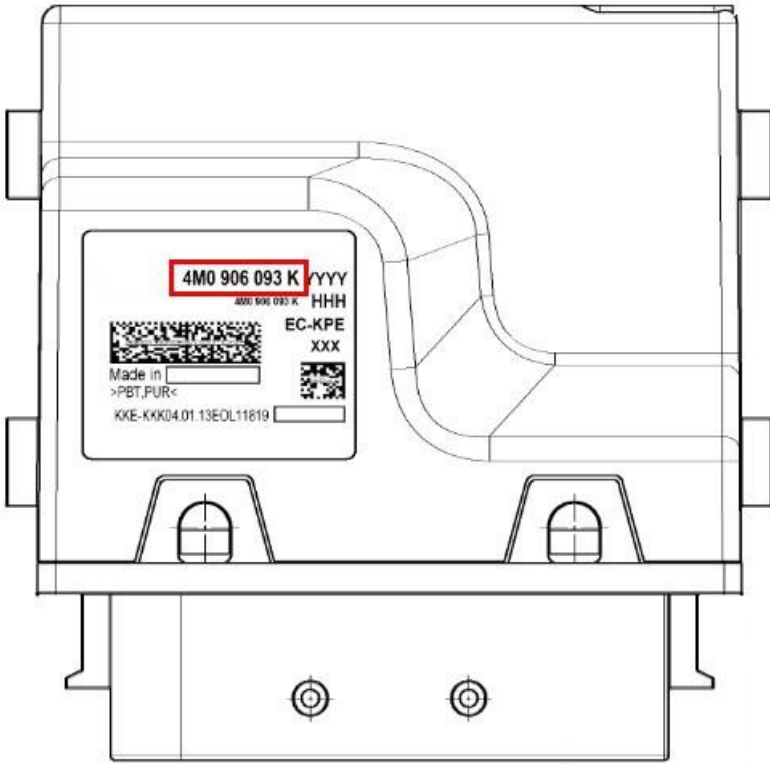
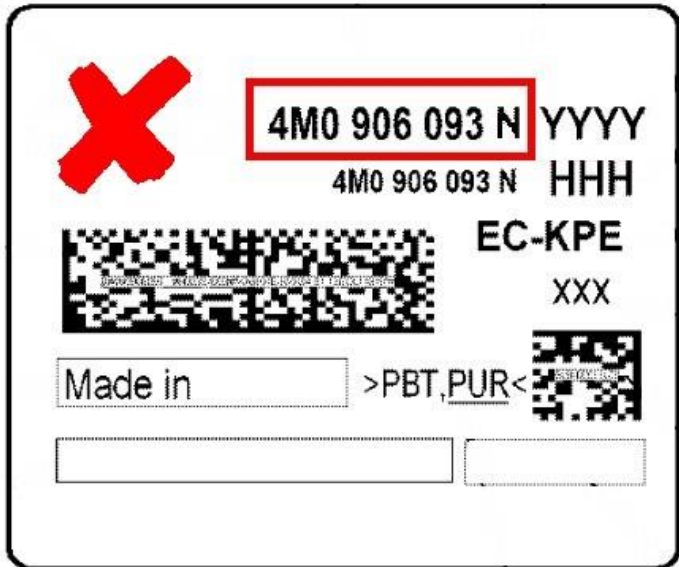
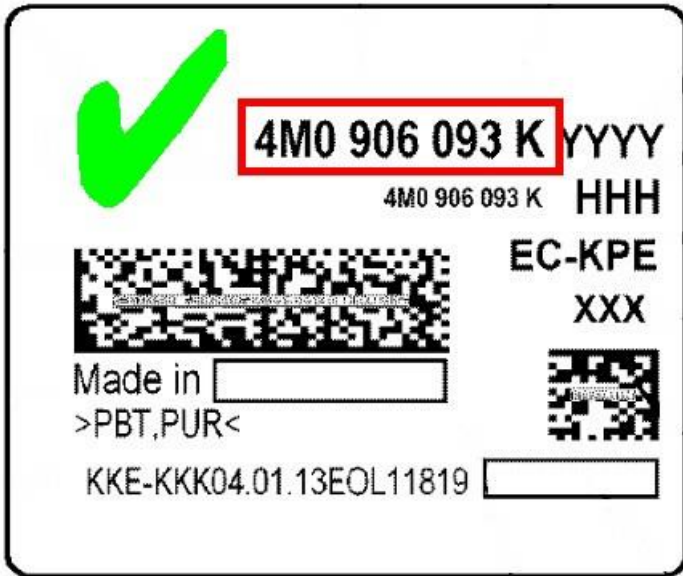
Check the part number marked on both fuel pump control units, refer to *Repair Group 20 Fuel supply, gas operation – 6.0L W12 TSI – Fuel pump control units (J538, J835) – To remove and fit.*

Check the part number marked on the fuel pump control unit, refer to *Repair Group 20 Fuel supply, gas operation – 4.0L V8 TSI – Fuel pump control unit (J538) – To remove and fit.*

If the part number on the fuel pump control unit(s) is 4M0 906 093 N or the control unit cannot be identified, proceed to replace with control unit 4M0 906 093 K. Should the original control unit(s) be identified as 4M0 906 093 K no further action is required.

Note: It is possible on 6.0L – W12 vehicle variants there may be a mixture of 4M0 906 093 K and 4M0 906 093 N control units, only the “N” level fuel pump control units should be replaced.
