NUMBER: 08-013-20

Body Control Module (BCM) Reconfigure for Enabling the Auto-On Comfort Settings

2018 - 2020

Jeep Wrangler

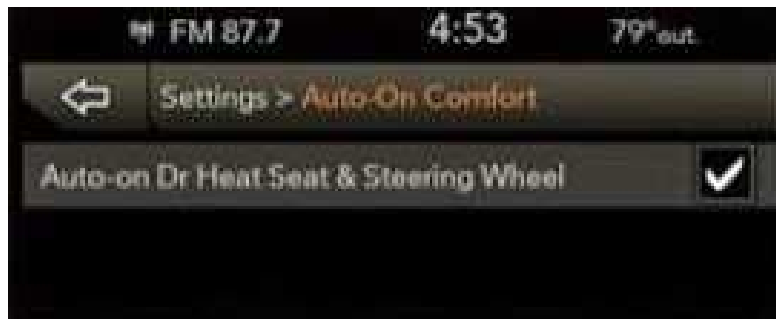
Fig. 1
Auto-On Comfort Screen

7. Is there a setting with single check mark to enable or disable the “Auto-On Comfort” feature ([Fig. 1](#)) ?
 - YES>>> This bulletin has been completed, use LOP (18-19-02-EV) to close the bulletin.

8. Perform a **radio reset** using wiTECH “Guided Diagnostics/Reset ECU”.
9. Place the ignition in the off position, disconnect the wiTECH MicroPod and open and close the driver door. This will allow all modules to go to sleep and should take about one minute.
10. Verify the “Auto-On Comfort” feature by going into the radio “Settings>Auto-On Comfort”.
11. Is there a setting with single check mark to enable or disable the “Auto-On Comfort” feature ([Fig. 1](#)) ?
 - YES>>> This bulletin has been completed, use LOP (18-19-02-EV) to close the bulletin.
 - NO>>> Further diagnosis should be performed.
