# Service Bulletin

Bulletin No.: 18-NA-182

**Subject:** Information on Water Leaks in Rear Cargo Area, Rear Compartment Well, Possible Loss of Chime and/or Radio Functions

Brand:	Model:	Model Year:		VIN:		Engine:	Transmission:
		from	to	from	to		
Chevrolet	Bolt EV	2017	2020			All	All
Opel	Ampera-e	2017	2020			All	All

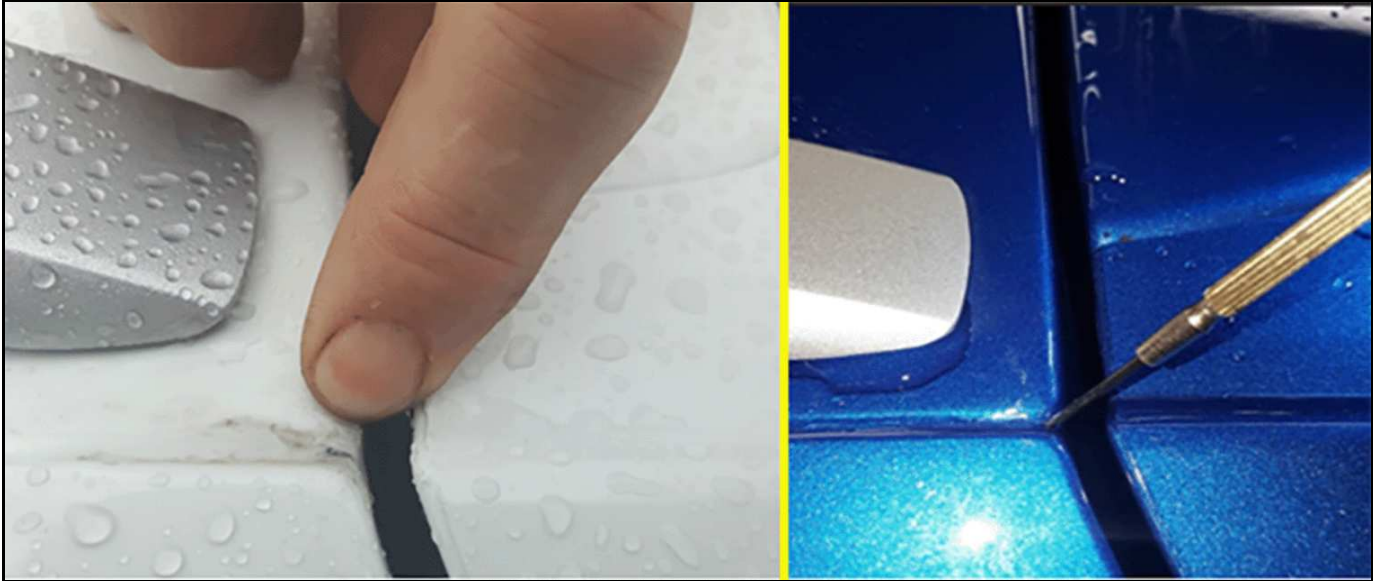
5074583

## Pinhole in Roof Drip Rail

Checking the locations noted below, verify the condition. Then as necessary, reposition/seal parts and/or repair the leak path and apply the appropriate sealant, referencing *Body Waterleak Repair* in SI.

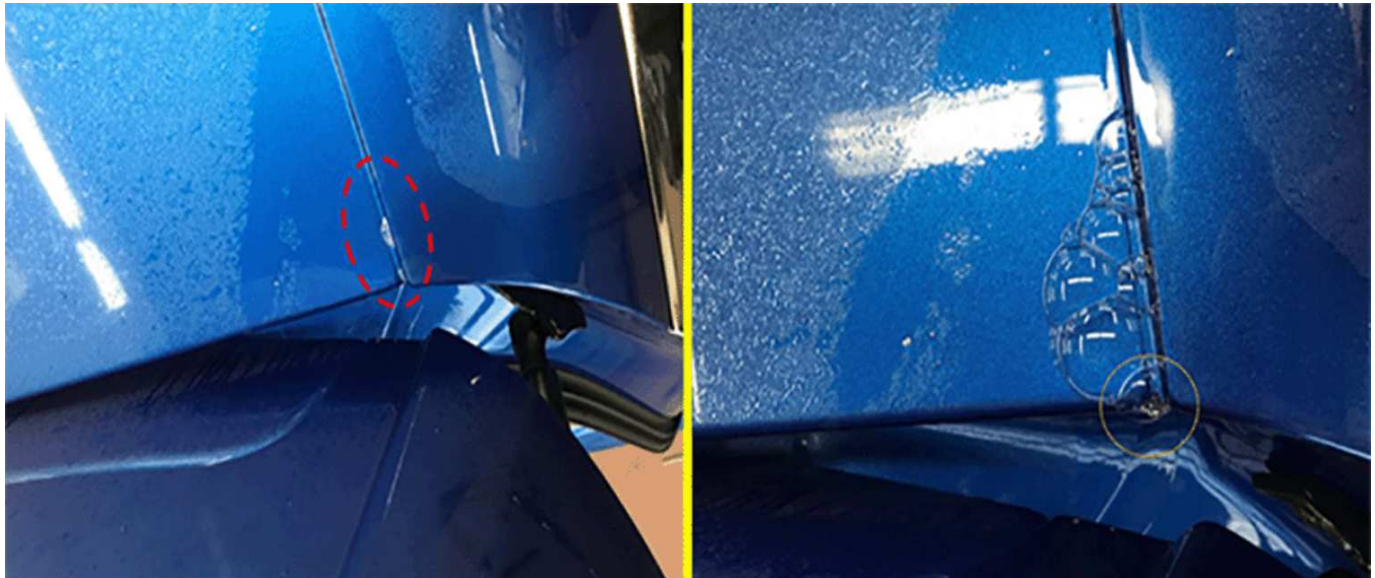
5249870

**Note:** In some cases, larger voids have sometimes been found in the same rear roof seam area noted above. Test the roof panel seam line by following the recommended steps below:

1. Lower the rear of the headliner to gain access to the roof seam. Refer to *Headlining Trim Panel Replacement* in SI.
2. Spray a soapy solution on top of the roof at the seam line.
3. Using a long nose spray nozzle, spray air on the bottom of the roof seam between the headliner and roof.
4. If air bubbles are visible on the top of the roof seam, repair using an appropriate body shop sealant and if necessary, touch up with the appropriate color paint.
5. Reinstall the headliner. Refer to *Headlining Trim Panel Replacement* in SI.

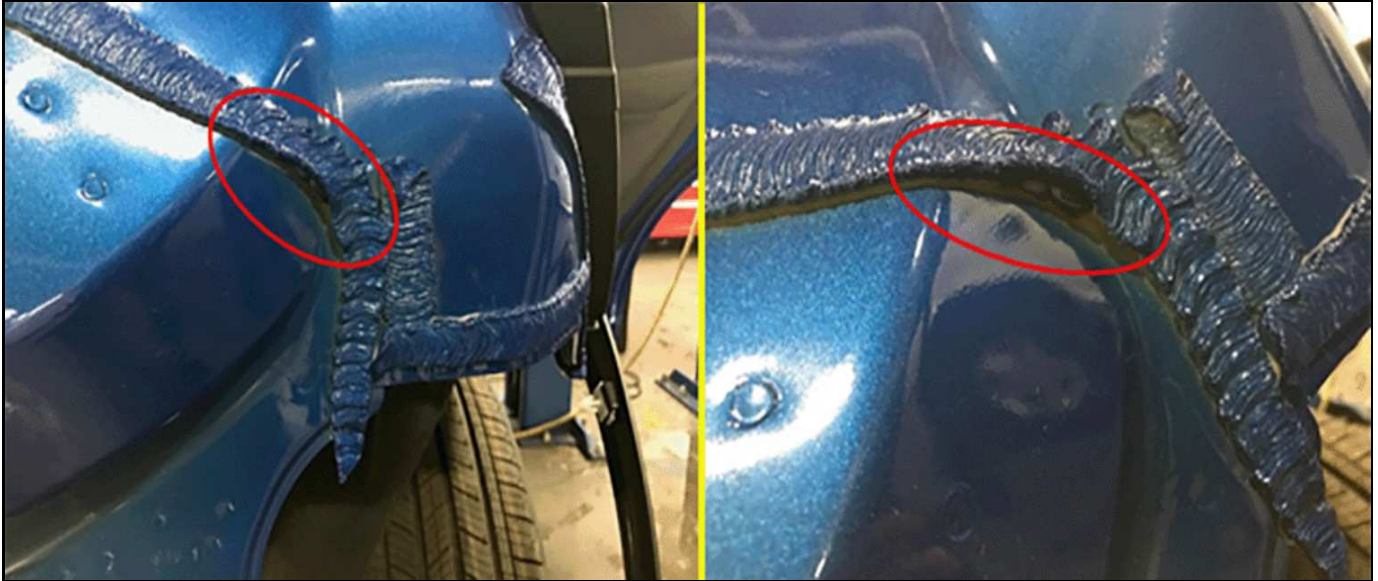
5074590

**Body Sealer Void Behind Rear Fascia**

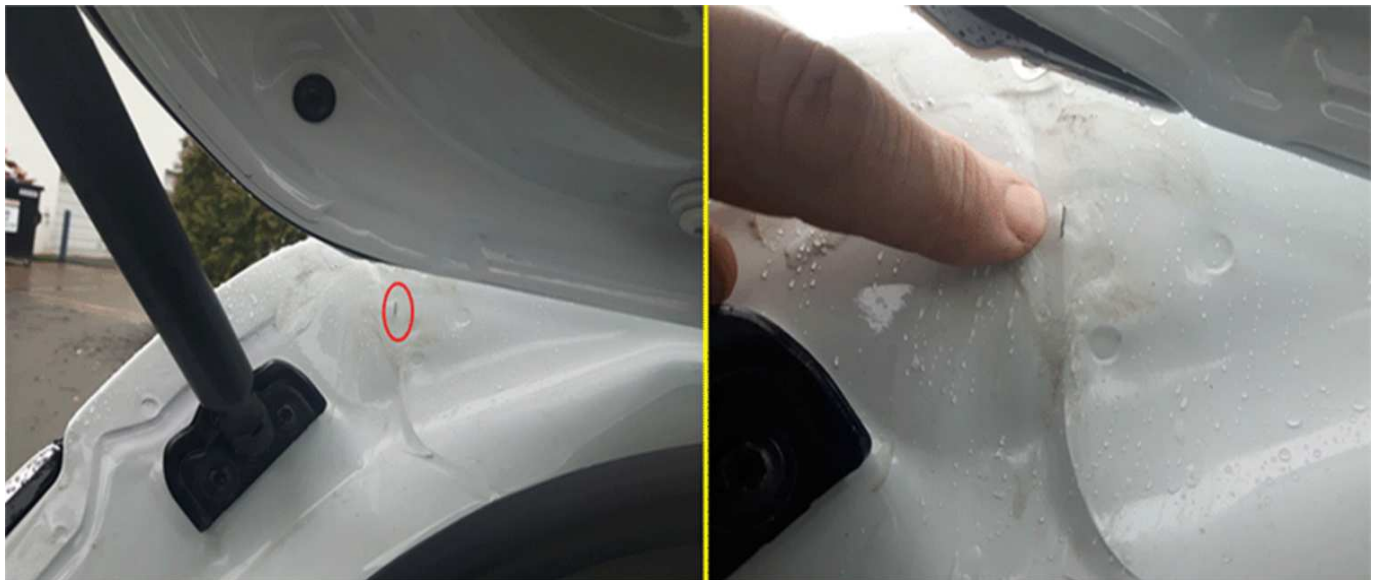
5074602

**Body Sealer Crack Near Left Liftgate Shock Bracket**

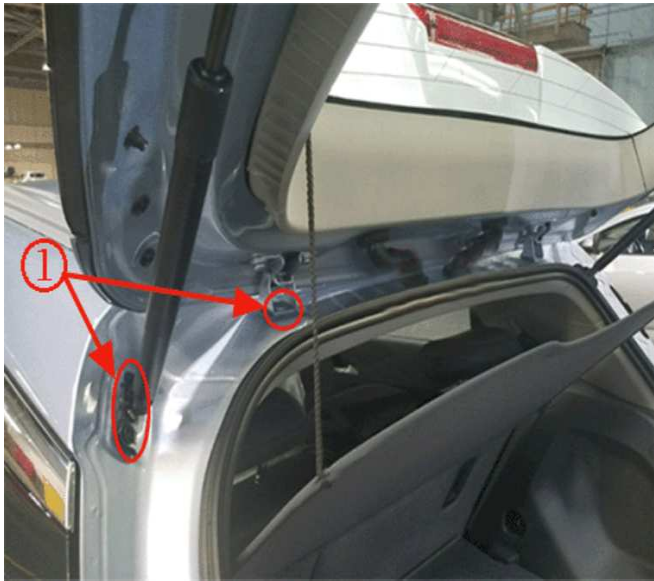
5075032

**Water Leak at Threads of Liftgate Hinge and Shock Retaining Bolts.**

**Note:** Apply sealer to bolt threads (1).

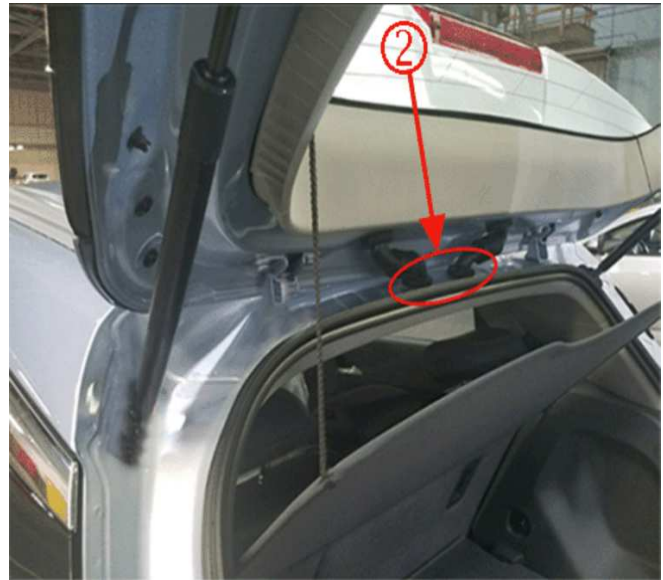
5075040

**Water Leak at Liftgate Wiring Harness Grommets.**

**Note:** Reposition grommets so they are fully seated (2).
