Title Diagnostic Trouble Codes (DTC) P20EE And P103C, Diagnostic Procedure; **REPLACE S GUIDED DIAGNOSTICS IN PREMIUM TECH TOOL ( PTT ) - US17+OBD16 Through US17+OBD2018 Emissions, Model Years 2018 And 2019**

**Mack Model** LR , MRU - TerraPro , TE - TerraPro , AN - Anthem , CHU - Pinnacle, Axle back , C XU - Pinnacle, Axle front , GR - Granite , GU - Granite , PI - Pinnacle

**Volvo Model** VNL , VNM , VNR , VAH , VHD

Cause Procedures and checks to follow for P20EE and P103C on US17+OBD2016 and US17+OBD2018 chassis.

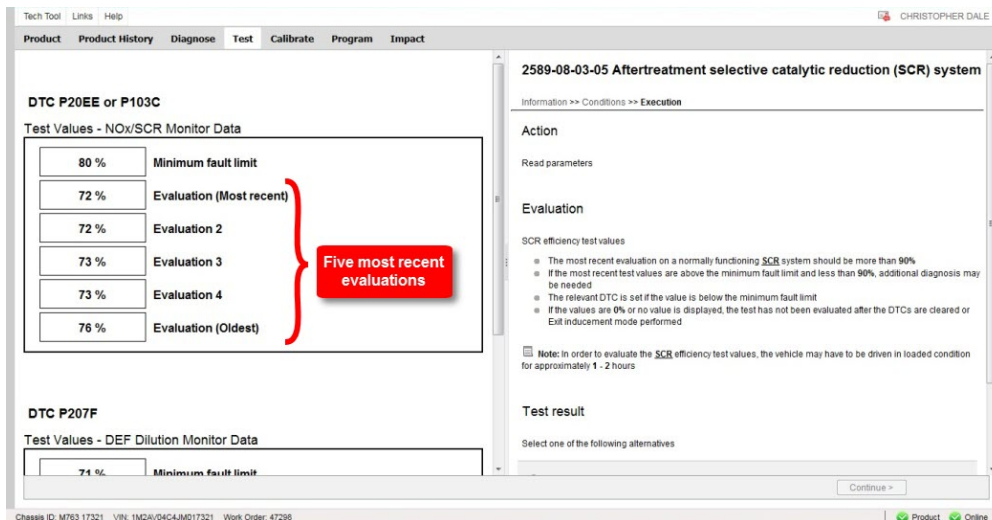
- The last five efficiency evaluations are displayed as shown in the screenshot above.

If all five tests are below the fault limit, SCR conversion has been poor for an extended amount of time.

If only one or two are below the fault limit, conversion is only intermittently poor.

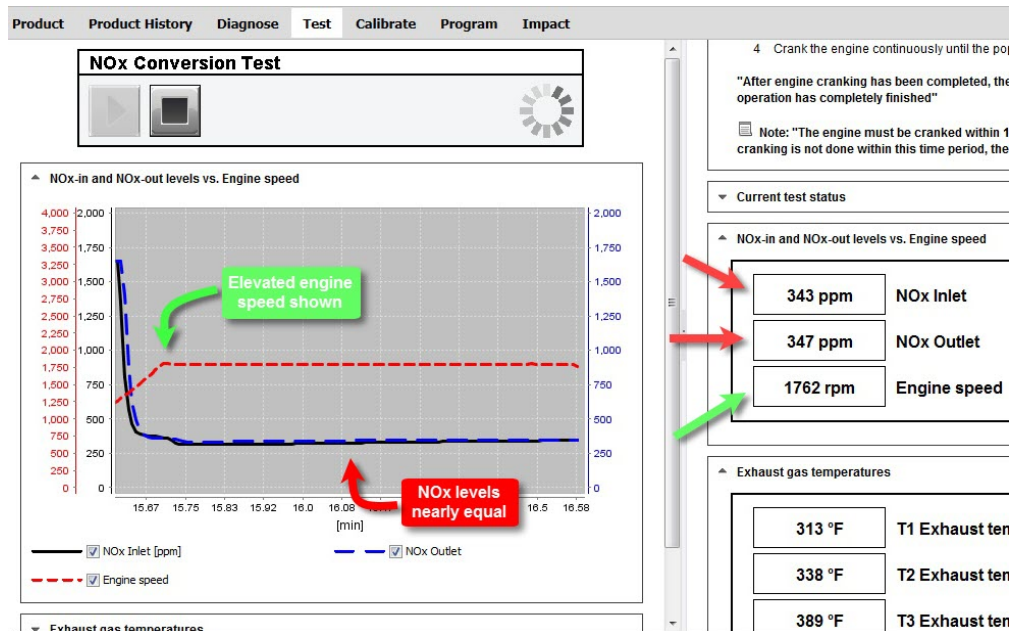
- While running NOx conversion test, if any new NOx sensor codes are logged (Egs: P220E-93, P220F-93), make sure to troubleshoot those codes.
- Inlet and Outlet NOx Sensor values should be close to each other at high engine speed (last portion of the test) as shown below.
- If during the test difference between NOx sensors are greater than 10%, it is recommended to replace the sensor reading the higher value and re-do the test.

The likelihood that both sensors require replacement at once is low. Replacement of both sensors at once should not be considered immediately unless affected by an upstream failure.

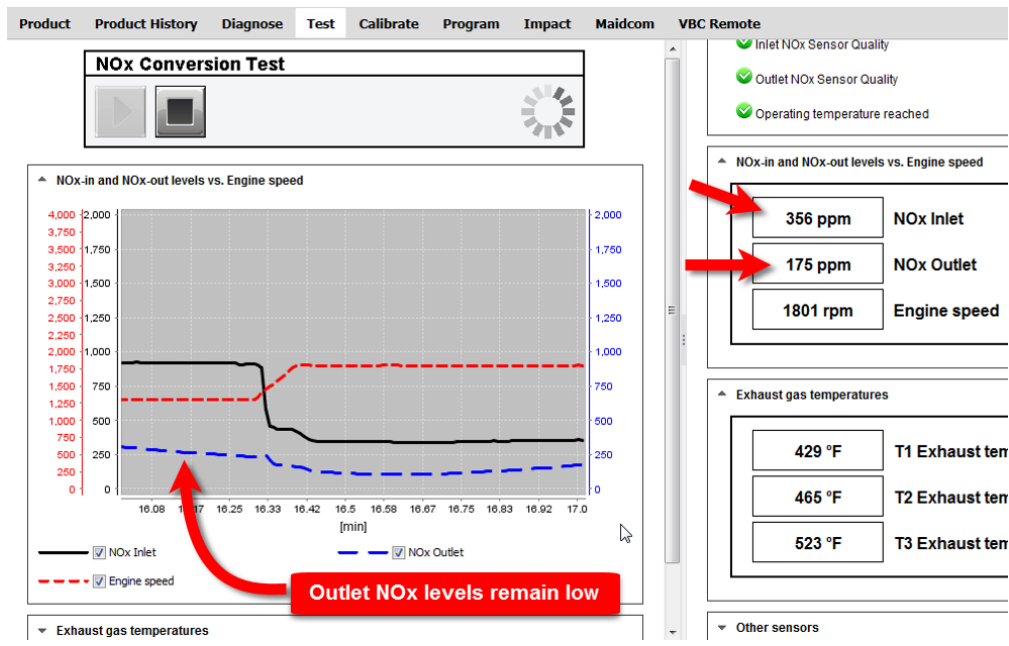
EMS Main Software Part Numbers 23470183 and 23470187, used for US17+OBD18 emissions, has a bug that allows DEF dosing to continue during the NOx conversion test. This causes continued low Outlet NOx sensor values as seen in the screen shot below and prevents the desired behavior shown above.

In this instance, review earlier sections of the test to ensure that both sensors are responding to changes in the same manner. Examples of different stages to review are shown below.

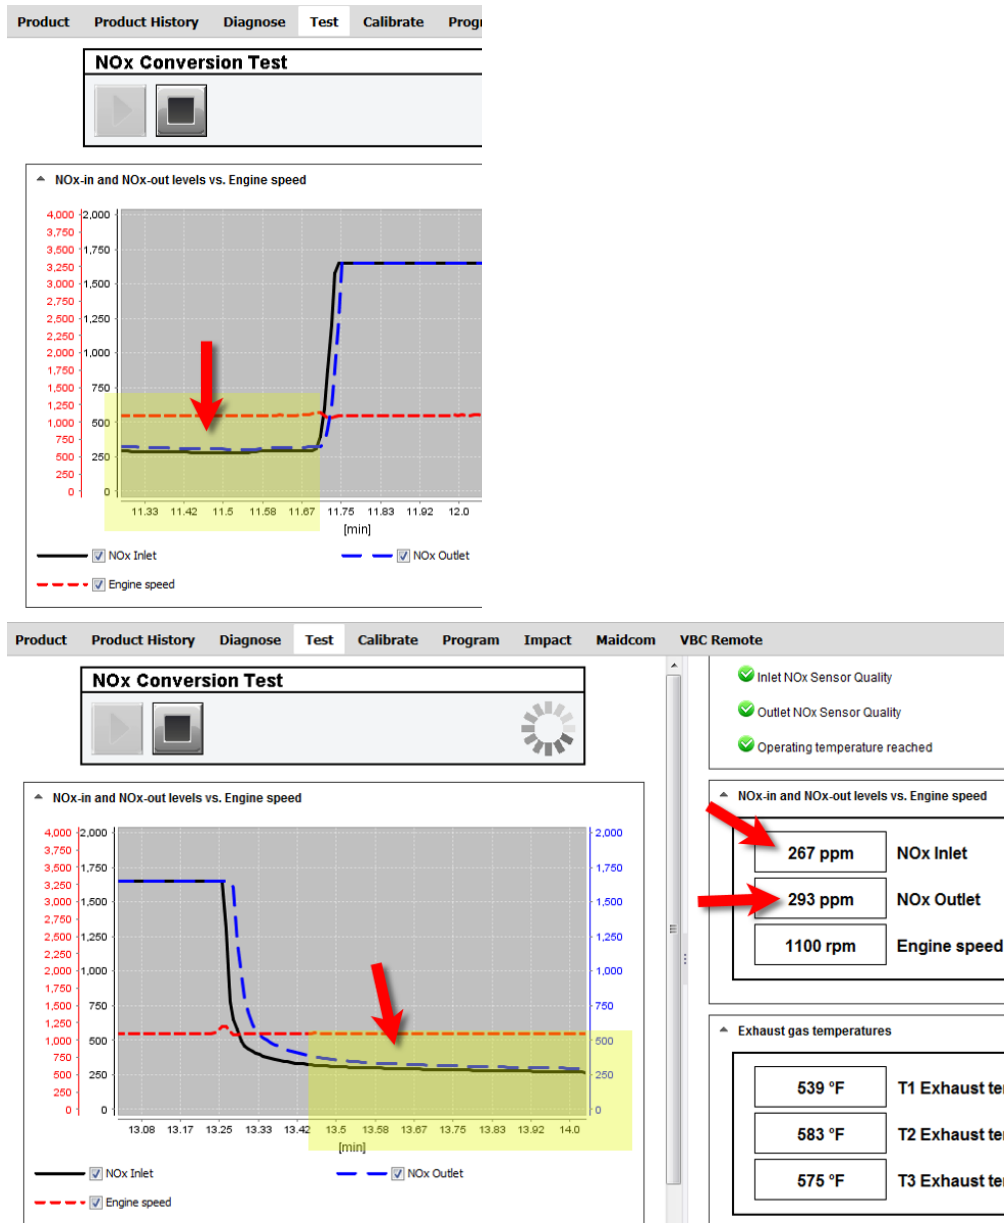
**COMPARISON SHOULD BE DONE WHEN BOTH NOx SENSORS ARE READING BELOW 600 PPM.**
