SERVICE CAMPAIGN BULLETIN

Classification: EC20-006	Reference: NTB20-021	Date: March 24, 2020
-----------------------------	-------------------------	-------------------------

VOLUNTARY SERVICE CAMPAIGN ENGINE CONTROL MODULE

CAMPAIGN ID #:	PC734, PM940, P0A05
APPLIED VEHICLES:	2019 Armada (Y62) 2019-2020 GT-R (R35) 2019-2020 GT-R NISMO (R35) 2019-2020 NV200 (M20) 2019 NV200 Taxi (M20T) 2019 NV Cargo and Passenger (F80) 2019 Sentra (B17) 2019 Titan (A61) 2019 Titan XD (A61)

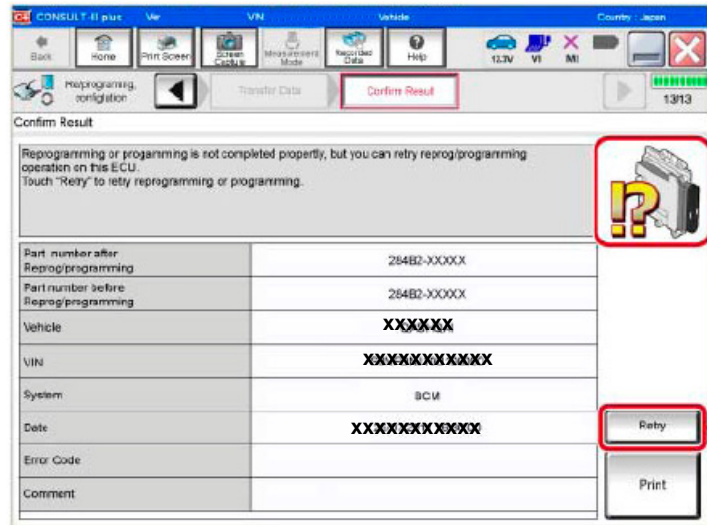
Figure 1

If reprogramming does not complete and the “!?” icon displays as shown in Figure 1:

- Check battery voltage (12.0 - 15.5 V).
- Ignition is ON, engine OFF.
- External Bluetooth® devices are OFF.
- All electrical loads are OFF.
- **Select retry and follow the on screen instructions.**
- “Retry” may not go through on first attempt and can be selected more than once.

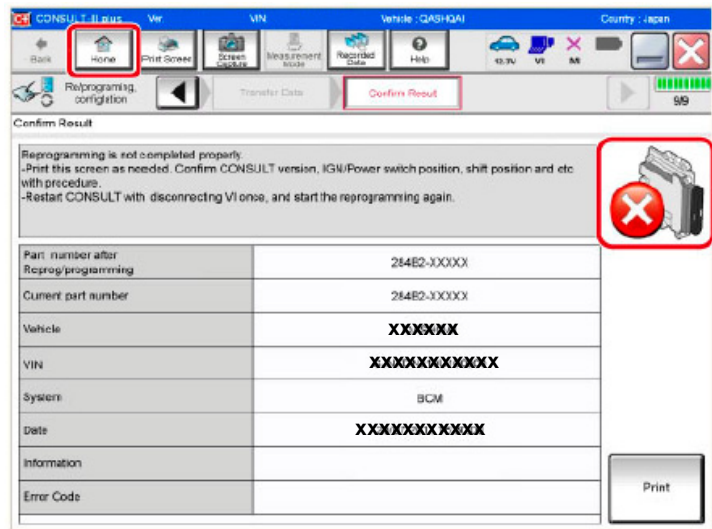
Figure 2

If reprogramming does not complete and the “X” icon displays as shown in Figure 2:

- Check battery voltage (12.0 - 15.5 V).
- CONSULT A/C adapter is plugged in.
- Ignition is ON, engine OFF.
- Transmission is in Park.
- All C-III plus / VI cables are securely connected.
- All C-III plus updates are installed.
- **Select Home, and restart the reprogram procedure from the beginning.**
