SERVICE BULLETIN

Classification:	Reference:	Date:
BT20-007	NTB20-026	March 31, 2020

2005-2019 FRONTIER; HIGH-MOUNTED STOP LAMP SERVICE PART

APPLIED VEHICLES: 2005-2019 Frontier (D40)

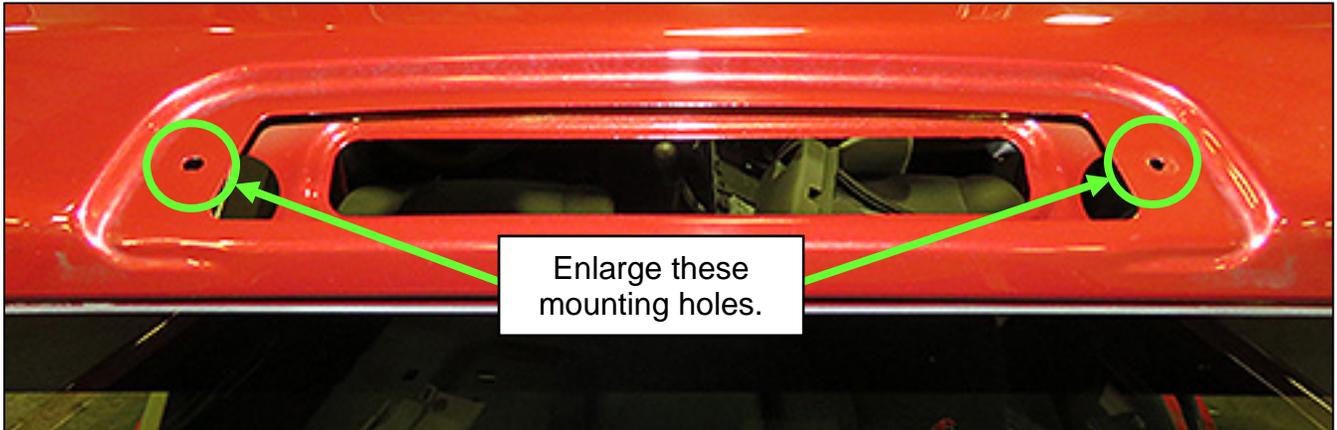
The mounting stud diameter for the high-mounted stop lamp service part has changed from 5 mm to a 6 mm.

Figure 1, below, shown with the high-mounted stop lamp removed.

1. Remove the high-mounted stop lamp.
 - For high-mounted stop lamp removal, refer to the Electronic Service Manual: Section **DRIVER CONTROLS > EXTERIOR LIGHTING SYSTEM > REMOVAL AND INSTALLATION > STOP LAMP**.
2. Enlarge the high-mounted stop lamp's mounting holes (see Figure 1 on page 2) using a 6.5 mm (¼ inch) drill bit.

NOTICE To avoid damage to the vehicle, apply light pressure to the drill while drilling. Excessive force may cause the drill bit to penetrate too far and damage the headliner.
3. Apply touch-up paint to the mounting holes to protect the bare metal.
4. Install the new high-mounted stop lamp using M6 mounting nuts. Refer to the **PARTS INFORMATION** on page 2.
