ITB20-008

March 18, 2020

2019-2020 QX50; RATTLE FROM MOONROOF

APPLIED VEHICLES: 2019-2020 QX50 (J55)
APPLIED VIN: Vehicles built before 3PCAJ5M(*)(*)F111639
APPLIED DATE: Vehicles built before December 6, 2019

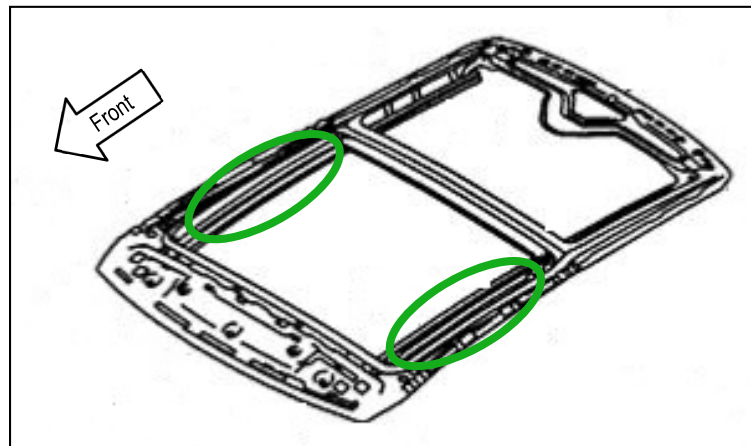
A rattle type noise is coming from the moonroof in the areas circled in green in Figure 1

The rattle goes away after removing the moonroof inner finisher(s).

NOTE: The rattle noise may be intermittent and may be heard from one or both sides of the vehicle.

Apply flocking tape to the moonroof inner finisher on both sides of the vehicle.
