EC20-007

March 24, 2020

VOLUNTARY SERVICE CAMPAIGN 2019 Q70 AND 2019 QX80; ENGINE CONTROL MODULE

CAMPAIGN ID #: P0A06
APPLIED VEHICLES: 2019 Q70 (Y51)
2019 QX80 (Z62)
APPLIED ENGINE: VK56VD

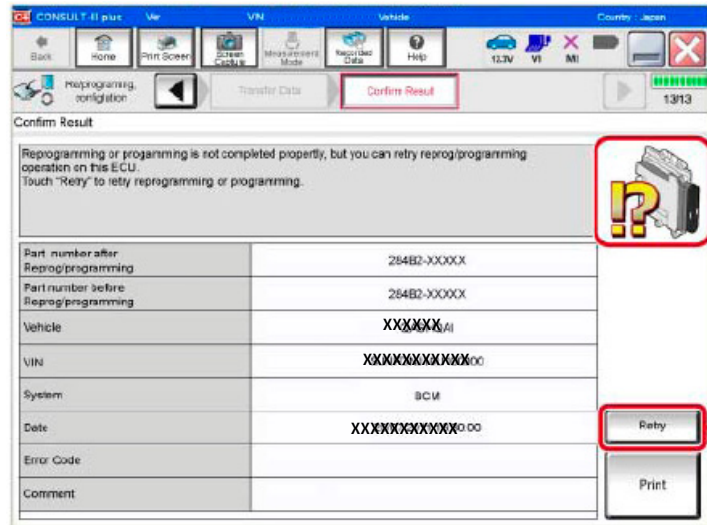
Figure 1

If reprogramming does not complete and the “!” icon displays as shown in Figure 1:

- Check battery voltage (12.0 - 15.5 V).
- Ignition is ON, engine OFF.
- External Bluetooth® devices are OFF.
- All electrical loads are OFF.
- Select retry and follow the on screen instructions.
- “Retry” may not go through on first attempt and can be selected more than once.

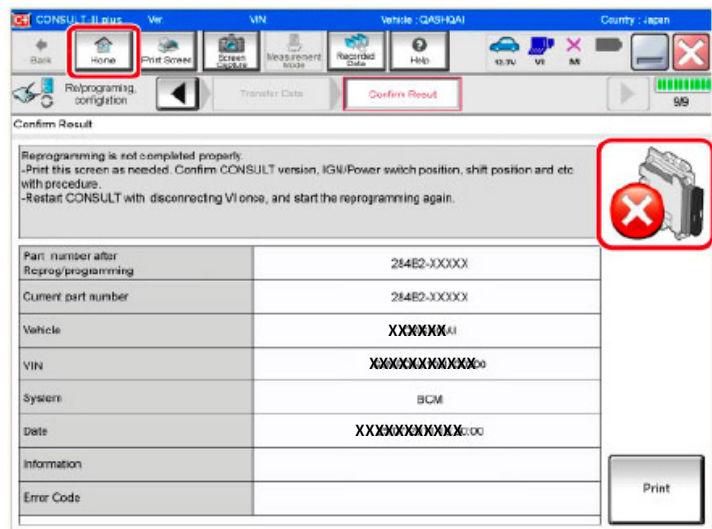
Figure 2

If reprogramming does not complete and the “X” icon displays as shown in Figure 2:

- Check battery voltage (12.0 - 15.5 V).
- CONSULT A/C adapter is plugged in.
- Ignition is ON, engine OFF.
- Transmission is in Park.
- All C-III plus / VI cables are securely connected.
- All C-III plus updates are installed.
- Select Home, and restart the reprogram procedure from the beginning.
