Preliminary Information

PIT5552D Rear Vision or Surround Vision Camera Image Yellow / Blurry / Distorted / Scrolling / No Grid Lines / Blue Screen with Gridlines / Service Rear Vision System Message

Product Investigation Review Required

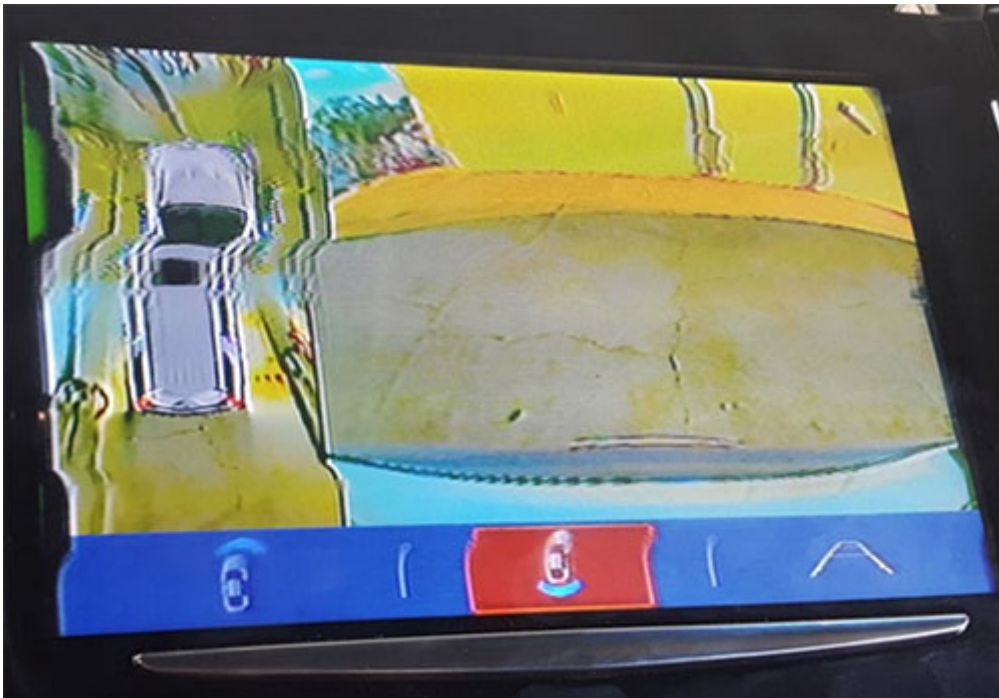
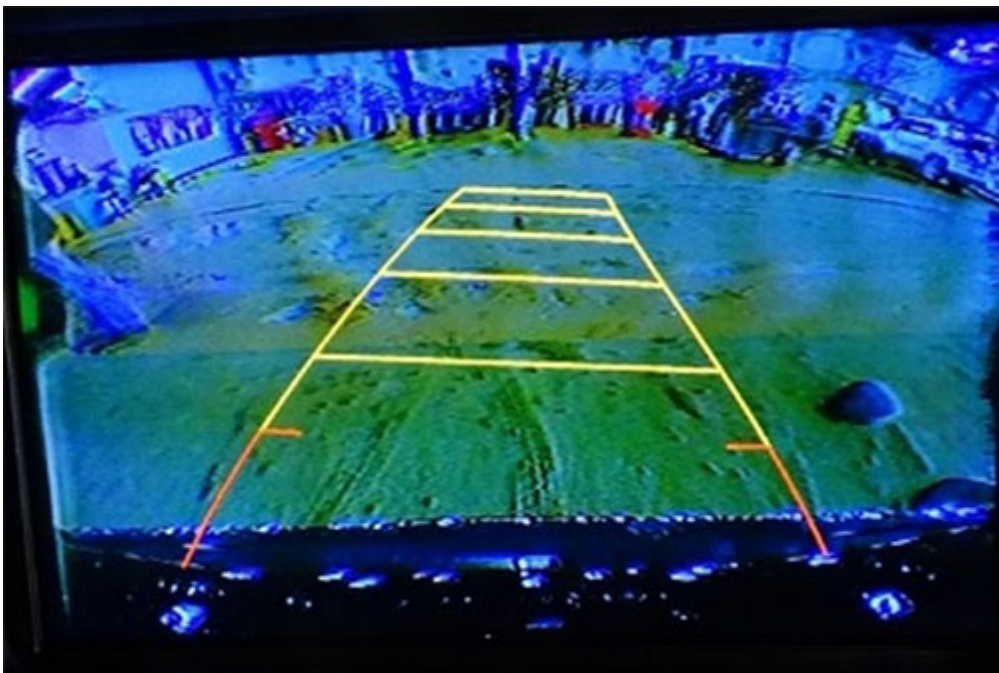
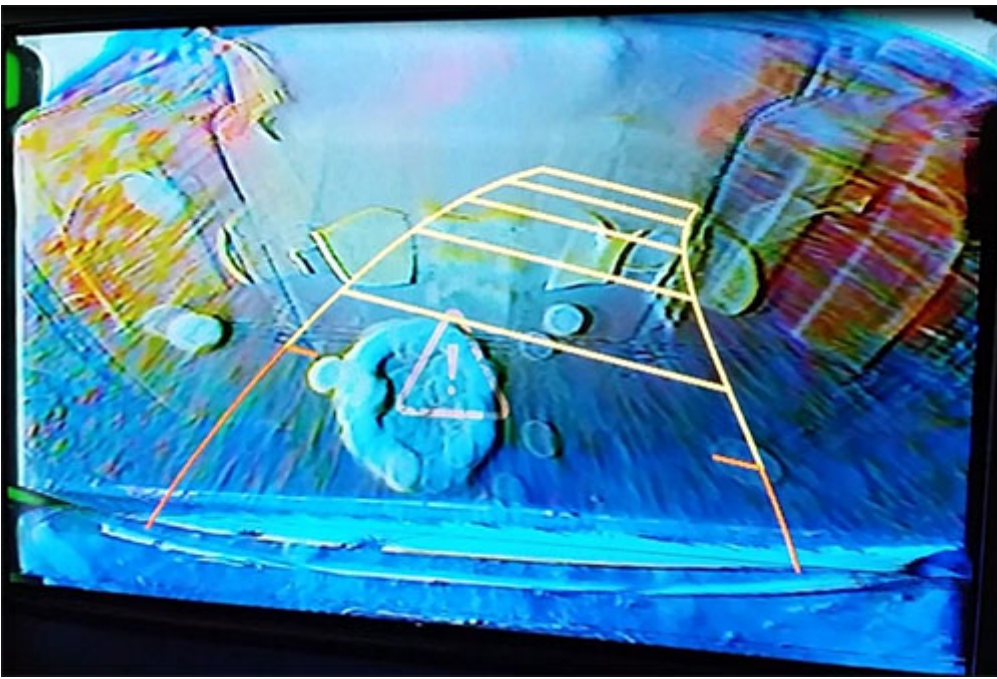
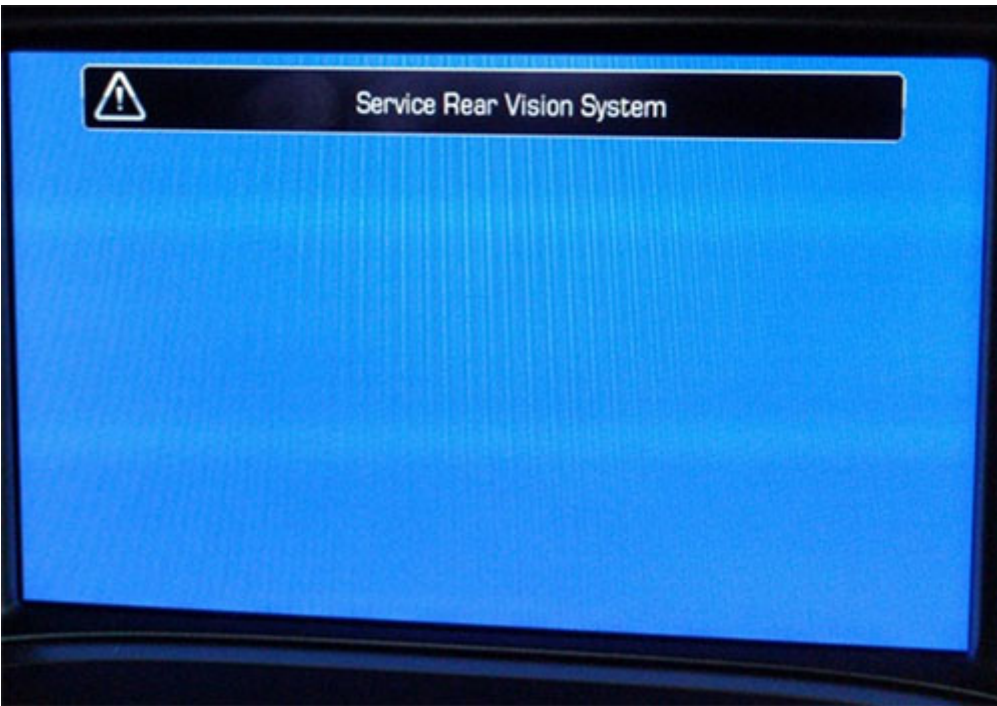
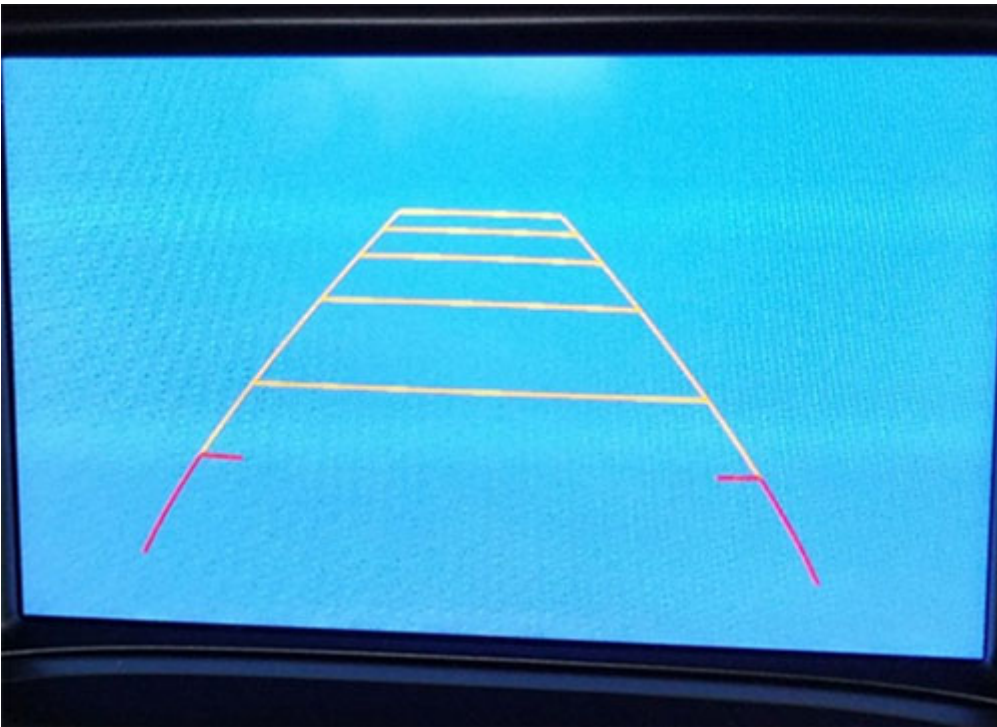
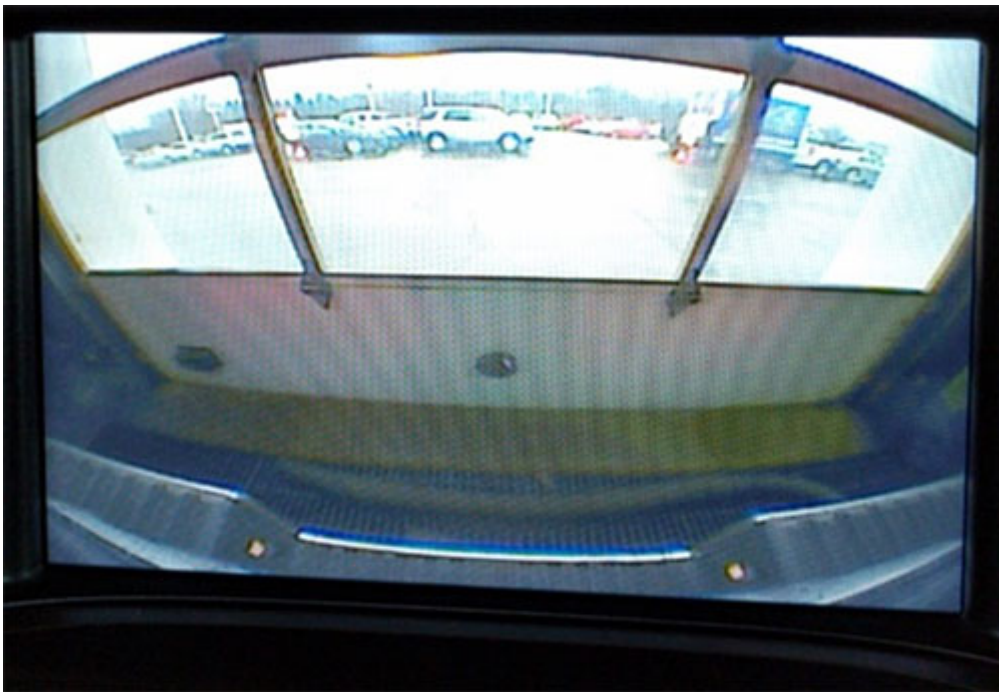
Involved Region or Country	North America and Middle East
Additional Options (RPO)	With Rear Vision Camera (RPO UVC) or Surround Vision (RPO UVH)
Condition	<p>Some customers may have a concern with the rear vision camera or surround vision camera image being:</p> <ul style="list-style-type: none"> - Yellow - Blurry - Distorted - Image scrolling - Image with NO gridlines - Screen is blue with gridlines - Screen is blue with Service Rear Vision System message <p>These concerns may be present with or without any DTCs. Examples of these issues are shown below.</p>
Cause	<p>Cause 1: Aftermarket devices such as the items listed in the latest version of PIC5650 have been known to cause issues with the camera display. Because they are so common, 12 volt to USB adapters have been the number 1 culprit causing image issues.</p> <p>Cause 2: A poor connection in the camera signal circuits 6972 and/or 6973. The camera signal circuits 6972 and 6973 run between the</p>

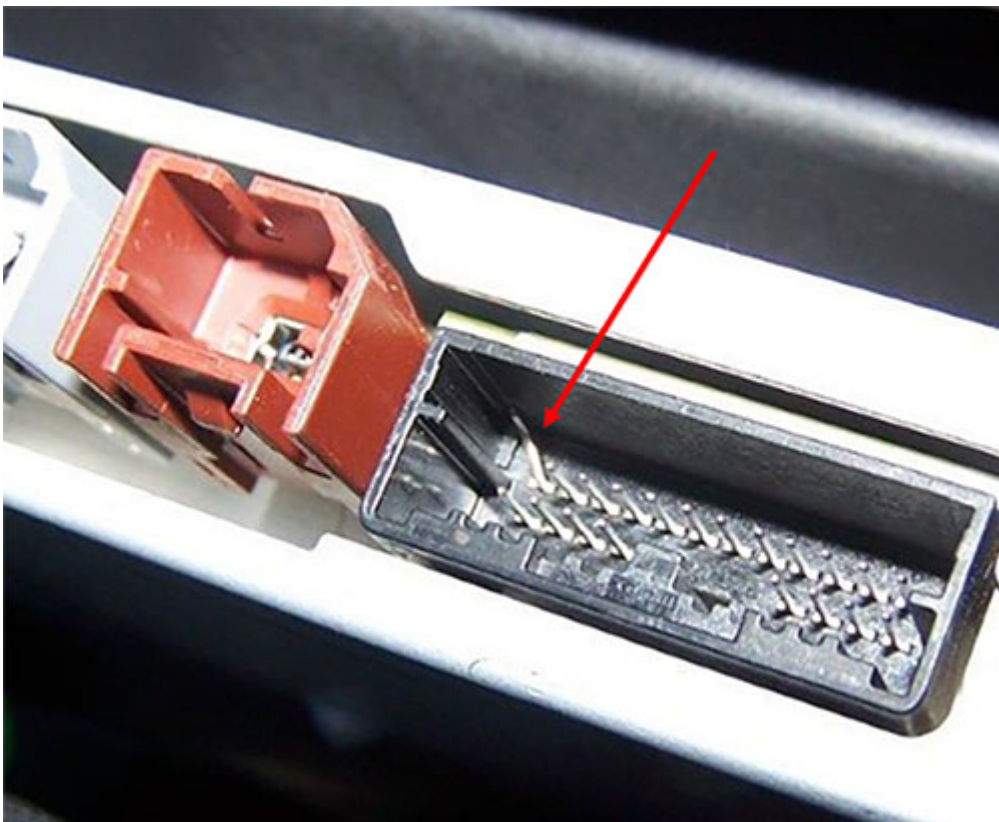
For the 2017-2020 Models, another common area is at the HMI Bypass Module K188. An example of this bent terminal at the HMI Bypass Module K188 connector X1 pin 20 can be seen below.

Correction 2: Inspect the camera signal circuits 6972 and 6973 for opens, high resistance, poor terminal tension, bent terminals, etc. Replace and/or repair any damaged terminals, module(s) with bent pins, or wiring as necessary.
