# Preliminary Information

**PIT5556A (Inspect Wiring Harness) Multiple Warning Lights / Messages / High Speed Lan / Chassis Expansion Bus / Intermittent Engine Stall at Stops / Service Power Steering / Service Stabilitrak / Service Park Assist / Service Traction Control / Service Suspension / Service Trailer Brake Message / Shift to Park / PRNDL May Not Display Gear**

Models

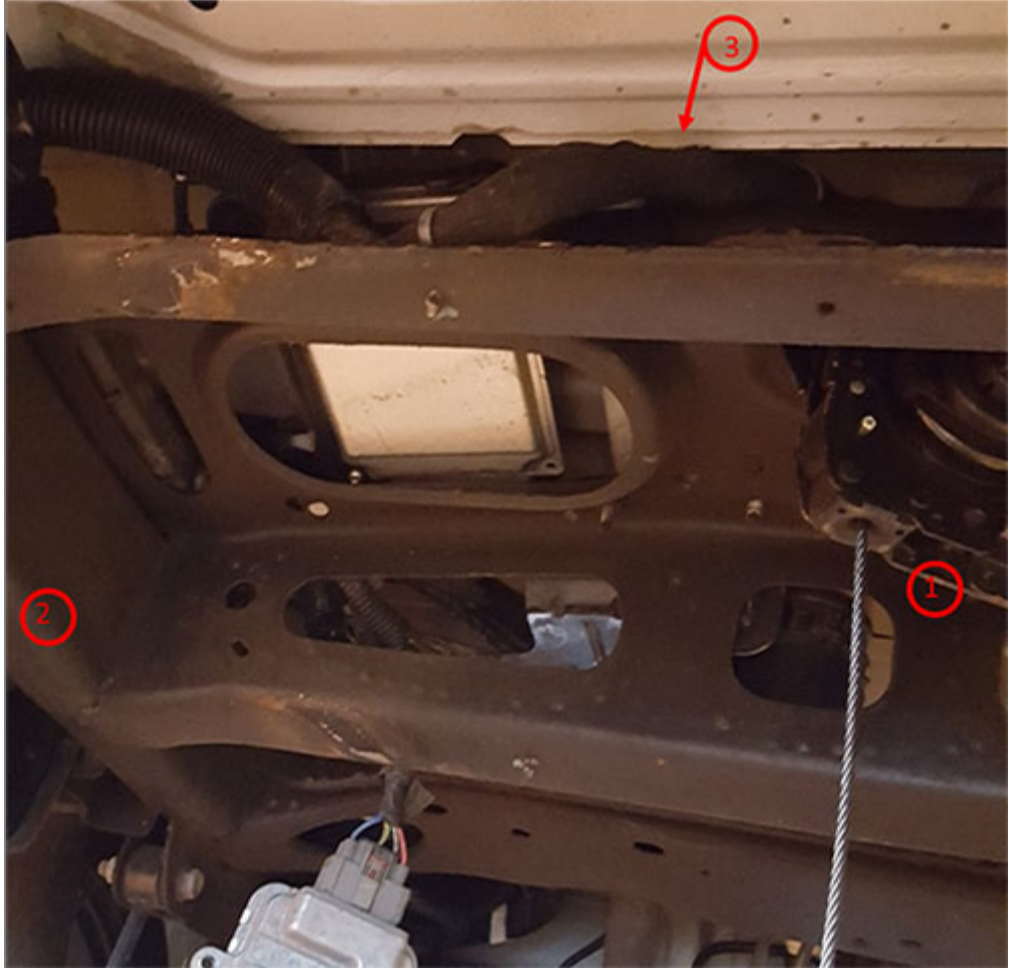
If the source of the issue(s) are not found after performing normal SI diagnostics, they could be caused by a shorted chassis harness (3) where it passes between the underbody floor structure and frame cross member above the spare tire, as shown below. Depending on which wire(s) are damaged will determine which vehicle system(s) are affected: Communication Busses High Speed Lan/Chassis Expansion, Electronic Suspension Control, Trailer Brake Control, etc.

The spare tire has been removed to access the area.

1. Spare Tire Hoist
2. Left Rear Frame Rail
3. Area of Shorted Harness

**Repair the affected wiring as needed. To provide more clearance between the wiring harness and the frame / body, attempt to reshape or flatten the harness in the affected area so it is more of an oval shape. Apply anti abrasion tape to help hold the shape, and, if needed, add additional protection to the harness to prevent any damage from reoccurring.**
