Bulletin No.: PIP5704B

PIP5704B Only 11 Digit PUN (Part Unique Number) Found On Service Solenoid Body Assembly GF9 9T45/50/60/65

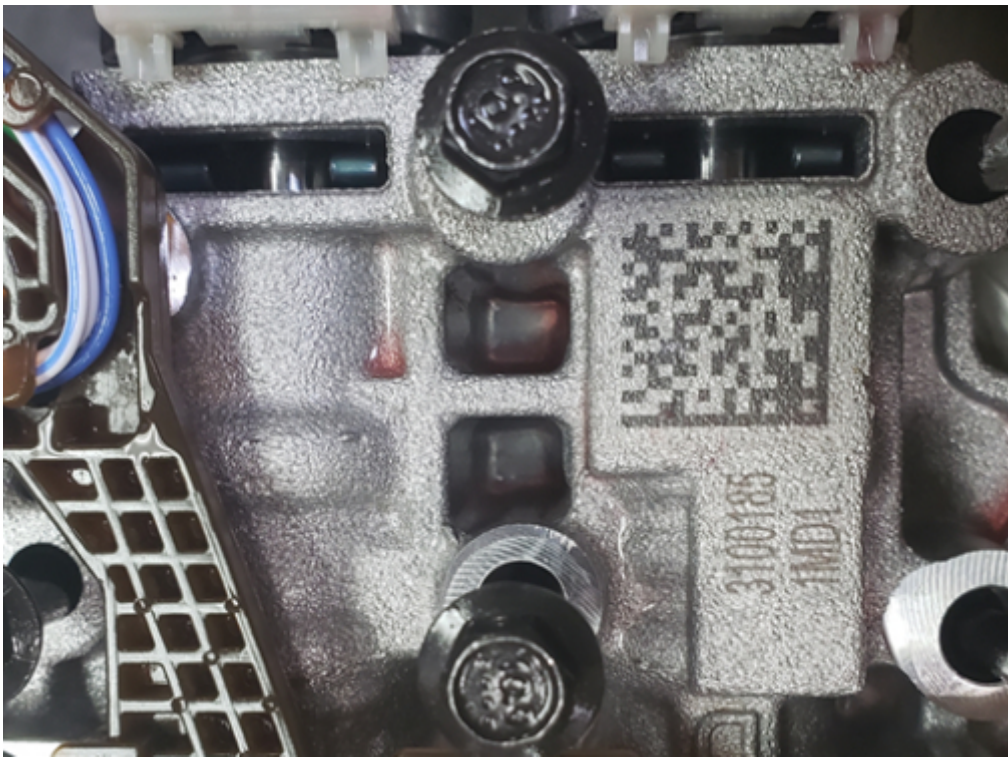
Involved Region or Country	North America and NA Exports.
Condition	Un-able to perform the shift characterization when installing replacement Solenoid Body Assembly due to only 11 digit PUN (Part Unique Number) found on the Service Solenoid Body Assembly.
Cause	Service Solenoid Body Assembly may not have the 16 digit PUN (Part Unique Number) printed on the assembly.

Example using above picture should be "WL0Y931001851MD1" as this part was manufactured in the Calendar Year 2019.

The complete 16 digit PUN (Part Unique Number) can be found on the back side of the instruction sheet that came with the service solenoid body assembly.

If the number is not found on the instruction sheet, use a QR scan code reader to obtain the full 16 digit PUN (Part Unique Number).

If 16 digit PUN (Part Unique Number) is not read when scanned, can try information listed below as the first 5 digits to use in front of the 11 digits printed on the Solenoid Body Assembly.

First five digits are dependent as to where the part was manufactured as well as Calendar Year built, can try WL0Y9, WL0Y0, WL4P9, or WL4P0.

If still un-able to complete the shift characterization with the 16 digit PUN, verify the digits being used are not transposed, and ensure "0" is being used and not "O".
