# ADDITIONAL ROCKET 3 PDI & SERVICE CARE POINT

**TOL Ref. # 14204-SVC**

## Additional Rocket 3 PDI & Service Care Point

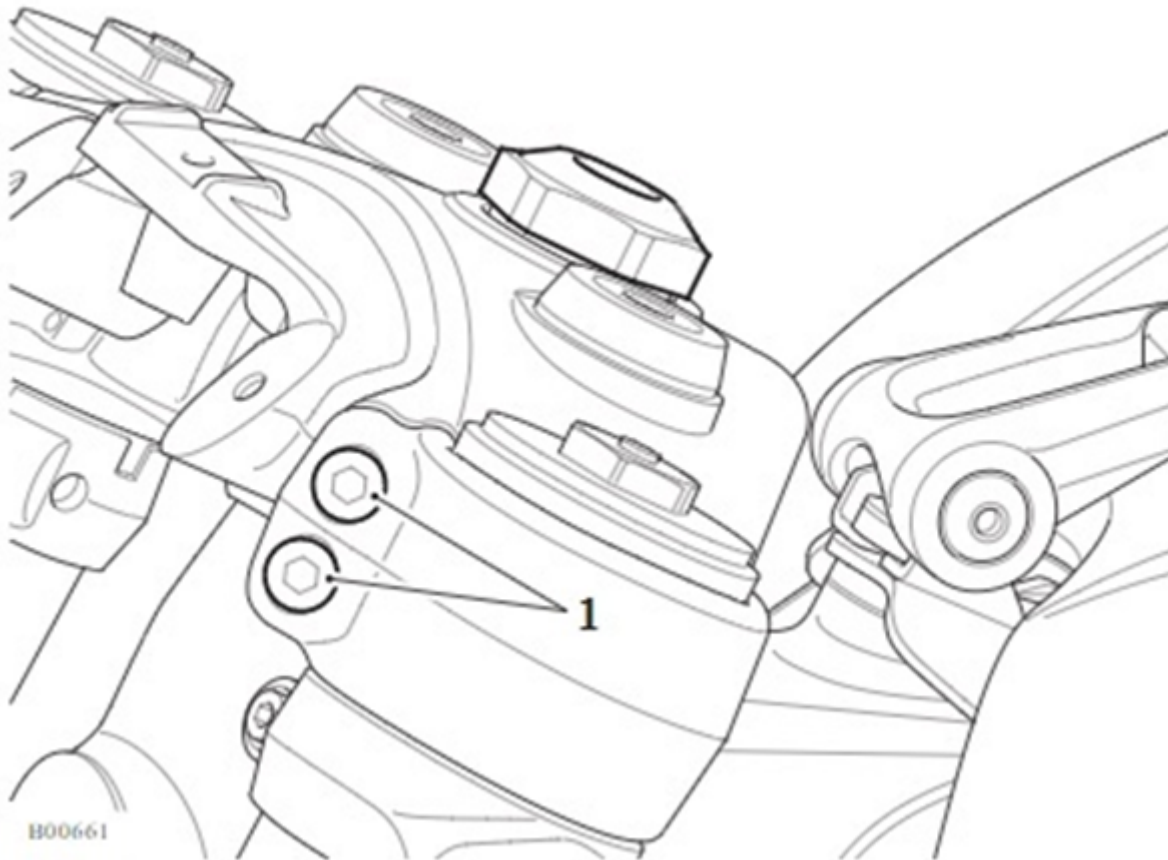
**1. Upper yoke pinch bolts**

Triumph has identified an additional care point for all Rocket 3 model PDIs and first (600 mile/1,000 km) service inspections. The upper and lower yoke pinch bolts are required to be checked and – if necessary – re-torqued as specified in the service manual.

Tighten both left-side and right-side the upper yoke pinch bolts to **25 Nm**:
