MIL ON With DTC(s) P1C5F19 and/or P1C5D19 Causing Over-current Condition

Service Category Vehicle Interior

Section Meter/Gauge/Display

YEAR(S)	MODEL(S)	ADDITIONAL INFORMATION
2019 - 2020	Avalon HV, Camry HV, RAV4 HV

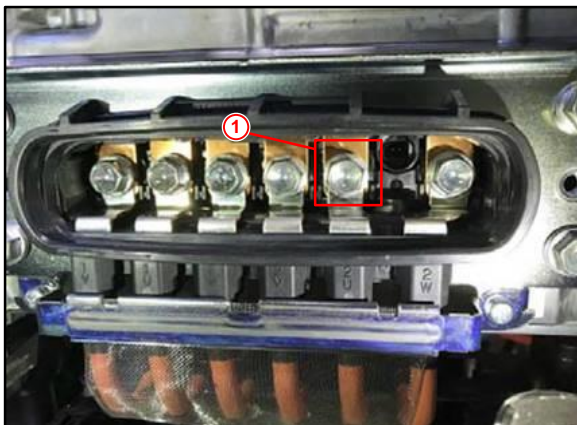
Figure 1. View of Terminals at the Inverter

1 Close-Up View of Terminal (See Figure 2)

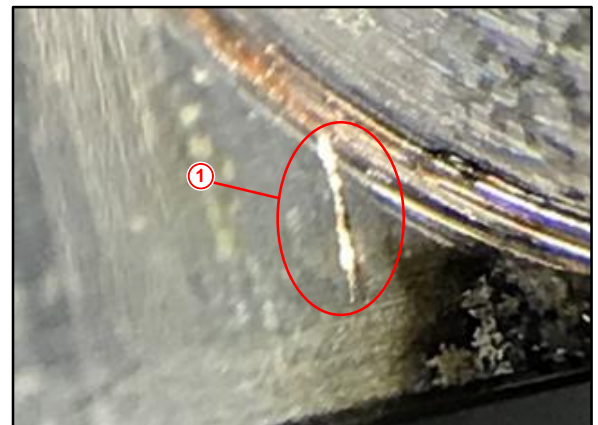
Figure 2. Close-Up View of Terminal

1 Debris Created From Bolt Tightening

Ensure correct fastening tools and torque are used when installing the MG cable. Over tightening can create debris.

3. Using compressed air, blow out ALL potential debris on the terminals and connections area of the inverter and transaxle. Visually confirm there is no debris present on terminals and connections area.
4. Reinstall the MG cable with NEW bolts into the transaxle assembly. Inverter bolts can be reused. Refer to TIS, applicable model and model year Repair Manual:
 - [2019](#) / [2020](#) Avalon HV:
Drivetrain – Hybrid Transmission/Transaxle – “P710 (Hybrid Transmission / Transaxle): Motor Cable: Installation”
 - [2019](#) / [2020](#) Camry HV:
Drivetrain – Hybrid Transmission/Transaxle – “P710 (Hybrid Transmission / Transaxle): Motor Cable: Installation”
 - [2019](#) / [2020](#) RAV4 HV:
Drivetrain – Hybrid Transmission/Transaxle – “P710 (Hybrid Transmission / Transaxle): Motor Cable: Installation”
