Technical Service Bulletin

44 TPMS malfunction warning in the cluster shortly after engine start

44 20 76 2059234/1 April 10, 2020.

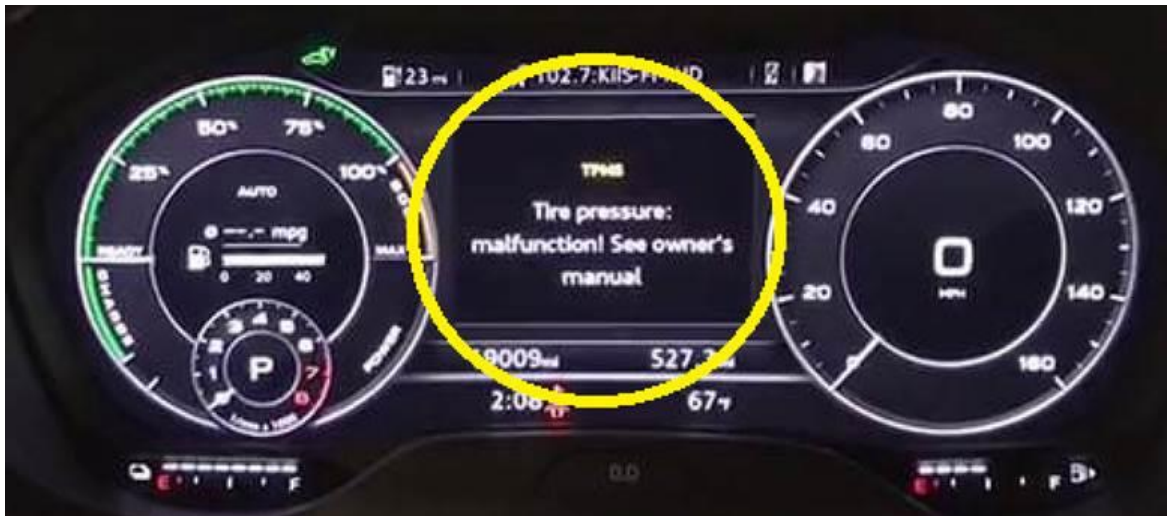
- The TPMS message "Tire pressure: malfunction!" appears in the instrument cluster shortly after engine starts (Figure 1).

Figure 1. TPMS warning message.

On vehicles with Audi virtual cockpit (PR number 9S8) the messages "TPMS malfunction" or "TPMS malfunction: See Owner's Manual" appears in the instrument cluster briefly after the engine starts and goes out after a few seconds.

After the engine starts the instrument cluster takes a shorter time to initialize compared to the tire pressure loss indicator. The message "TPMS malfunction" appears while the instrument cluster is already initialized and the tire pressure loss indicator is still building up.

If the message "TPMS malfunction" only appears briefly after the engine start and then goes out, there is no technical malfunction.

Do not repair or replace any component, release the vehicle.
