Technical Service Bulletin: TSB200079	Released Date: 31-Mar-2020
Heat Exchanger Main Support Bracket Installation

Heat Exchanger Main Support Bracket Installation

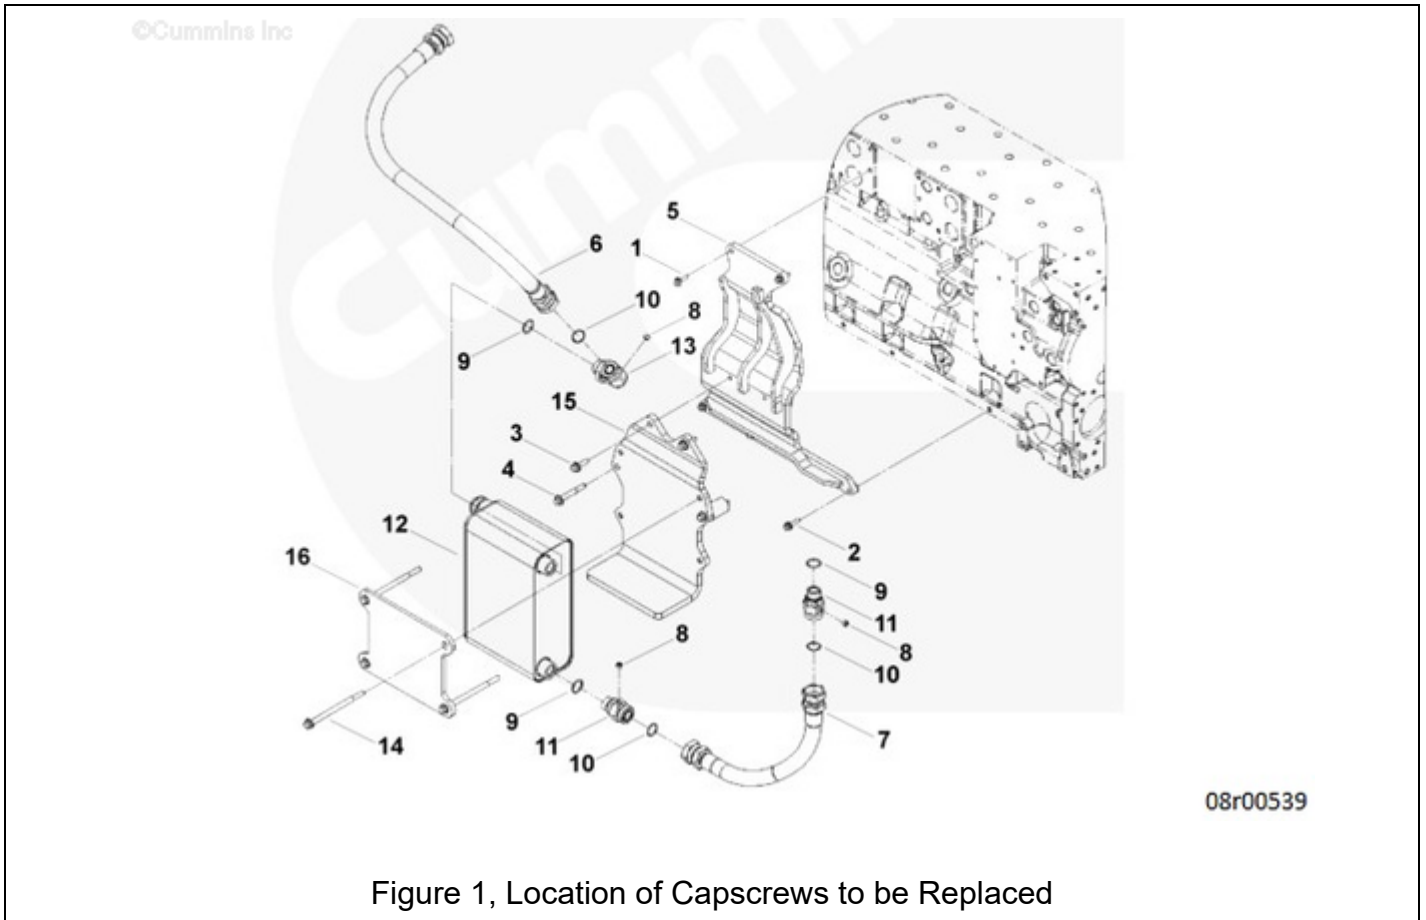
Figure 1, Location of Capscrews to be Replaced

- Broken capscrews found on the heat exchanger main support bracket to engine cylinder block.

- Capscrew strength insufficient.

Replace broken capscrews shown in location 1 and 2 in Figure 1 below with new higher grade capscrews. Reference Table 1 below for applicable part numbers.
