# Paint Blistering Due to Corrosion on Lower Door Sill

YEAR(S)	MODEL(S)	ADDITIONAL INFORMATION
2007 - 2020	Tundra

Some 2007 – 2020 model year Tundra vehicles may exhibit corrosion or paint blistering on the front and/or rear lower door sill(s). Follow the Repair Procedure in this bulletin to address this condition.

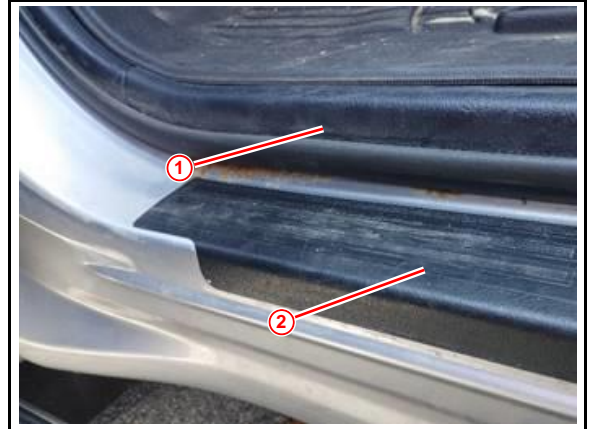
**Figure 1.**

<b>1</b>	Door Scuff Plate
<b>2</b>	Door Sill Protector

2. Sublet the vehicle to a body shop to repaint the door sill(s).
  - A. If the vehicle has door sill protectors installed, remove the door sill protectors on the affected door BEFORE painting. A NEW door sill protector MUST be ordered and installed AFTER the vehicle has been repainted.
  - B. Remove the door open trim weather strip.
  - C. If burrs are present on the top of the pinch weld flange, sand down the burrs BEFORE repainting.
  - D. Repaint the lower door sill(s) following the paint manufacturer's system specifications.
  - E. AFTER repainting, continue to step 3.

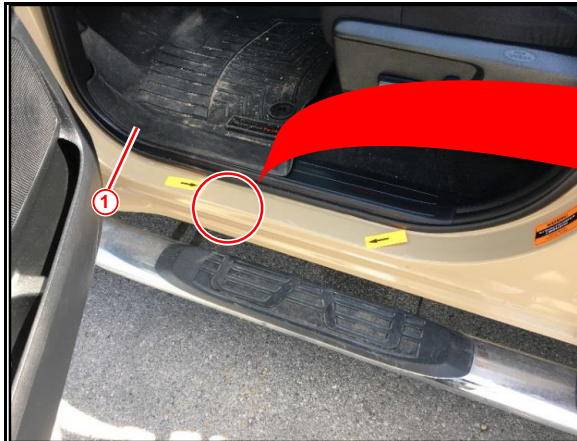
**Figure 2.**

<b>1</b>	Kick Panel
----------	------------

4. Apply the quarter panel protector (clear flange tape).
  - A. Remove the plastic door scuff plate and kick panel. Remove the lower half of the door open trim weatherstrip.
  - B. With a clean rag and rubbing alcohol, remove ANY debris or dirt from the outer, upper, and inner portions of the lower door sill flange.
  - C. Center the clear flange tape over the lower door sill flange. Do NOT overlap the door sill protector and the clear flange tape.
    - (1) For all affected front doors, apply the clear flange tape over the pinch weld flange. Align the front most part of the tape with the front most flange bowl as shown.

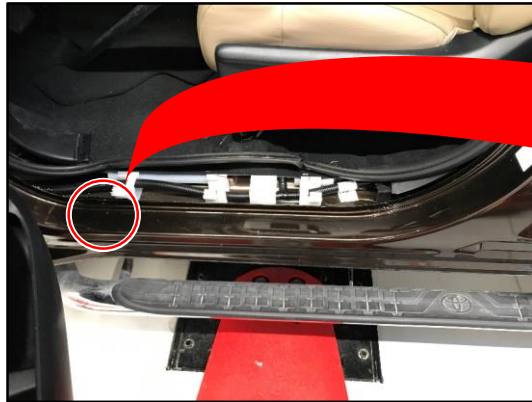
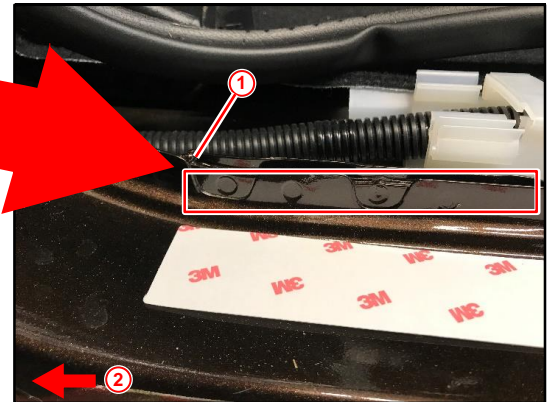
<b>1</b>	<b>Front-most Flange Bowl</b>
<b>2</b>	<b>Front</b>

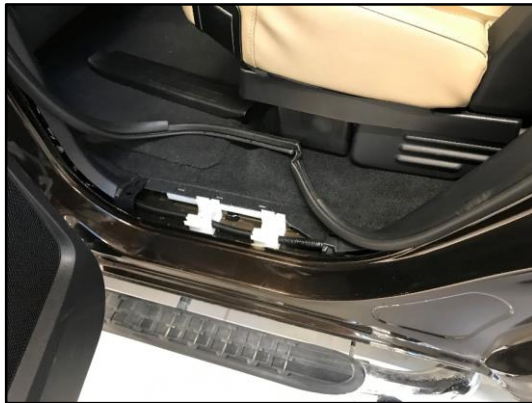
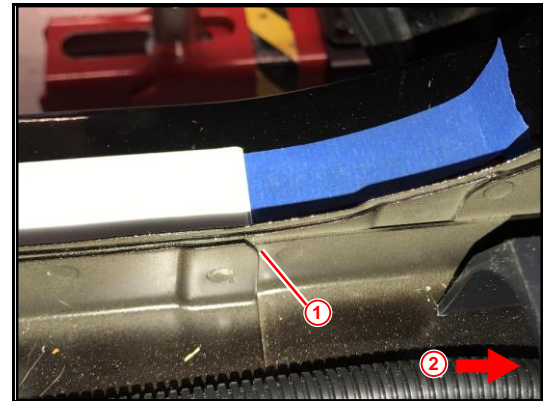
**Figure 6. Left Rear Door Sill for Double Cab**

<b>1</b>	<b>Align Tape With the Leading Flange Edge</b>
<b>2</b>	<b>Front</b>

- (2) For double cab rear doors, align the front of the clear flange tape with the inner flange sheet metal edge as shown.

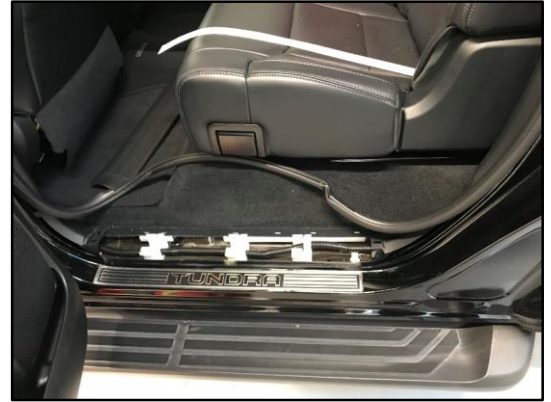
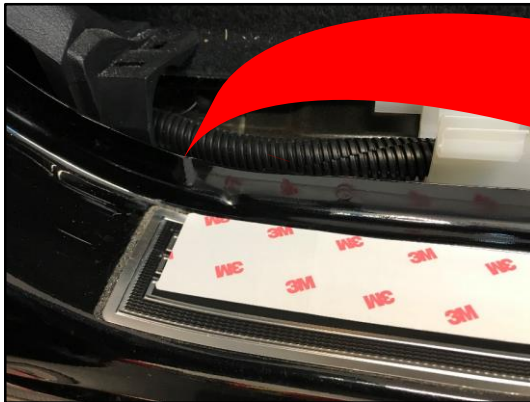
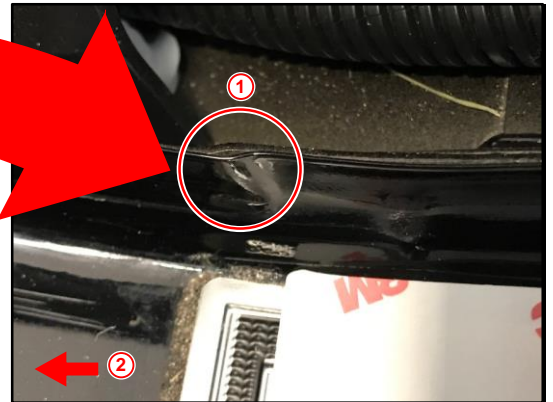
**Figure 8. Left Rear Door Sill for Crew Max**

<b>1</b>	<b>Align Clear Tape With Flange</b>
<b>2</b>	<b>Front</b>

- (3) For crew max rear doors, align the front of the clear flange tape with the bend in the flange as shown.

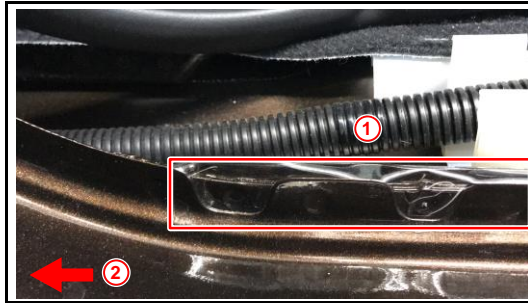
**Figure 11.**

<b>1</b>	<b>Clear Flange Tape Installed</b>
<b>2</b>	<b>Front</b>

- E. Continue to install the flange tape to the front, top, and back side of the flange, making sure NO air bubbles or wrinkles are present.

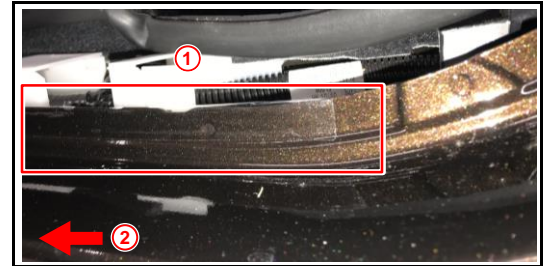
**Figure 12.**

<b>1</b>	<b>Clear Flange Tape Installed</b>
<b>2</b>	<b>Front</b>
