SIB 51 04 20

RATTLE NOISE FROM STEERING COLUMN TRIM

E-Series	Model Description	Production Date
G29	Z4 Roadster	Up to December, 2019

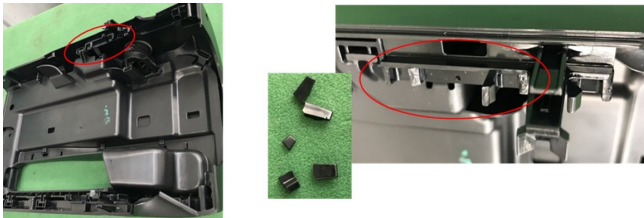
One or more of the lower steering column trim latching mechanisms is broken.

2. Inspect the latching mechanism shown to the left for damage. Is damage found?

Yes: Replace the lower steering column trim. Replacement parts have been improved.
