BULLETIN NUMBER:
IB16-J-001B

CRANK NO START – INSPECT FOR SHEARED CAM PIN

- 2012-2020MY Isuzu N-Series
Equipped with 6.0L Gas V-8 Engines

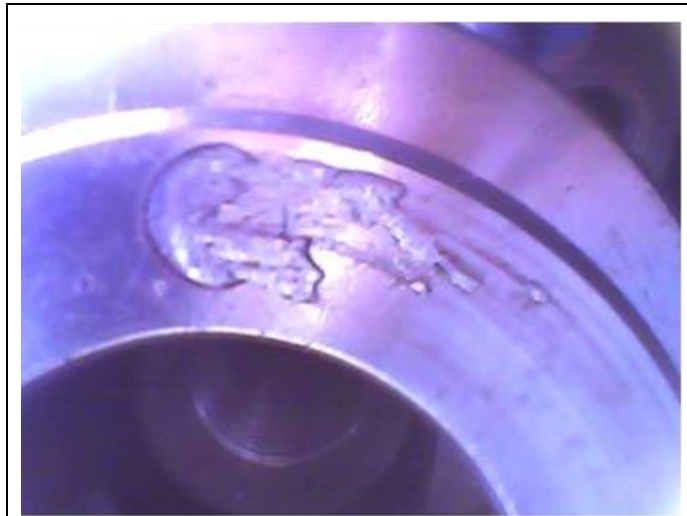
This concern may be the result of a sheared camshaft sprocket locating pin due to the camshaft seizing to the camshaft bearings at one time.

4. If you have completed steps 1, 2, or 3, remove the front cover to inspect for a sheared cam sprocket locator pin. See sheared cam locator pin in Figure 1 below.

5. If it is determined the cam sprocket locator pin has sheared the engine assembly will need to be replaced. Technicians are to contact the IQC per bulletin IB09-X-001E. Follow the instructions provided from the IQC to complete the repair.
