# Service Bulletin

Bulletin No.: 20-NA-054

**Subject: Rear View Camera Guidance Lines Dim After Radio Replacement or Programming**

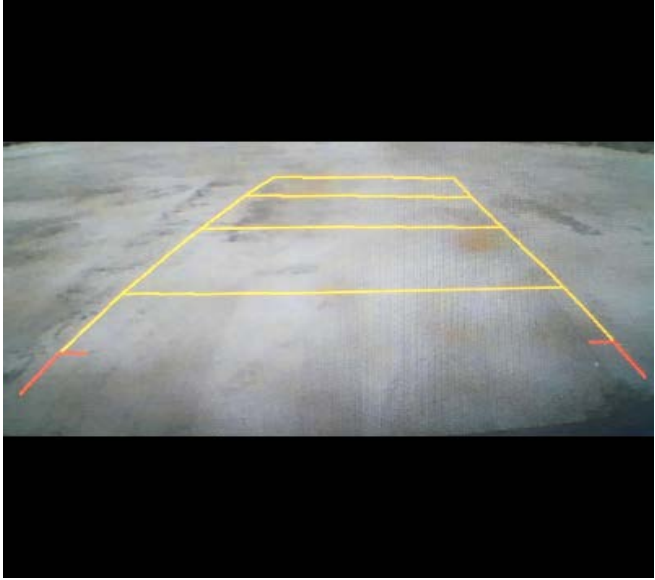
<b>Involved Region or Country</b>	North America
<b>Additional Options (RPOs)</b>	Equipped with Infotainment system IOS, IOT, or IOU
<b>Condition</b>	<p>Some customers, after having radio replacement or radio reprogramming, may report that the Rear-View Camera (RVC) guidance lines are not as bold as previously viewed, that they are faint, see-through, thinner, dim, or translucent; and they used to be more visible. A comparison between similar vehicle models may, or may not, show a difference in rear view camera guidance line appearance.</p> <p>Original design:</p>

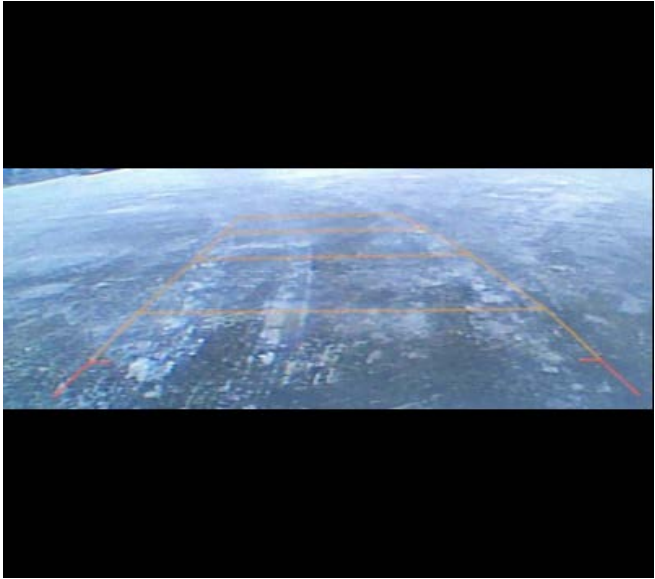
5525912

<p>New design:</p>

<p style="text-align: right;">5525914</p>
<p><b>Cause</b></p>	<p>This may be caused by installing calibration files released in mid-2018 during radio replacement or reprogramming of the radio. The change to increase translucency was done to prevent the lines from obstructing objects in the field-of-view.</p>
<p><b>Correction</b></p>	<p>Do not attempt repairs. The thinner, lighter appearance of RVC guidance lines is operating to design intent.</p>
