## STAR ONLINE PUBLICATION

**Case Number:** S2023000013

**Symptom/Vehicle Issue:** Water Leak In Area Of A Pillar Or On Passenger Floor

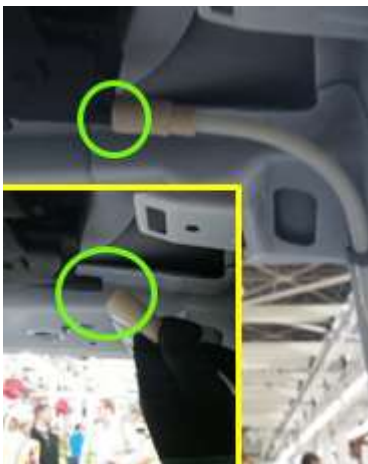
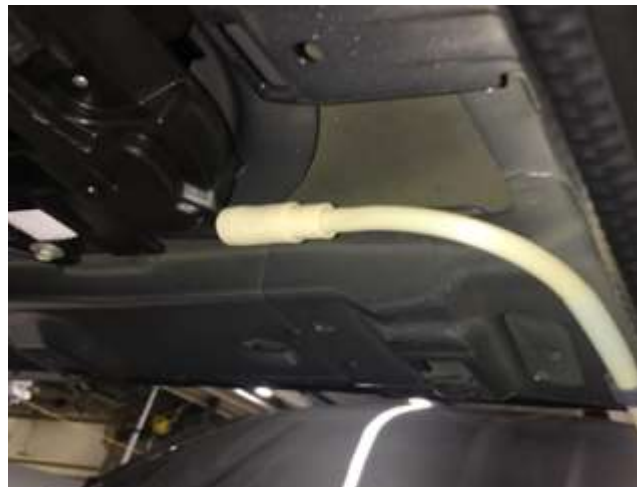
**Discussion:** If equipped with a sunroof, inspect the right front sunroof drain tube. Ensure the tube connection is fully hand pressed on.

**Fully Connected**

**Verification:** Water test to confirm repair.
