STAR ONLINE PUBLICATION

Case Number: S2023000014

Symptom/Vehicle Issue: Single Pop Noise From Rear Of Sunroof While Opening

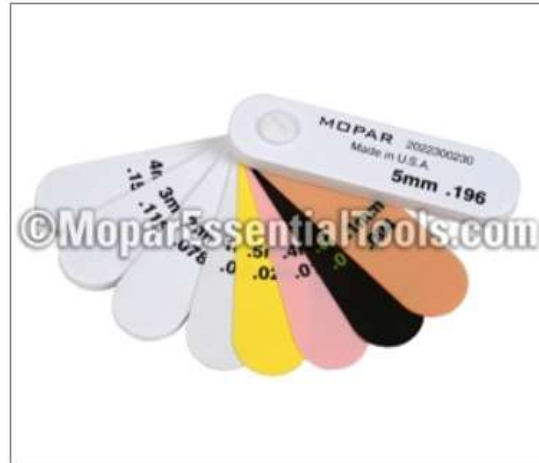
Discussion: With aid of a helper, view the roof while operating the sunroof in “Vent” and “Open” positions. If the sheet metal of the roof is grabbed and pulled down by the sunroof glass/seal causing a single pop noise follow the below prior to replacing any components. Note minor movement of the roof skin is normal. The sunroof seal presses against the roof and some minor deflection will occur without a pop noise.

1. Inspect the sunroof glass seal for damage, taking a “set” or wear to the surface. The surface of the seal should be slick to the touch. If it is worn smooth, feels tacky or sticky replace the sunroof glass (seal comes bonded to the glass). Normal seal appearance is slightly rough texture but slick to the touch. If the texture is ok and no wear found, apply weather strip lubricant 04773427AB to the seal. Note it is necessary to remove the glass to apply the lube. Reinstall the glass and go to step 2.
2. Verify glass installed height first. Refer to service information 23 - Body / Sunroof / GLASS, Sunroof / Adjustments. Set the glass position to the 0mm to -2mm in front and -1mm under flush to roof at rear corners.- Note this differs from service information. Use non-marring body gap feeler gage Mopar Essential tool #2022300230 to help center the glass in the roof opening.

3. Operate the sunroof through the Open and Vent positions again. Is the condition still present?
 - a. Yes, still popping> continue to step 4
 - b. No, condition no longer present> perform Verification test at the bottom of this document.

4. Adjust sunroof glass forward using glass-mounting screws while still maintaining the glass height specification from step 2. Loose the screws, insert (2) 5mm feeler gauges (tool 2022300230) between rear of sunroof glass and the roof to space the glass 5mm forward. Tighten screws to 49 in.lbs (5.5nm). Test operation of the sunroof in Vent and Open/Close positions. Is concern still present?
 - a. Yes still popping> go to step 5
 - b. No> perform verification test.
