NUMBER: 09-004-20

No Weep Hole In Muffler Assembly

This bulletin involves drilling a weep hole in the muffler assembly.

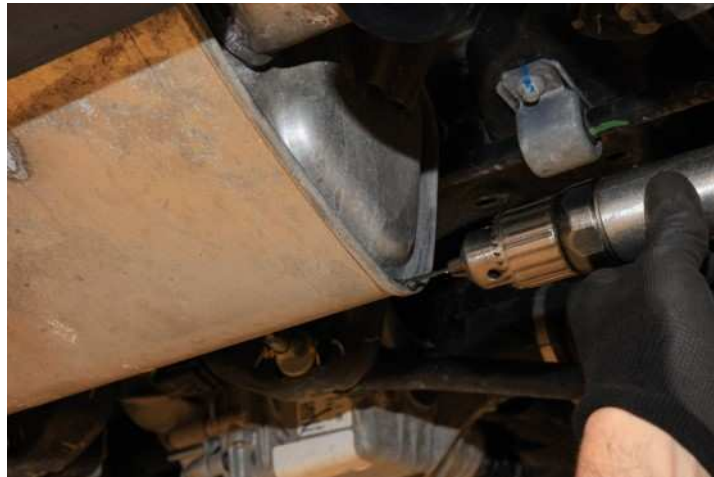
Fig. 1
Muffler Assembly With Weep Hole

The customer may describe a crank, no start condition, in freezing temperatures. This condition can be caused by condensation freezing in the muffler assembly.

1. Raise the vehicle on hoist. Refer to the detailed service procedures available in DealerConnect> Service Library under: Service Info> 04 Vehicle Quick Reference> Hoisting> Standard Procedure.
2. Is there a weep hole on the end of the muffler as shown in (Fig. 1) ?
 - YES>>> This bulletin does not apply. Normal diagnosis should be performed.
 - NO>>> Proceed to Step 3.
3. **NOTE: The weep hole must be drilled into the end of the muffler assembly as shown in (Fig. 1) .**
 Using a 3 mm (1/8 in) drill bit and a drill, drill a weep hole no deeper than 2.5 cm (1 in.) into the muffler assembly at the bottom lower corner (Fig. 1) .
