Service Bulletin

Bulletin No.: 18-NA-121

Subject: Malfunction Indicator Lamp (MIL) Illuminated, 1st Gear and/or Reverse Only with No Upshift, Vehicle Will Not Go Above 40 km/h (25 mph), 1-2 Shifts Feels Like a Momentary Tie Up, DTC P2731 Set

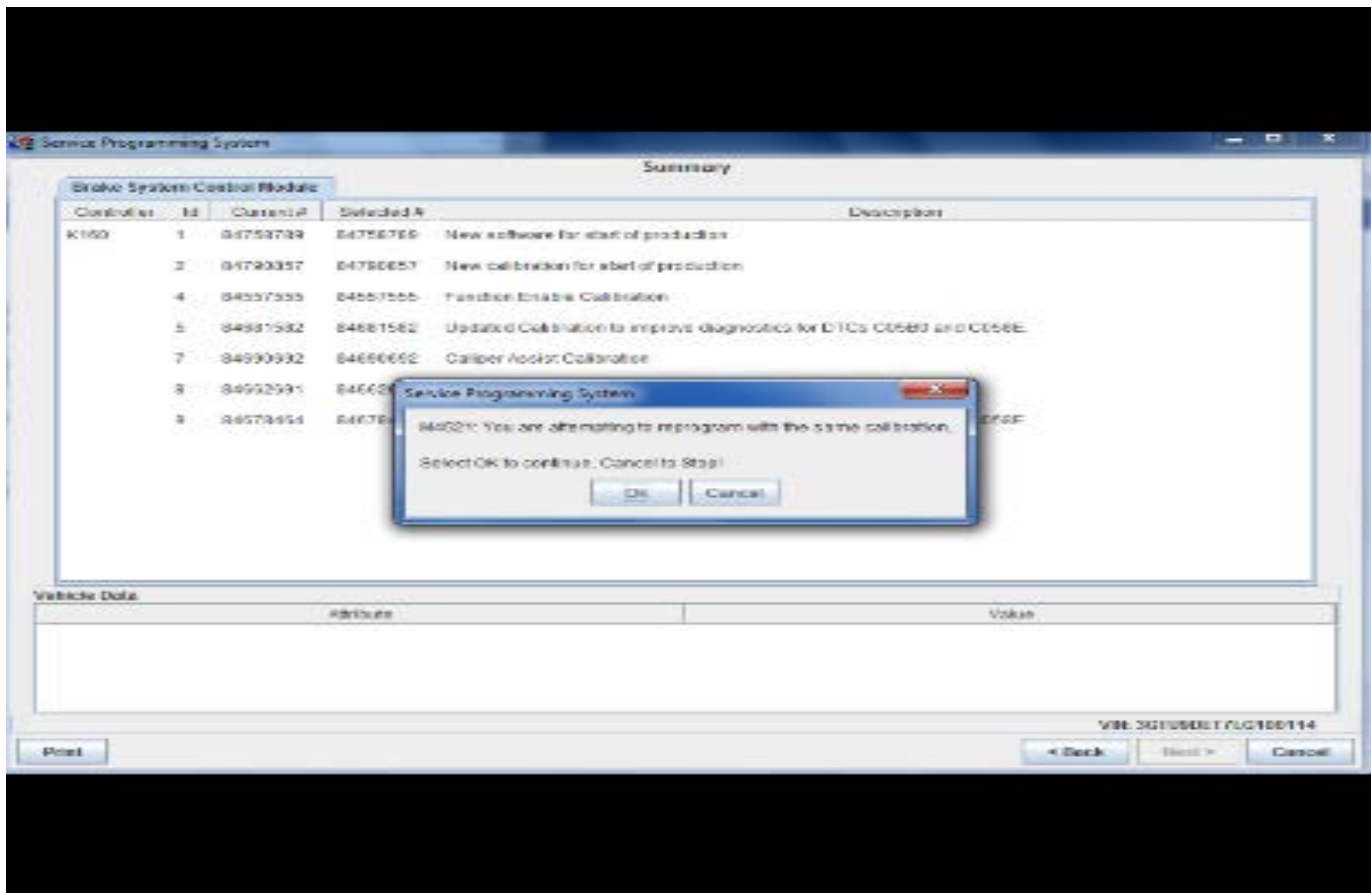
5431207

Important: If the Same Calibration/Software Warning is noted on the SPS screen, select OK and follow screen instructions. After a successful programming event, the WCC is located in the Service Programming System dialogue box of the SPS Summary screen. No further action is required. Refer to the Warranty Information section of this bulletin.
