## **Service Bulletin**

Subject: Launch Shudder/Booming Noise Between 40-50 MPH (64-80 KM/H)

Brand:	Model:	Model Year:		VIN:		Engina	Transmission:
		from	to	from	to	Engine:	Transmission.
Chevrolet	Silverado (MD) 4500HD/ 5500HD/ 6500HD	2019	2019

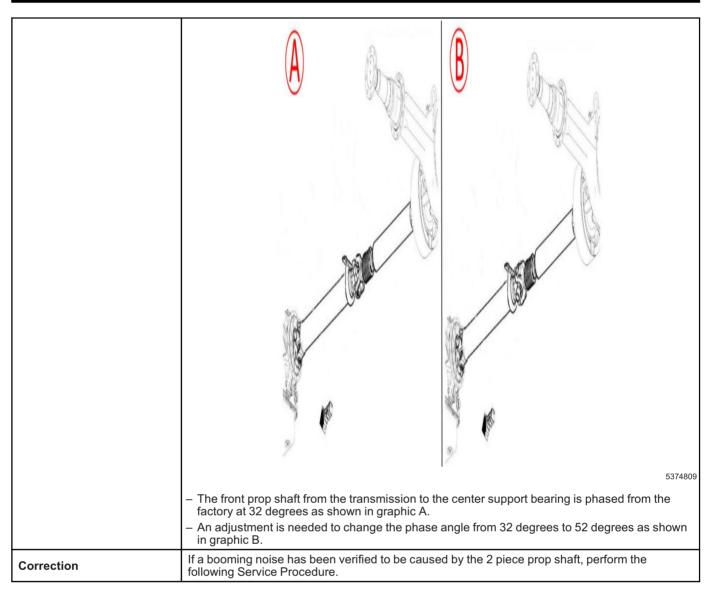
Involved Region or Country	volved Region or Country North America, Middle East and Israel	
Condition Some customers may comment that a booming noise can be heard between 40-50 mph (64-4 km/h).		
Cause	This condition may be caused by the front propeller (prop) shaft.
