Service Bulletin

Bulletin No.: 20-NA-081

Subject: Surface Rust on Front Seat Bottom Frames

Brand:	Model:	Model Year:		VIN:		Engine:	Transmission:
		from	to	from	to		
Chevrolet	Bolt EV	2017	2020			All	All

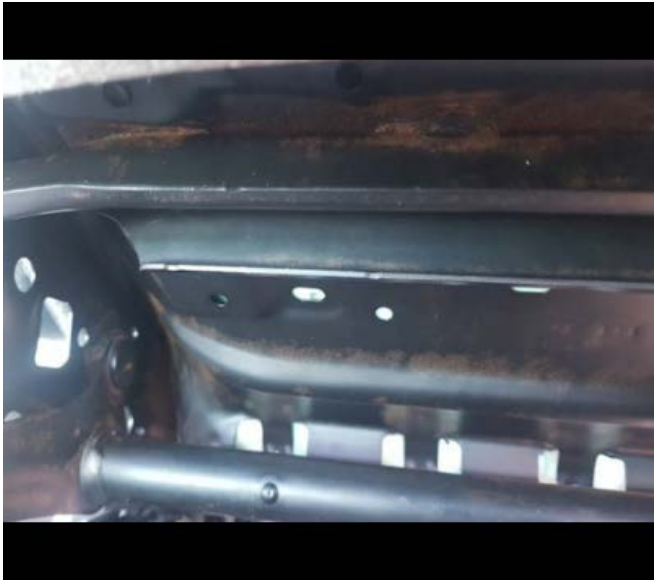
<p style="text-align: right; font-size: small;">5552481</p>
Cause	Depending on the exposure of the vehicle to outside weather conditions, including salt in the air, surface rust can be found on the underside of the front seat cushion frames.
Correction	This is a cosmetic condition in an area that is not visible to the customer during typical vehicle use. Please do not replace the front seat frames for cosmetic corrosion in areas that are not visible to the customer during typical vehicle use.

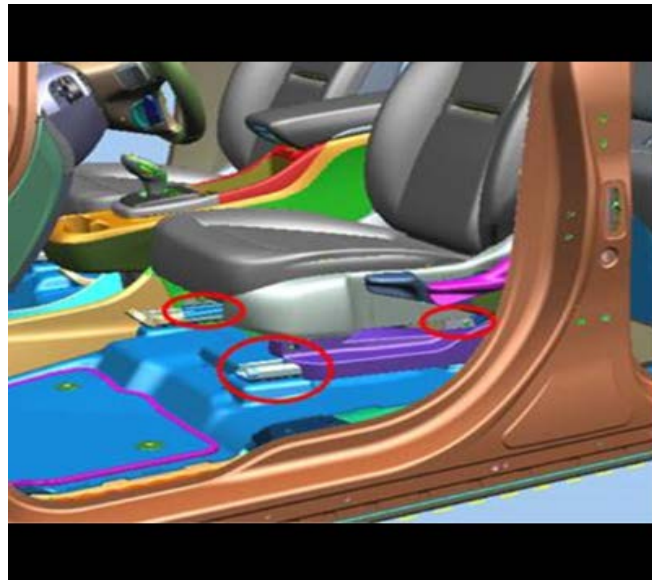
5552478

Note: Areas that are considered “visible to the customer during typical vehicle use” can be seen while standing outside the vehicle, sitting in the vehicle, or during entry/exit like illustrated above. This includes, but is not necessarily limited to: seat tracks, adjuster handles, and visible portions of the adjuster linkages.
